The Bent Pyramid

A Layman's Guide part 1

Keith Hamilton. 15 July 2017

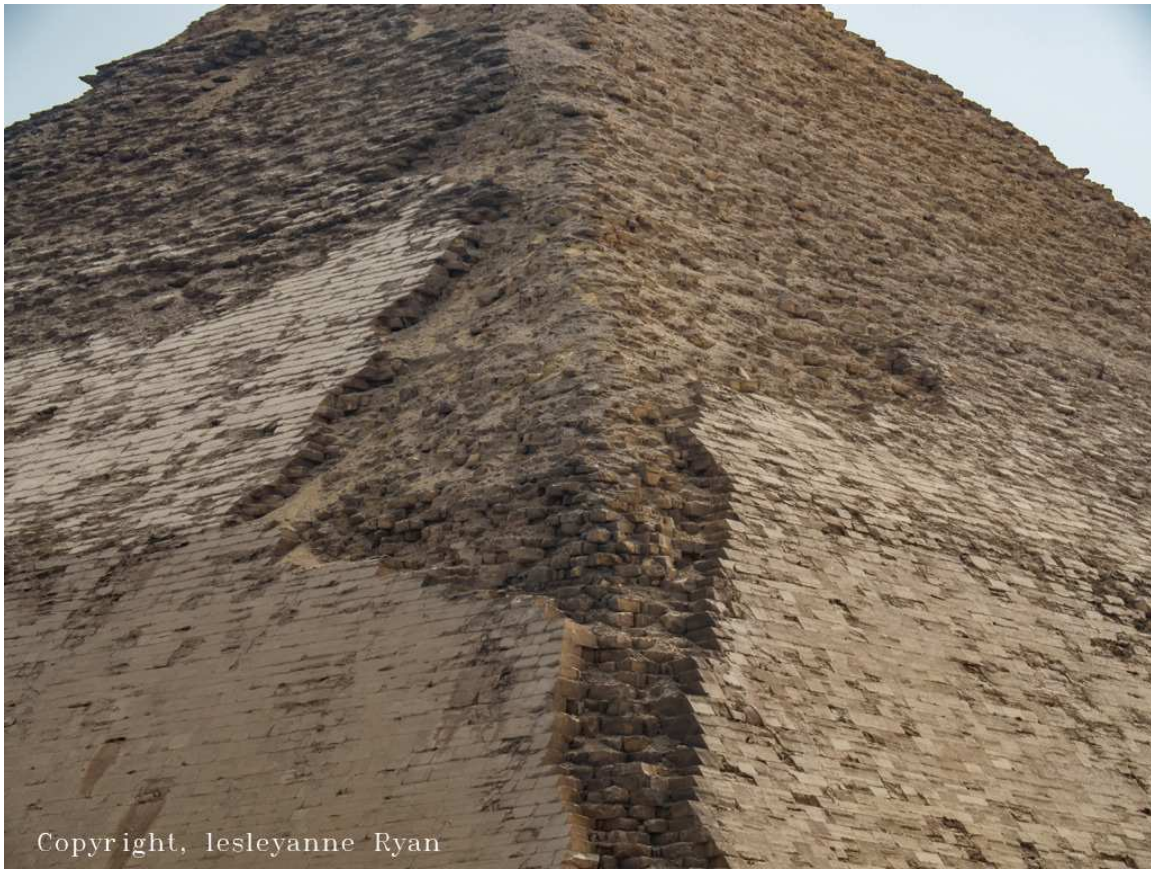
The image above, kindly provided by Lesleyanne Ryan, shows some of the surviving casing stones. Petrie was of the opinion that “...*much of the destruction has been done in the present century, and even a few years ago.*” Perring mentions; “*The masonry in the lower part has also been destroyed, principally, it is said, by the late Deftarder Mohammed Bey, to get materials for his palace near Cairo.*” Though I feel it is quite likely that looting of good quality stone, be it from the surrounding wall, causeway etc stretches back into antiquity.

The casing stones display numerous patches and slips of stone along joint lines, possibly to effect repairs to stones damaged by installation. There are also instances where cracks can be seen running vertically through several adjacent casing stones. These cracks have been used by proponents of the settlement theory to explain the form of the pyramid. To me, these cracks, in the scheme of this giant structure, by crude analogy, are no worse than a crack visible from, say, a window corner in our modern homes. Like at Meidum, the core stones are not laid with the care and accuracy of the casing stones, gaps existed between blocks, where mortar is absent and contact between adjacent blocks would be restricted to the high points of those

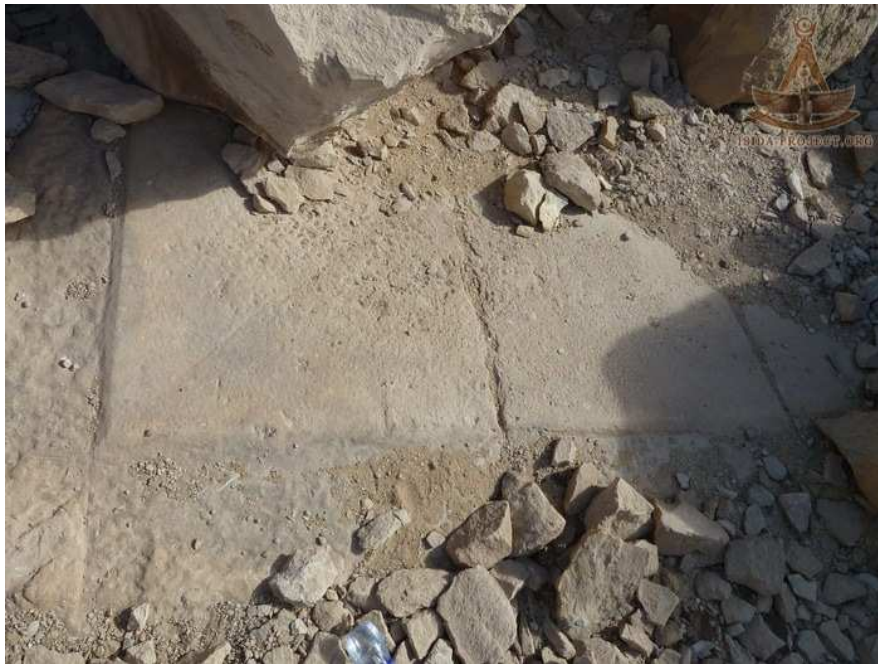
Image of N.W. corner

socket block in the ground; its level is 13 inches below the pavement, part of which there still overlies it. This socket block bears a sloping bed on its upper face, as all the bedding of the courses of this pyramid is inclined inwards 5° or 10°. This bed is well dressed, having of course a slight re-entering angle along its diagonal, where the sloping bed of the north side cuts that of the west. Outside of this sloping surface it falls away slightly and runs about level, to receive a level pavement outside of the pyramid. The block is over 10 feet x 4 ½ feet, with another adjoining it, both together forming this socket bed. The slant face of the casing started directly from the edge of the sloping socket bed, and must thus have been covered over its face by the pavement to a depth of 13 inches. This is proved by the remaining block of pavement still on the socket floor, having a sloping line of dressing on its edge rising at the pyramid angle, in the plane of the casing.”

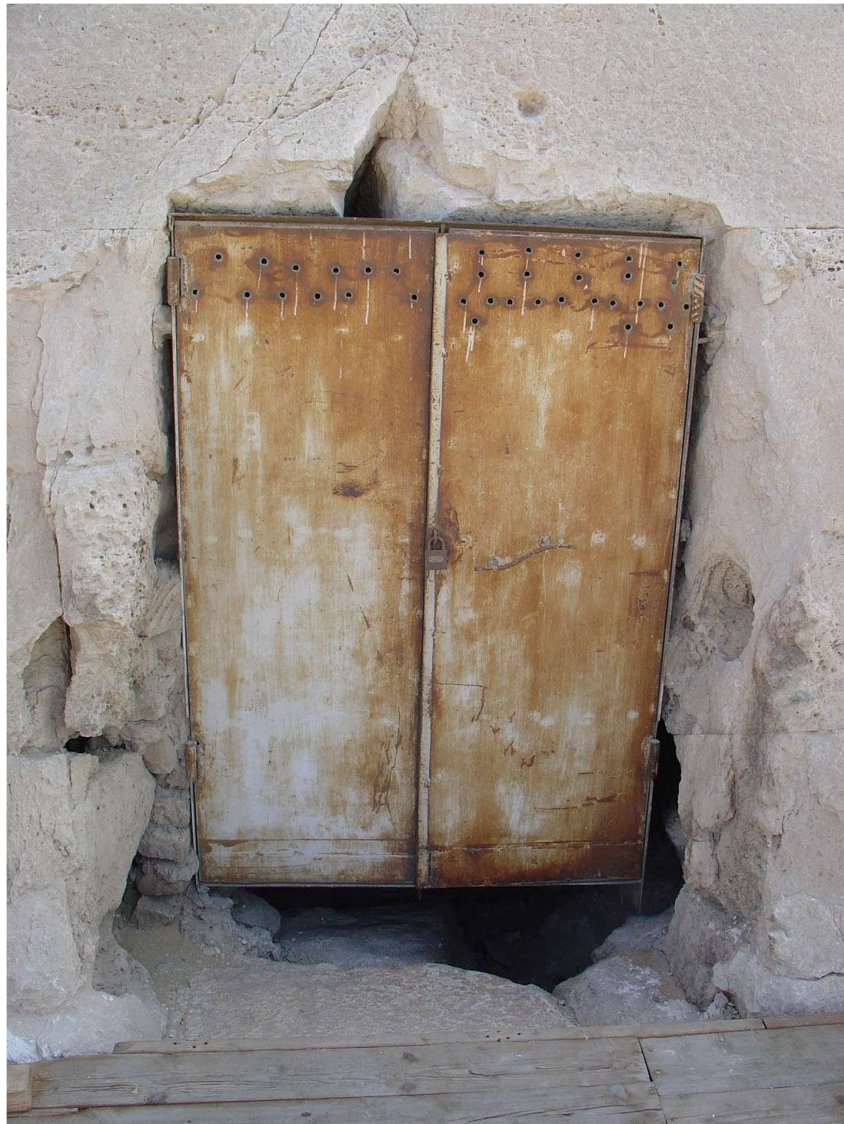
Photo by Iverienen

Above the steel doors, and cut out of the lintel block, is the cutaway that Petrie mentions and it is about 8cm higher than the plane of the passage roof and slopes down to rejoin the ceiling plane; measured along the slope as 40cm. M&R have unusually omitted masonry joint lines for the upper passage walls from their drawings. Puchkov states that the walls from the continuous joint to the entrance are made of single blocks, though pictures of the entrance casing stones suggest two courses; this is not surprising and, like at Meidum, was probably done to disguise the entrance, though how the casing courses married with the single blocks of the passage is not recorded.

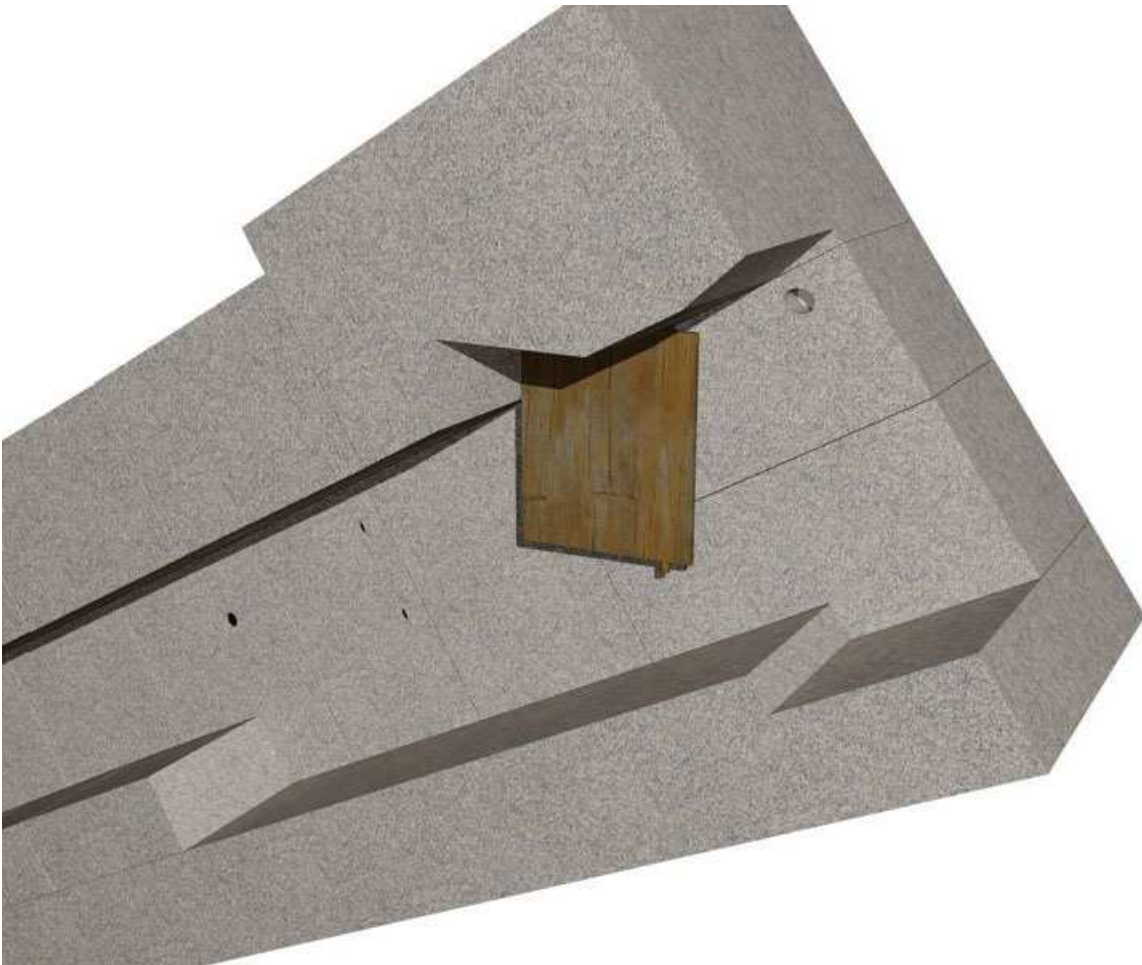
With the steel doors removed we might expect to see something like above, based on M&R's drawing TAV 11. The tapered cut above the door is visible and just below that a round hole that has a partner on the opposing wall. Petrie States;

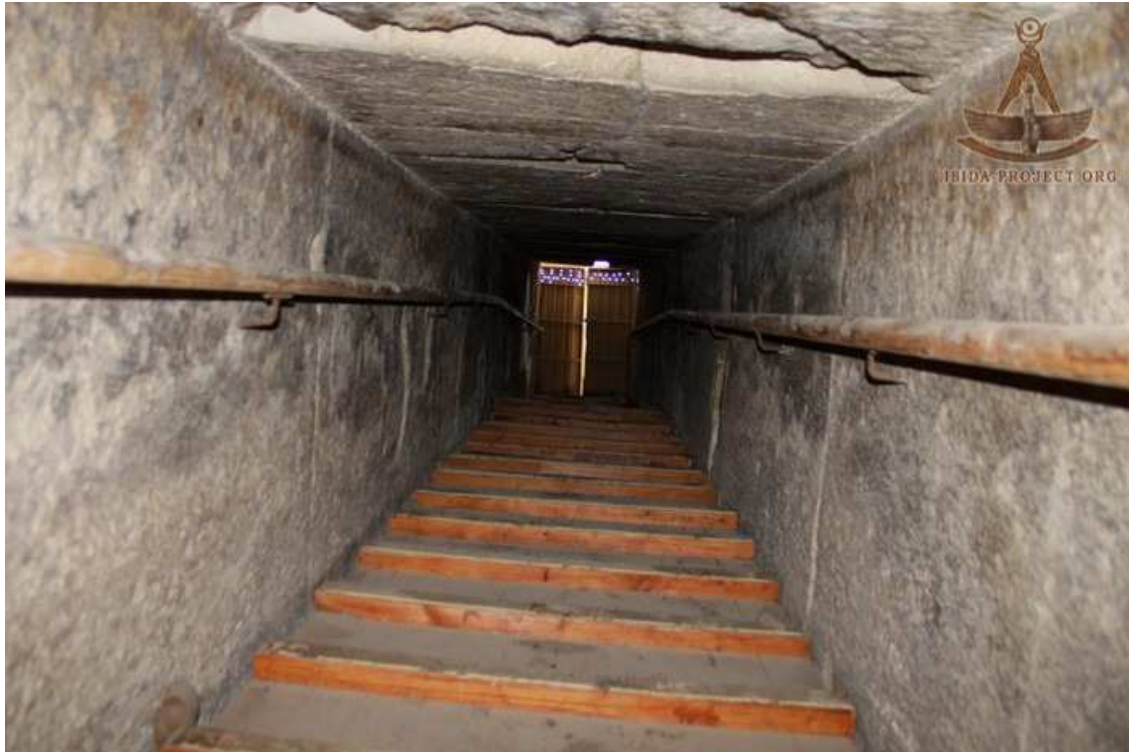
In this view looking up towards the entrance we see the vertical joints of the single blocks mentioned by Puchkov that make the walls of the upper passage, below the continuous joint they revert back to two courses. This use of single blocks will become apparent in later pyramids.

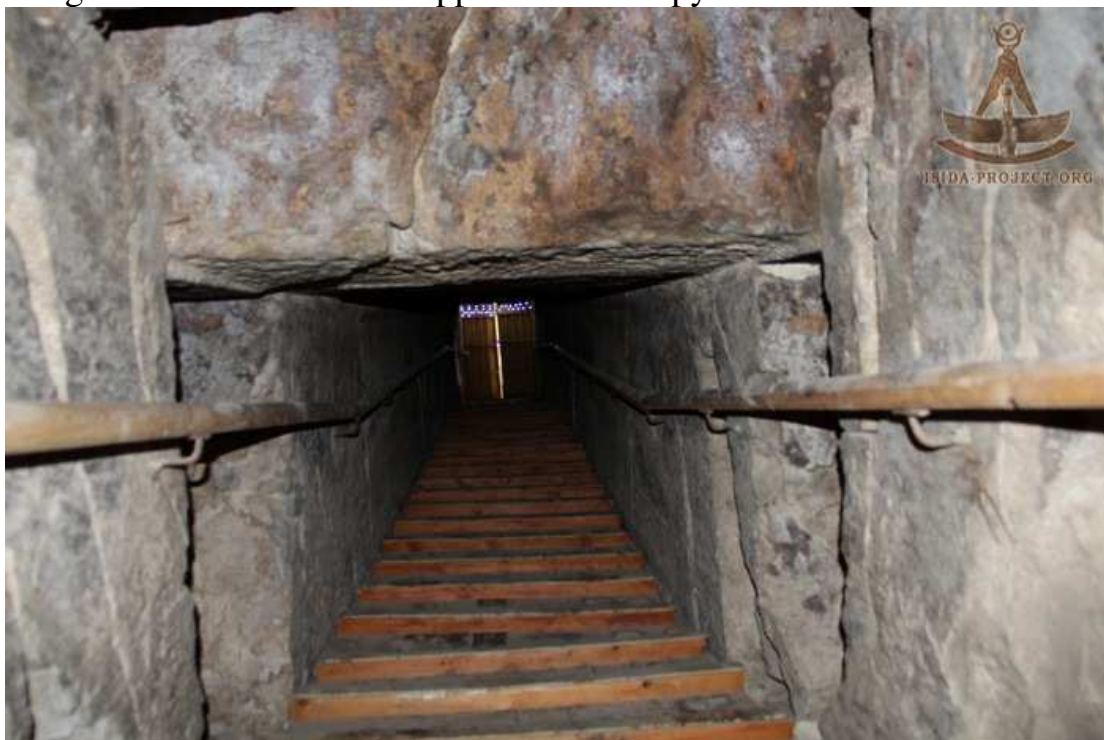
Looking up towards the entrance with the area of so called settlement.

The so called settlement at the continuous joint of some 23 cm is accepted by most as evidence of structural failure and subsidence, though I would tend to accept Petrie's view;

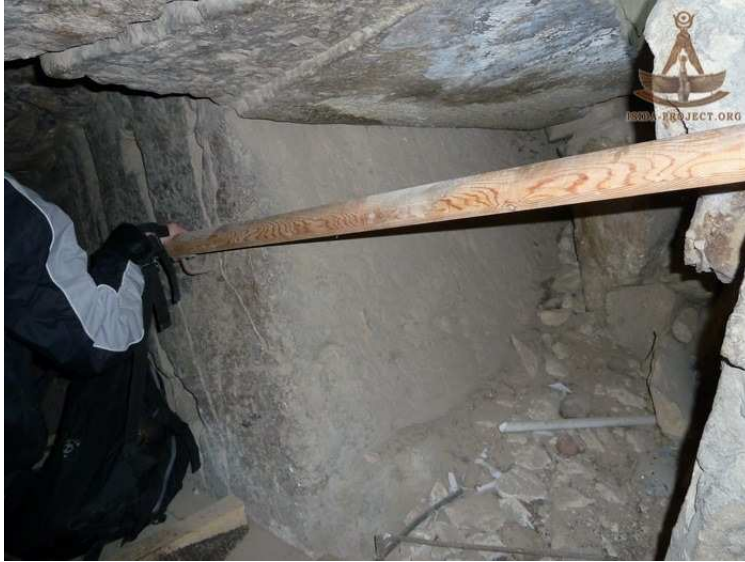
A view into the excavated west wall, showing the face of the continuous joint; also in view is the dressing of the roof mentioned by Petrie.

These faces have an angle of approximately 60 degrees and the continuous joint runs round the walls ceiling and floor. A similar continuous joint displaying a lesser angle of 55 to 58.5 degrees exists in the western corridor; in this corridor there is no so-called settlement at this joint. To explain these

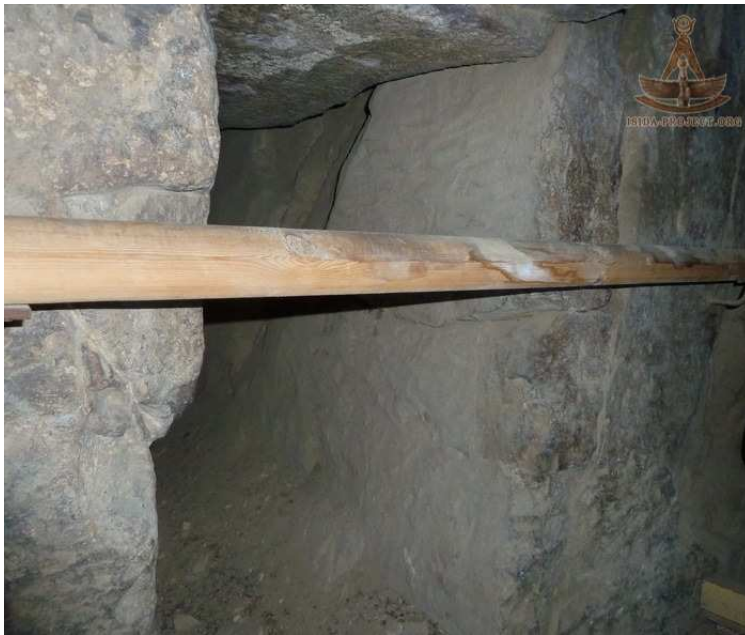
A view into the excavated east wall showing the face of the continuous joint.

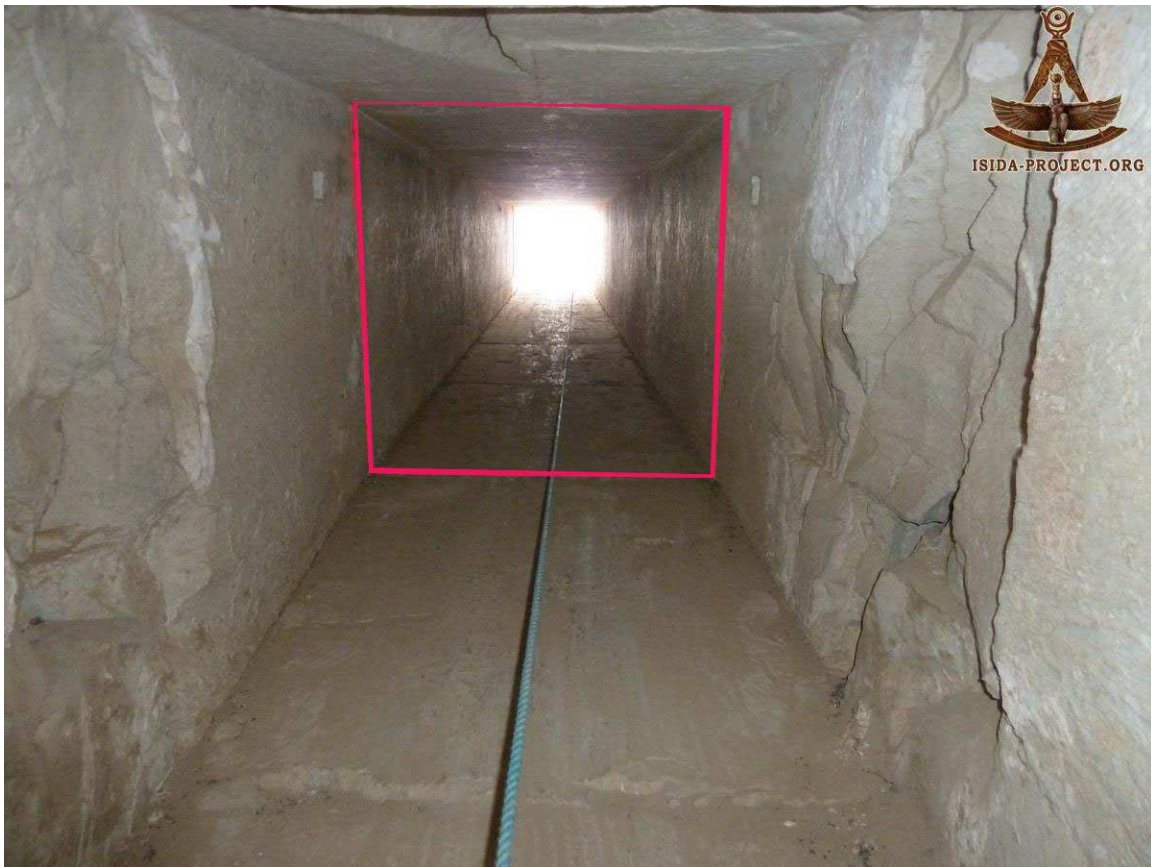
Looking up the western corridor towards the entrance. The red line denotes the continuous joint, east of that are the square holes. The floor is well preserved and smooth and no evidence of 5cm settlement that M&R show in their TAV 13.

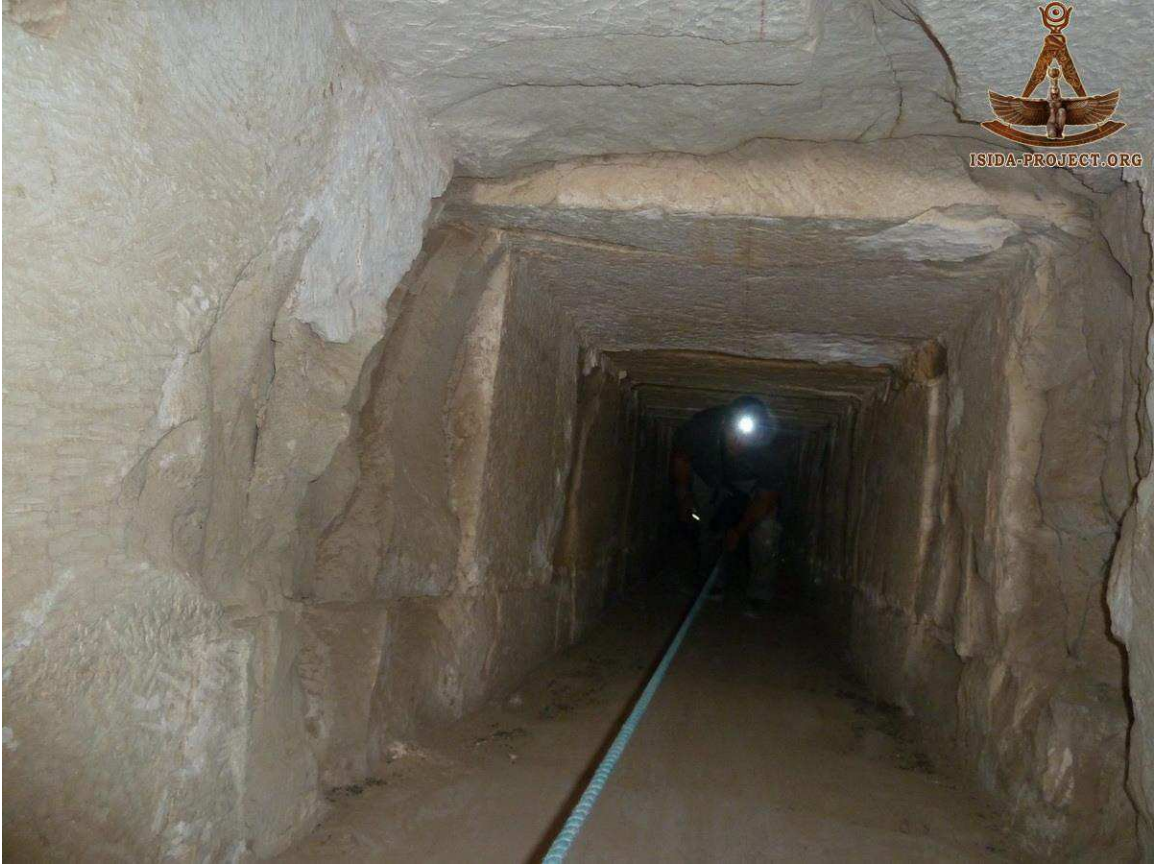
Looking down the western corridor, from the continuous joint; a square hole is just visible in the top left hand corner. The damage to the walls is a bit clearer and is similar to what we see further down the passage and may be related to similar processes of degradation. If there is a 5cm drop in the roof, it could have been built in, as a backstop for a casing block, should it be required in that building phase.

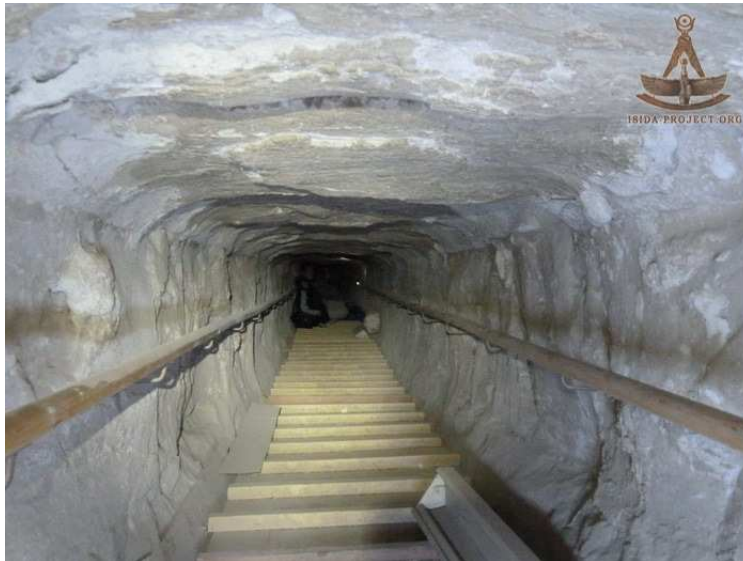
The cavernous form that we see at Meidum is apparent in the Bent pyramid too. Monnier and Puchkov suggest that this may be due to a different type of rock used in the lower parts. It would be useful to obtain a geologists report on the rock and the processes involved that explains what we see today.

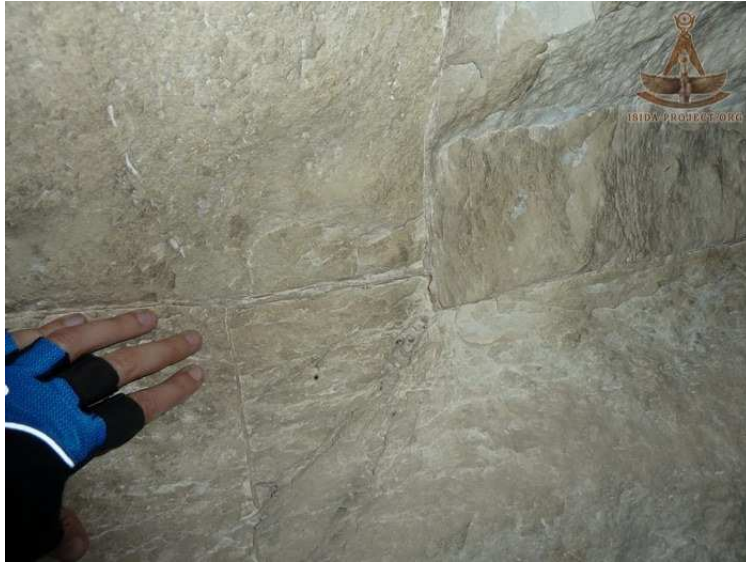
“Along the upper edge of the side walls it is possible to note that the ceiling blocks are placed like the teeth of a saw. This fact which is seldom apparent

in the lower part of the corridor, becomes almost a rule in the upper part. Due to the good state of preservation of the ceiling we were able to notice that the wall blocks were intentionally cut in the upper part in order to receive slabs and that the indentation of the saw-teeth varies from 2 to 4 cm.

We will see a similar use of this saw tooth arrangement on the ceiling slabs in Khufu's grand gallery. The extent of this arrangement in the corridors is not clear from M&R, in TAV 13 they provide a drawing suggesting that the western corridor also has this saw tooth arrangement, but in what locations of the corridor it is not clear. In Fig 15 of Monnier and Puchkov's paper a picture with the title "*Sinking of the ceiling stones in the western passage*" can also be explained as an effect given by the saw tooth pattern; like the rest of the pyramid more detailed scrutiny is required to find and map the locations of this arrangement. Though images I have of the northern extension appear to not have this saw tooth arrangement.

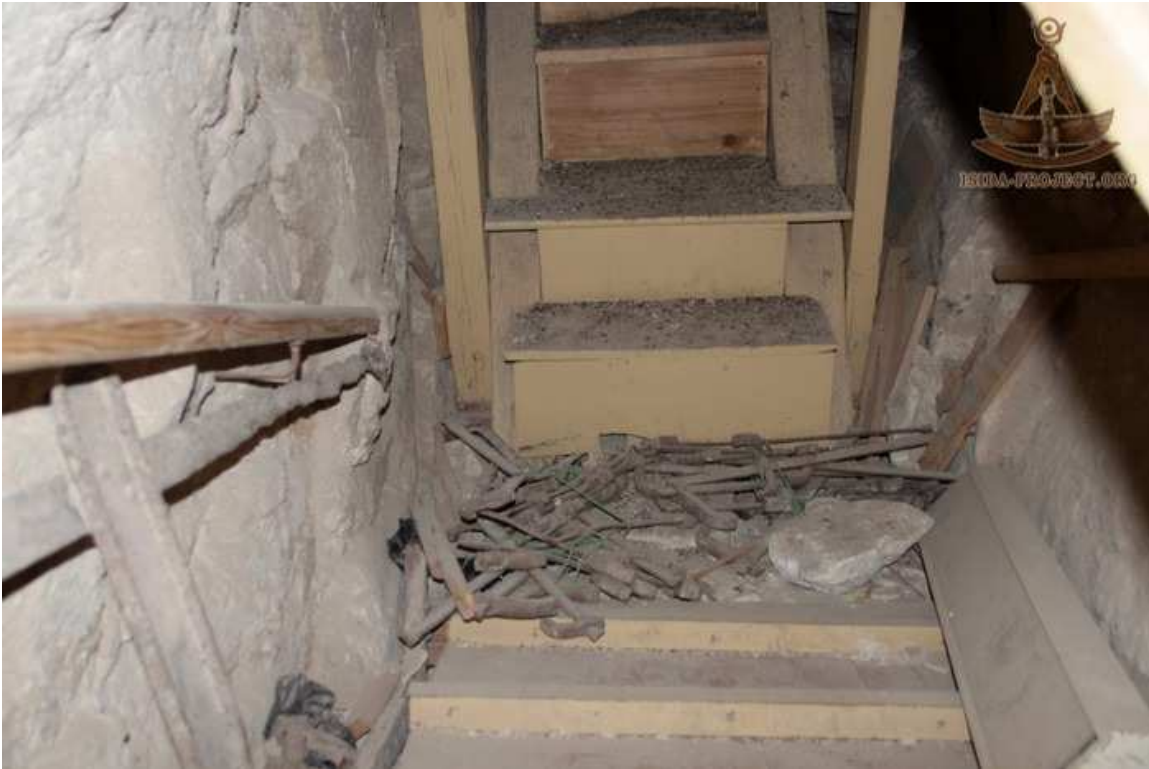
Today the end of the descending corridor meets the modern stairs that provide access to the lower chamber; the same stairs prohibit us from viewing the south rock wall of the antechamber.

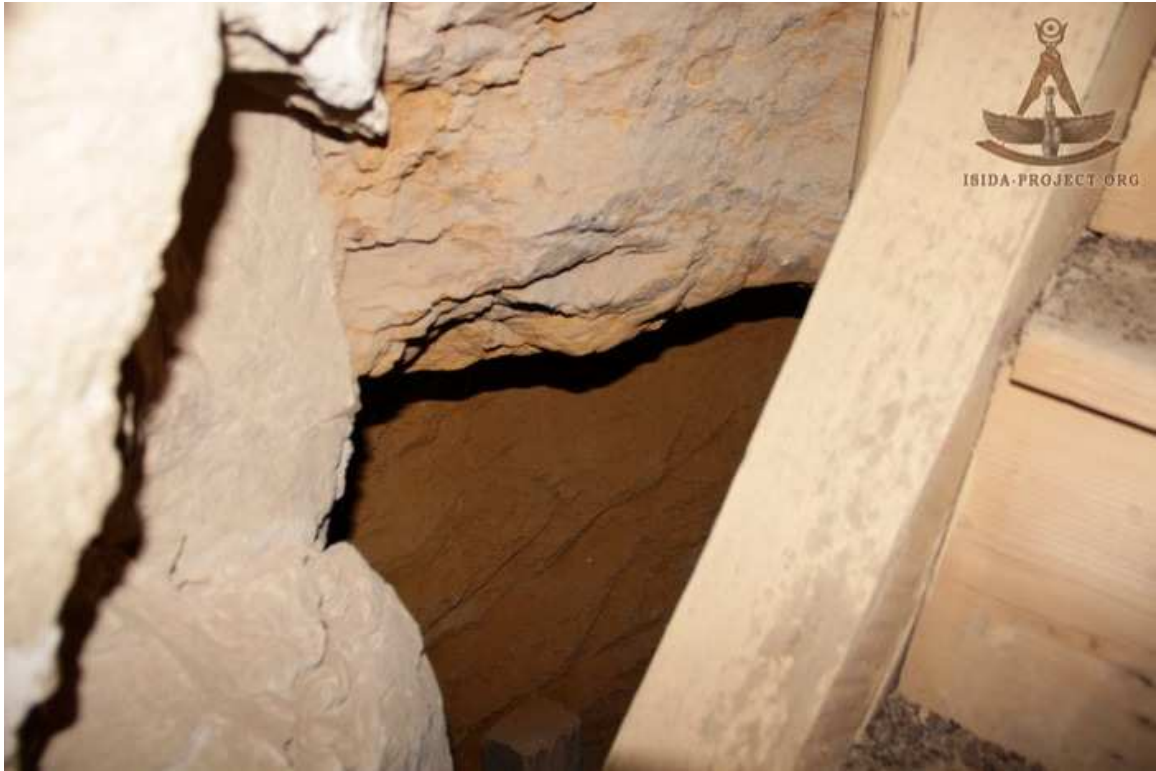
Could this be the natural rock and missing tiling?

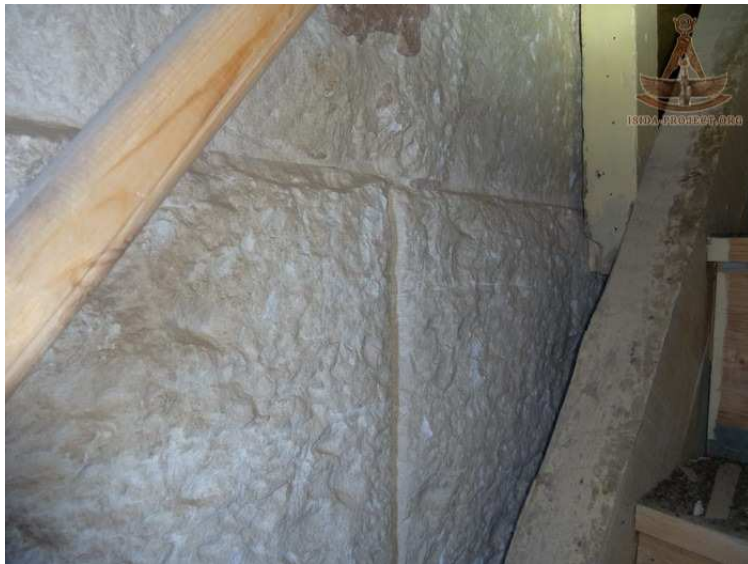
The walls of the antechamber are well preserved where they were protected by the stone staircase.

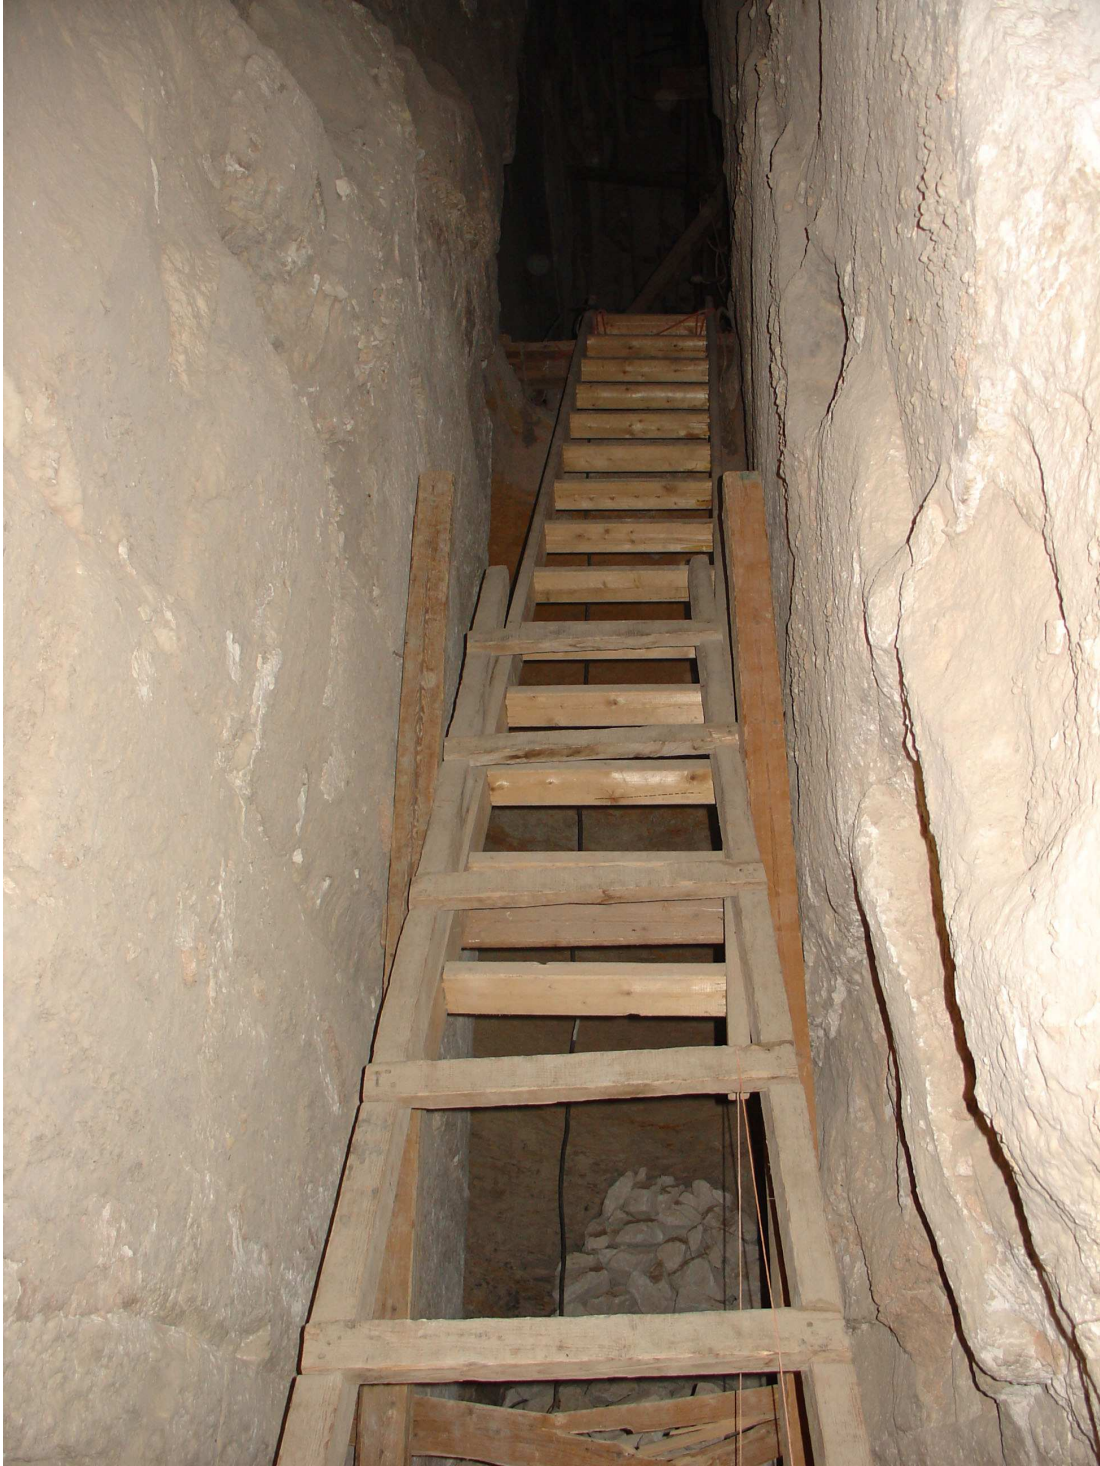
Photo by Ivrienen.

In this earlier image, with somewhat less secure steps, we can make out the southern rock wall of the antechamber.

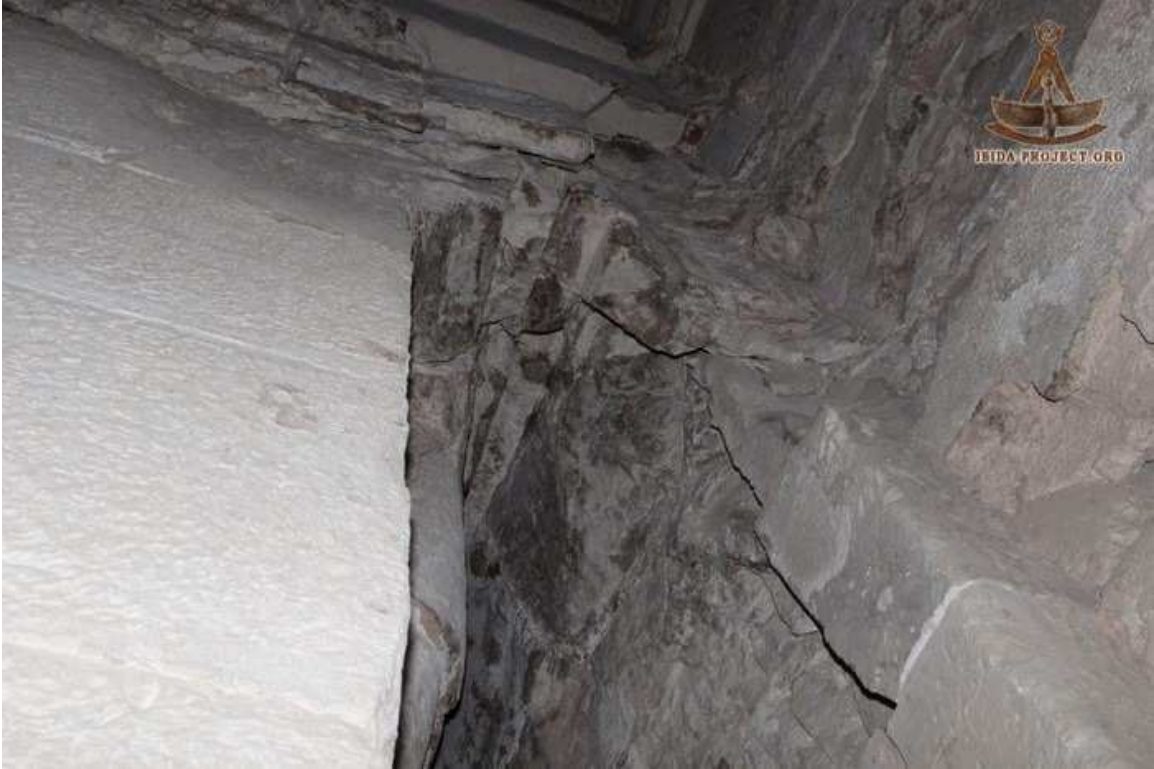
From the floor of the lower chamber we see the damage to the top of the entrance, its original form may never be known.

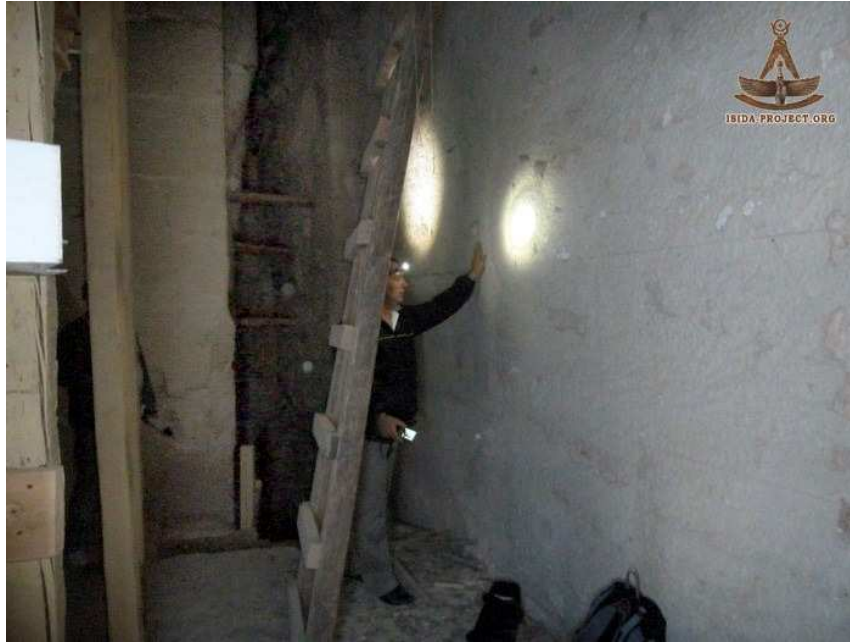
Looking along well preserved east wall

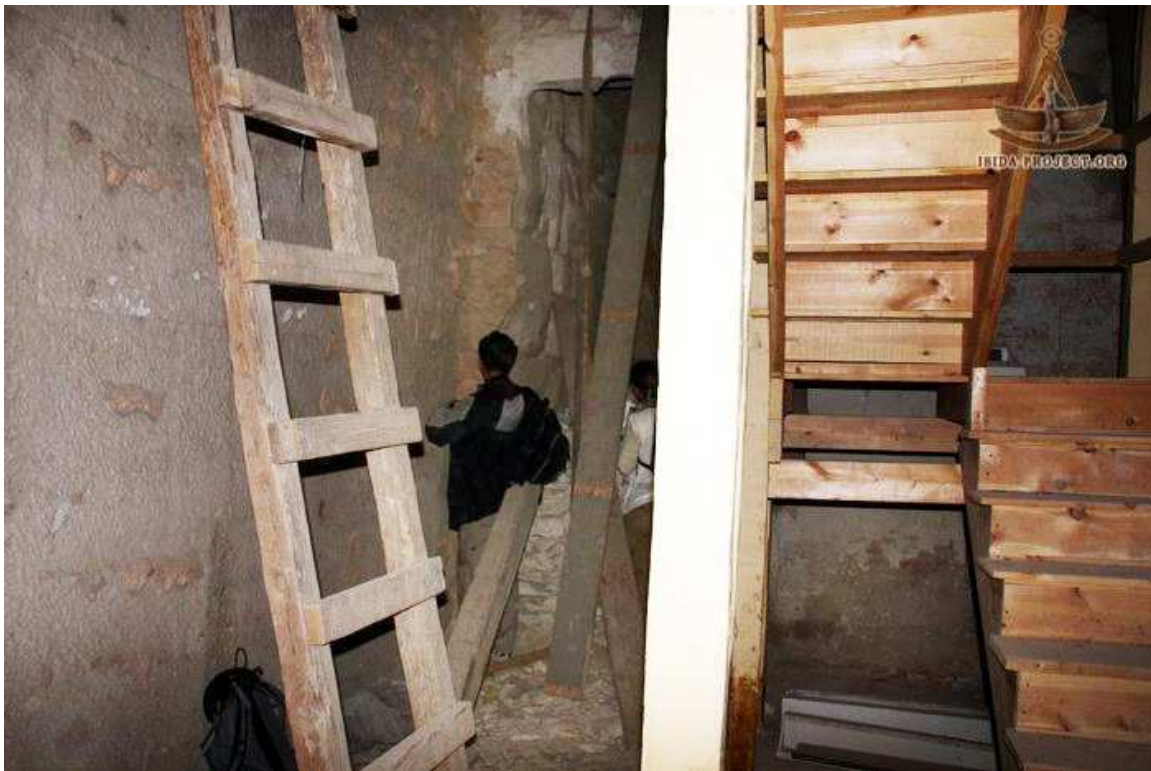
looking along east wall towards entrance to chimney, note traces of red plaster on the walls.

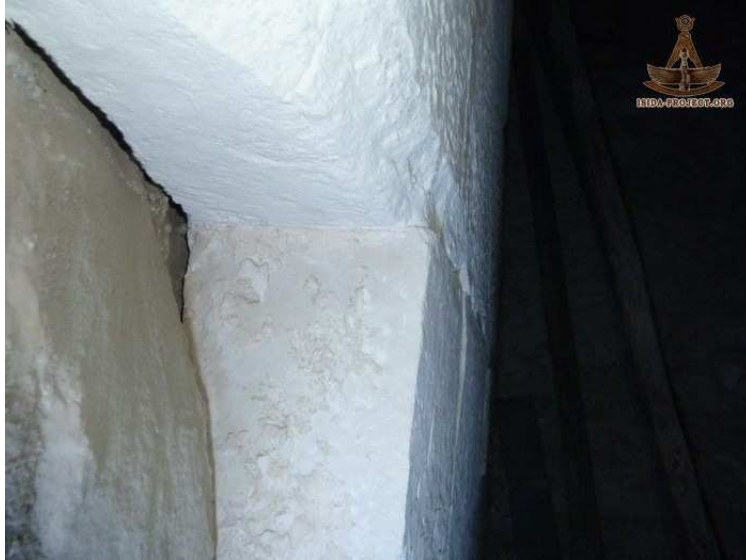
Closer view of what appears to be thick tiling.

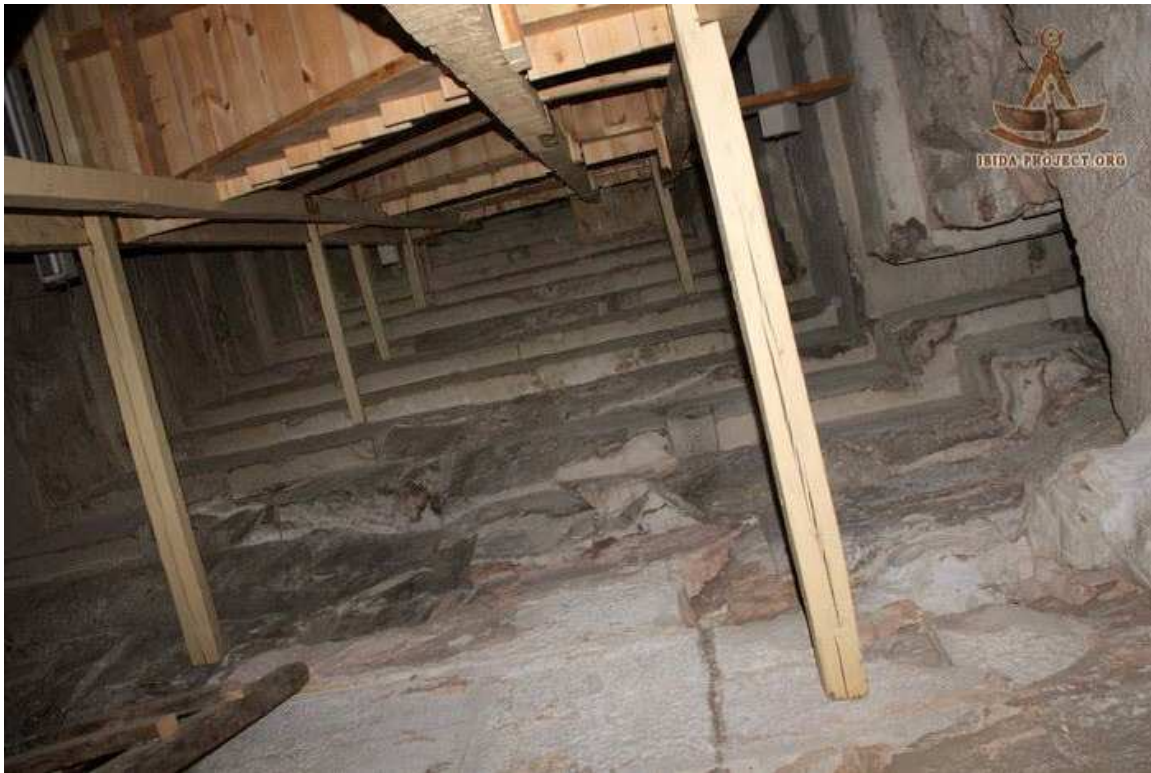
Looking up at the ceiling along the east wall, the entrance into the corbelled window can be seen on the right.

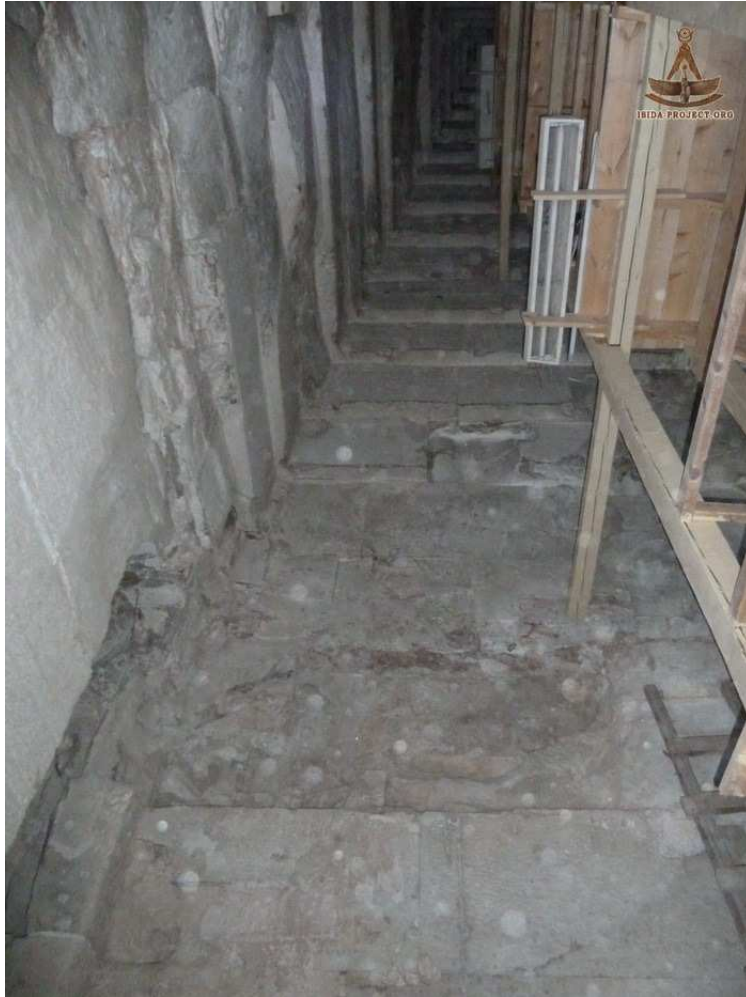
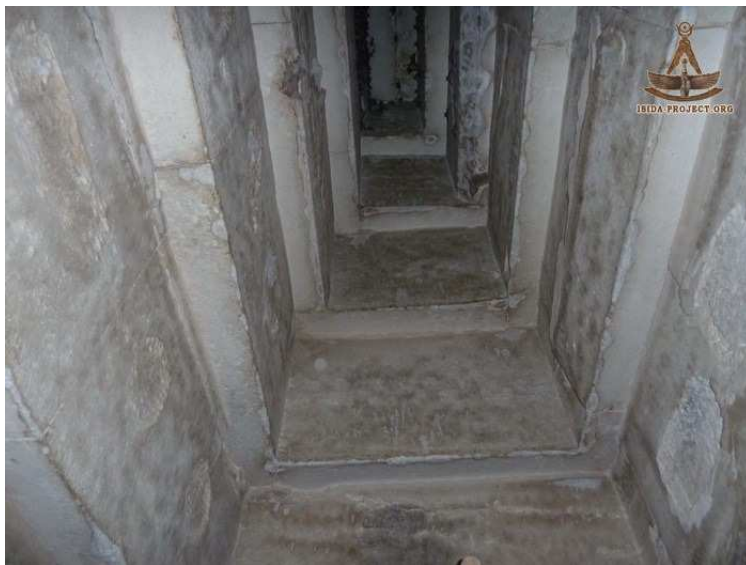
Close up view of the upper corbels.

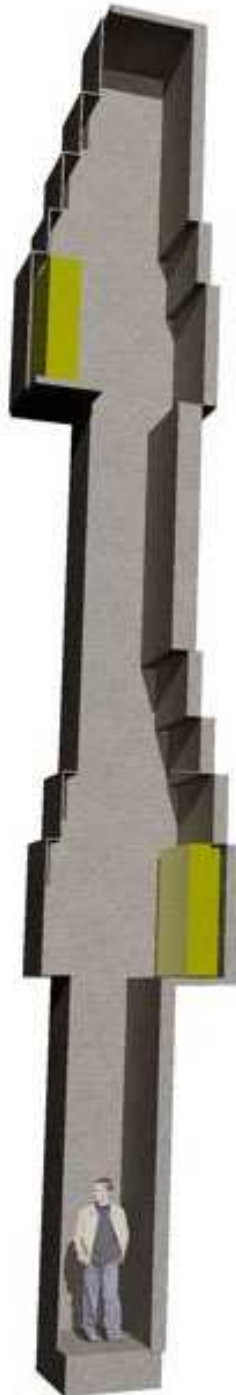
The E-W dimension of the shaft excluding the two corbelled spaces is the same as the horizontal passage leading to it, at .90m. The N-W dimension is not so clear, M&R show 1.6m in their drawing TAV11, but I think they have made an error here, using a scale rule on their drawing it is about 1.4m from the top of the window and below the window it widens to just over 1.5m, or the distance from the south end of the large lintel block to the shaft's south wall; which appears to be confirmed when you take the dimensions from the neighbouring architecture into account. This widening from approximately 1.4 to 1.5m is caused by a corbelled step at the window. This first corbel of the window coincides with the first corbel of the lower chamber. The bottom of the window, which is the top surface of the large lintel block appears to align with the top of the antechamber roof. On the window M&R say;

“Its width is reduced by means of two narrowings corresponding to the overhangs of the western wall. The lower part of the window is not dressed but left in the rough, as though a block was missing or the masonry cut in order to increase the height of the window. Originally it must have been only 1.40m high and, in the lower part, 0.64m wide:”

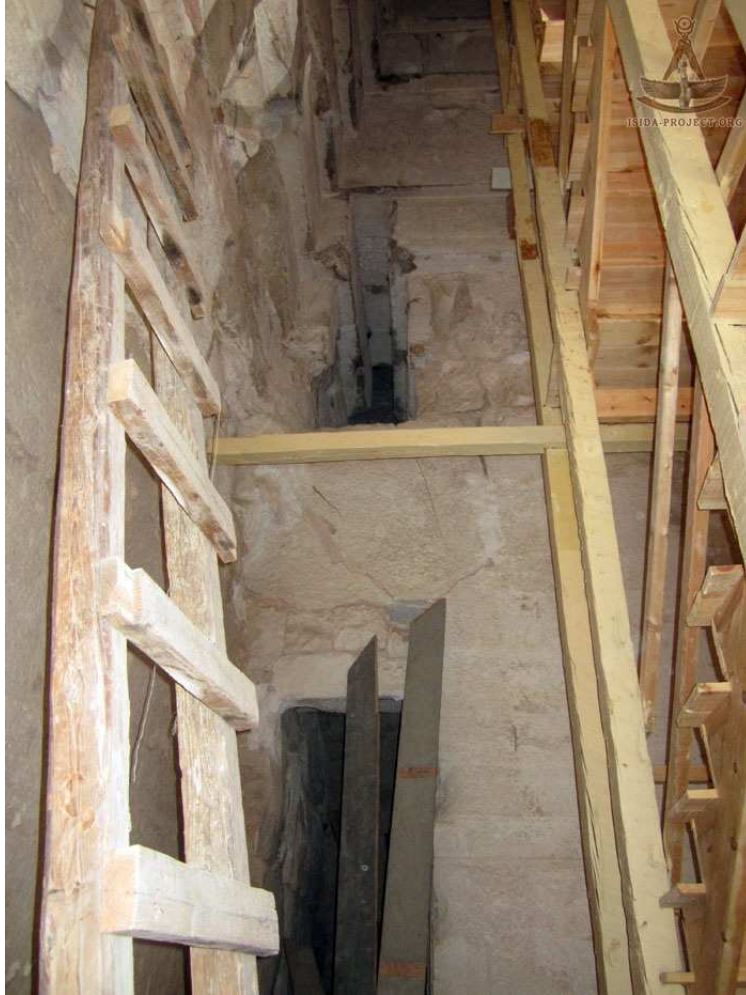
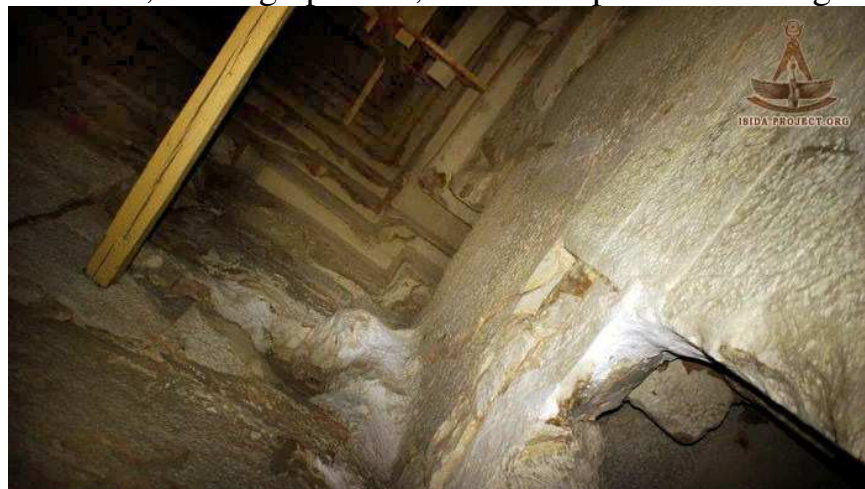
Looking at the lower chambers south wall, we see the doorway leading to the chimney and the small window above the doorway. Just above the doorway we can just make out what appears to be a repair to strengthen the lintel stone. Below, looking upwards, with the repair in the foreground.

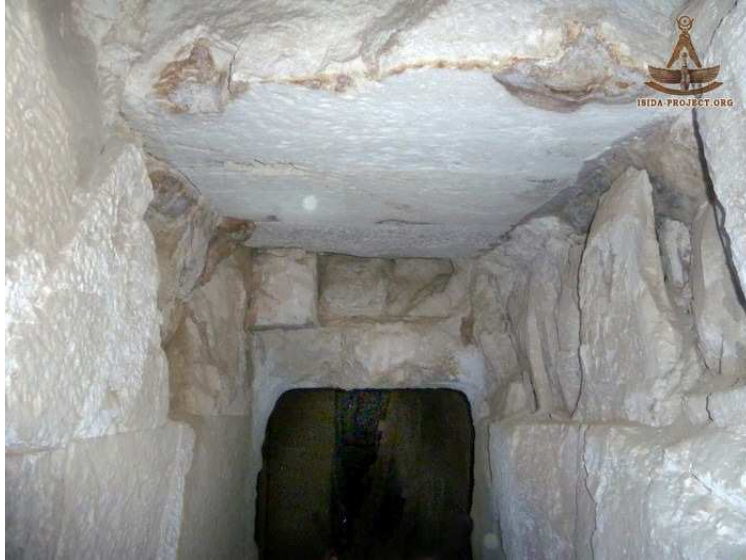
Looking north from the chimney, we see the back of the repair below the large lintel stone; this repair appears to be shown in Perring's plate XVI, fig 4.

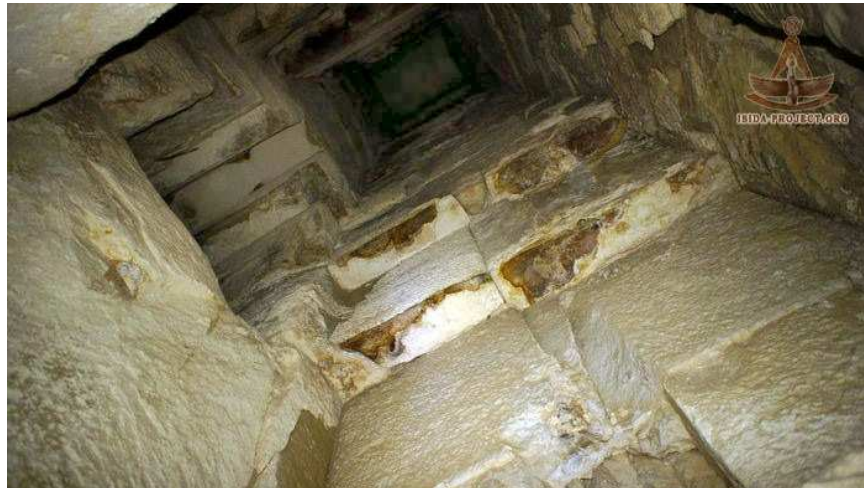
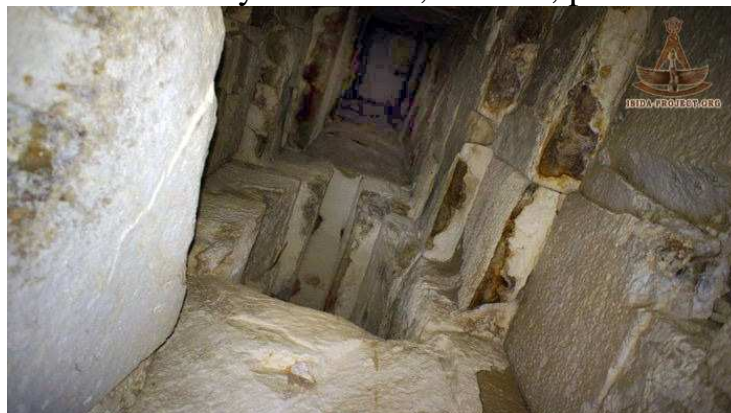
Looking up the chimney we see the window enter from the left. Below, we see the window enter chimney north wall, and left, part of the vertical block.
