The Bent Pyramid

A Layman's Guide part 1

Keith Hamilton. 15 July 2017

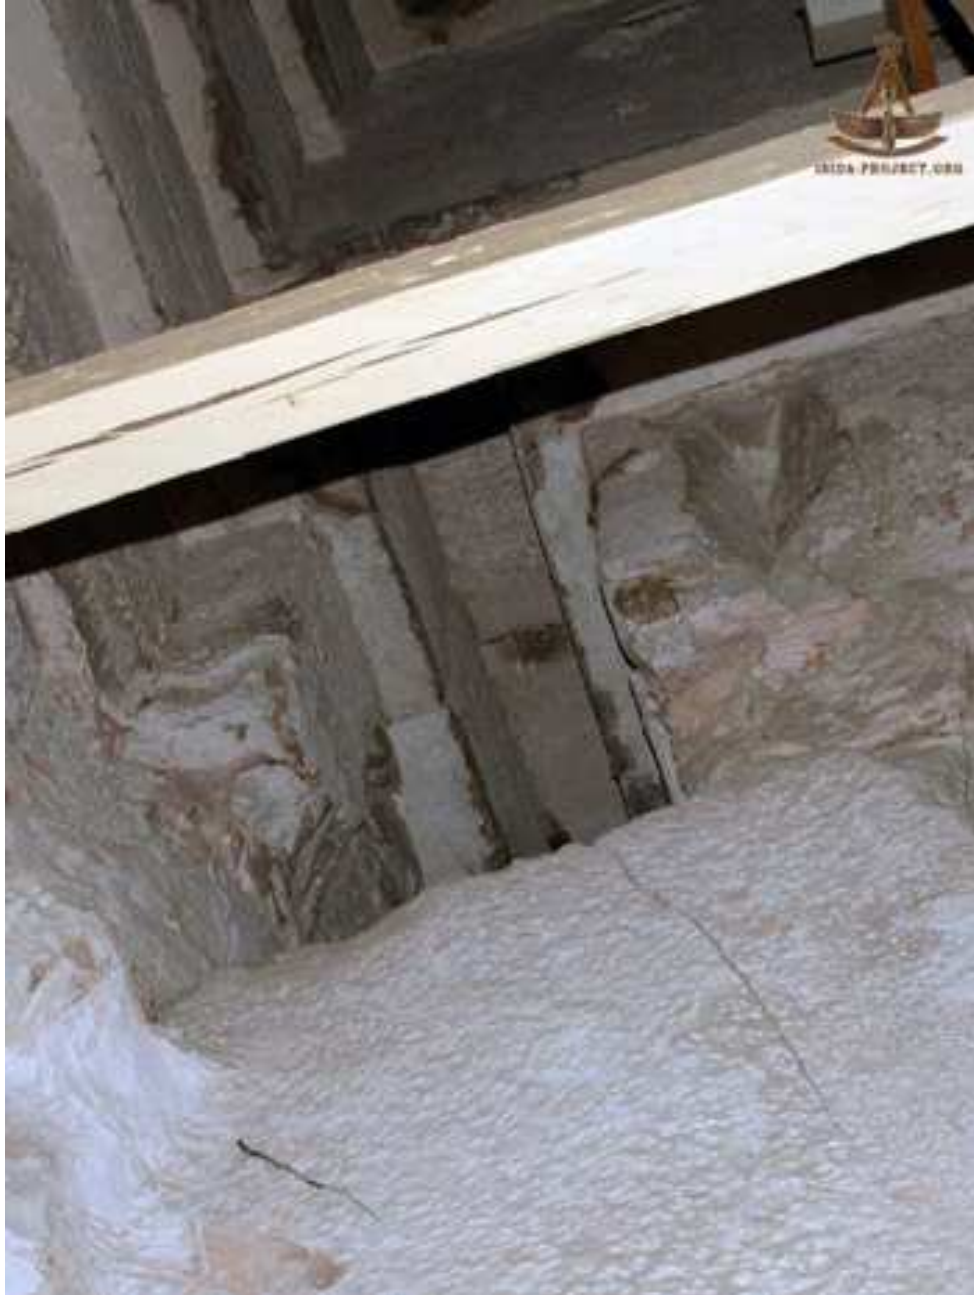
Above the lintel stone in the lower chamber, M&R say *“The lower part of the window is not dressed but left in the rough, as though a block was missing or the masonry cut in order to increase the height of the window. Originally it must have been only 1,40m high and in the lower part, 0.64m wide”*

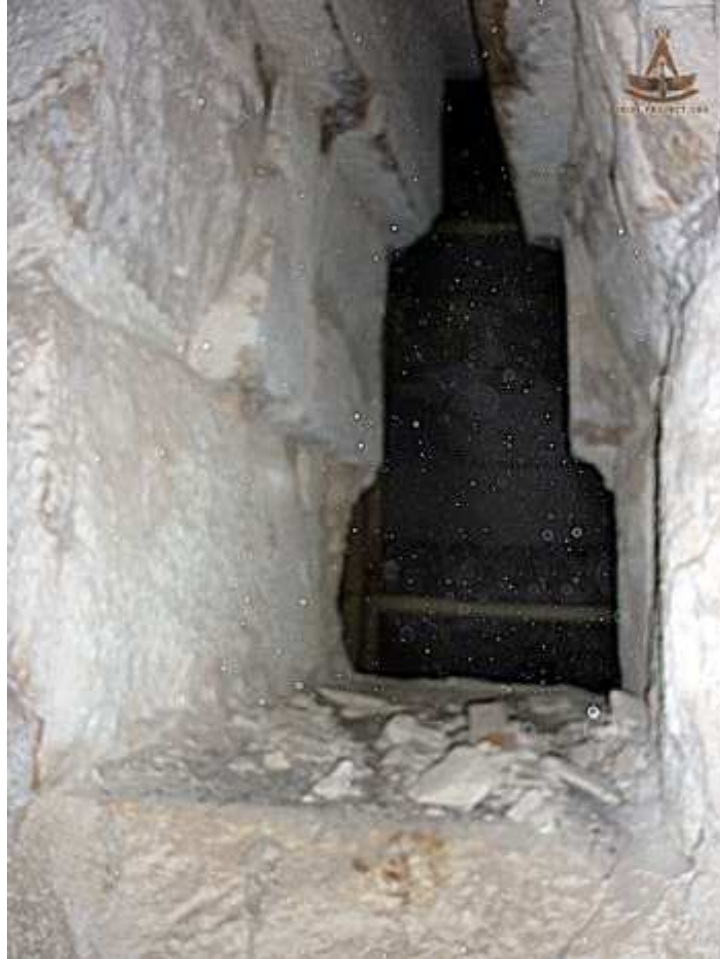
From the rear of the window, chimney side, the corbels appear more defined, it would seem unlikely that originally the window was smaller as M&R describe. It may be possible that originally a plate of stone was left on the lower block, lower chamber side, and the rest of the window walled up above this plate to disguise the window from the lower chamber side. This would make sense, for if the window was left open; the first portcullis block in the chimney could be easily bypassed. In the Queens chamber in the Great pyramid, we see how a plate of stone was left to disguise the shaft entrances.

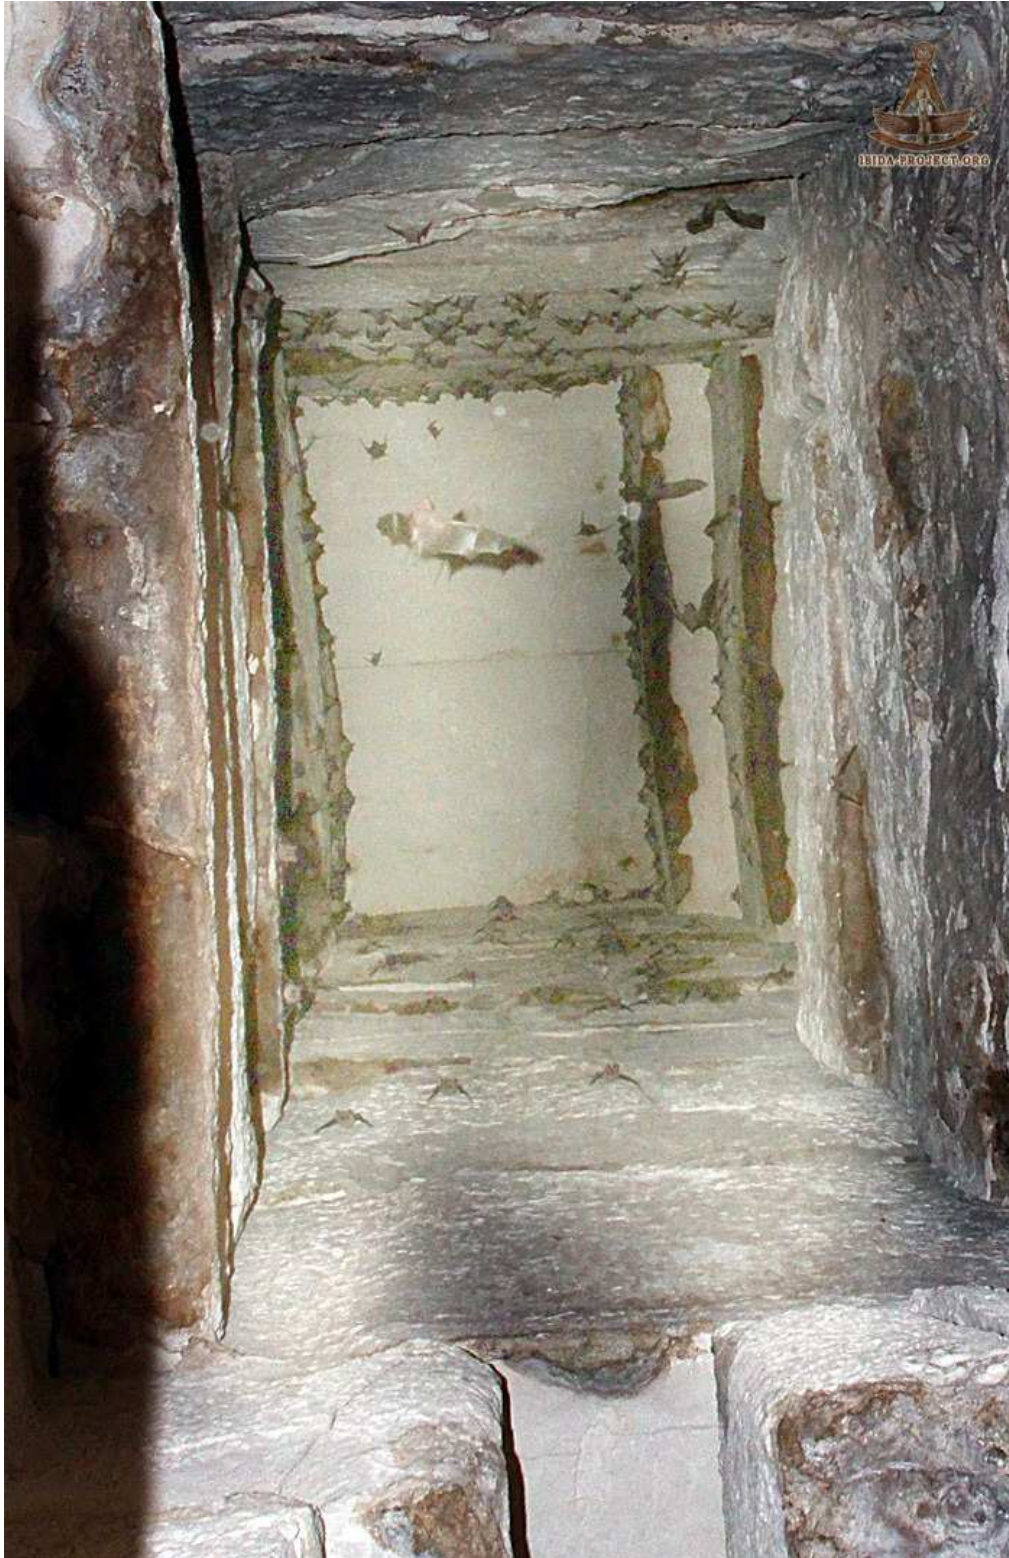
The top of the chimney, here we see the join between the two stones that close the top of the chimney.

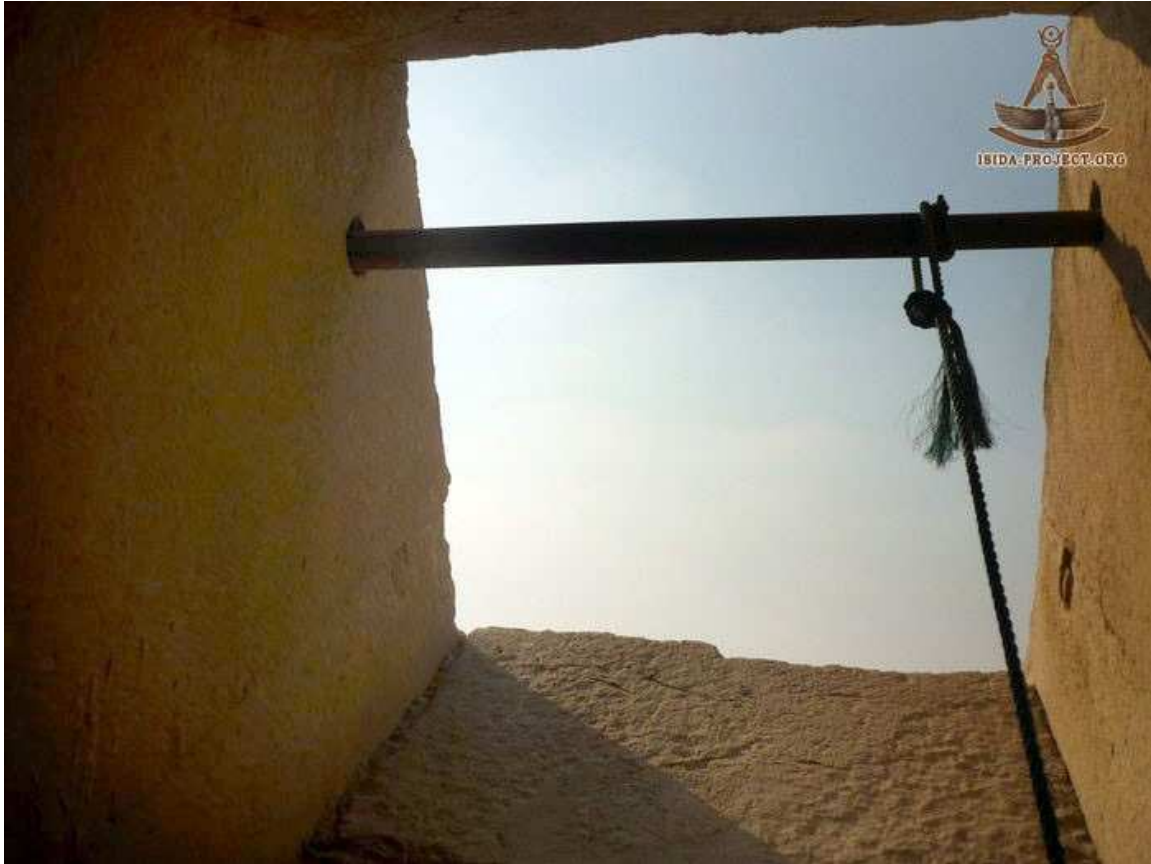
In the image above we see the western corridor entrance, the bar and rope is inserted into one of the pair of D holes that run parallel to the casing slope and about 27-28 cm from the face. M&R say;

“At the entrance there are two corresponding pairs of D-shaped holes, more or less deformed: one of the holes is filled up with mortar.”

In the image above we can see the joint line for the two courses of stone that make up the corridor walls and inserted between them a paving block a cubit thick; this paving block runs to the face and is cut to the slope of the face.

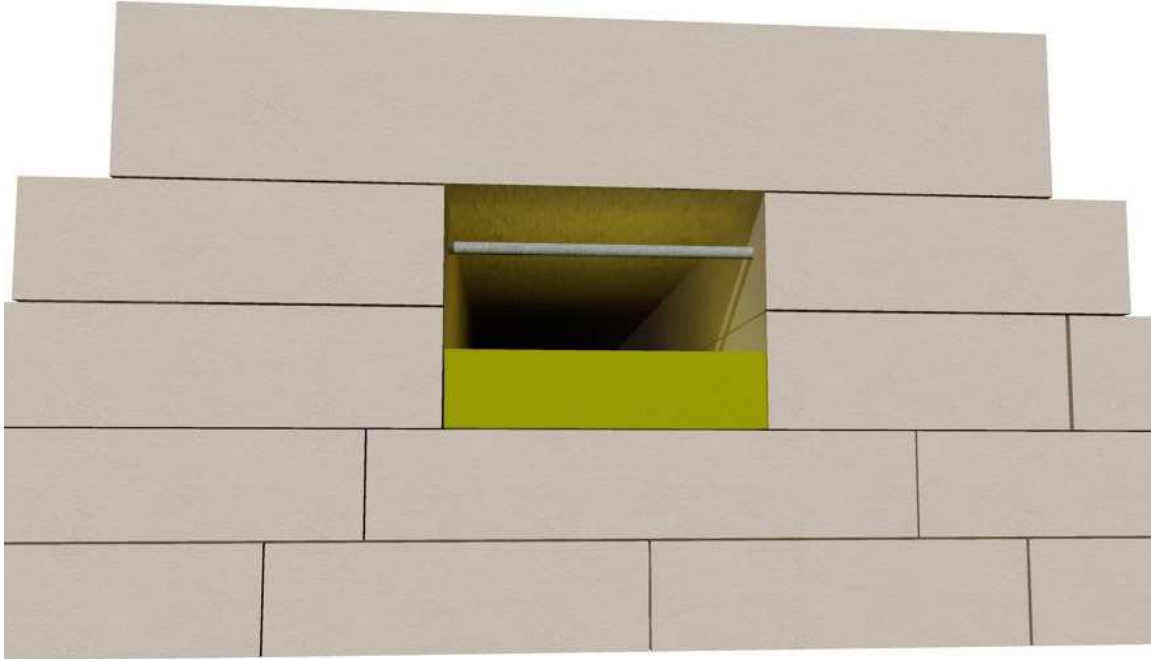
In the distorted view of the western entrance above, we see what the entrance is like in its current form. There appears to be no attempt of clever concealment that we see present on the E3 phase entrance at Meidum; the yellow block is the paving stone, whose end face would be cut to match the slope of the pyramid, above this a closure stone would be set. Above the entrance is a large lintel stone, such a closing arrangement would be conspicuous. Perring appears to have found it easy enough, and in his day he gives it a height of 29.8m; likewise early violators who knew of a western entrance would have little problem in finding it, and maybe they did, but did not require its opening. Fakhry's statement of;

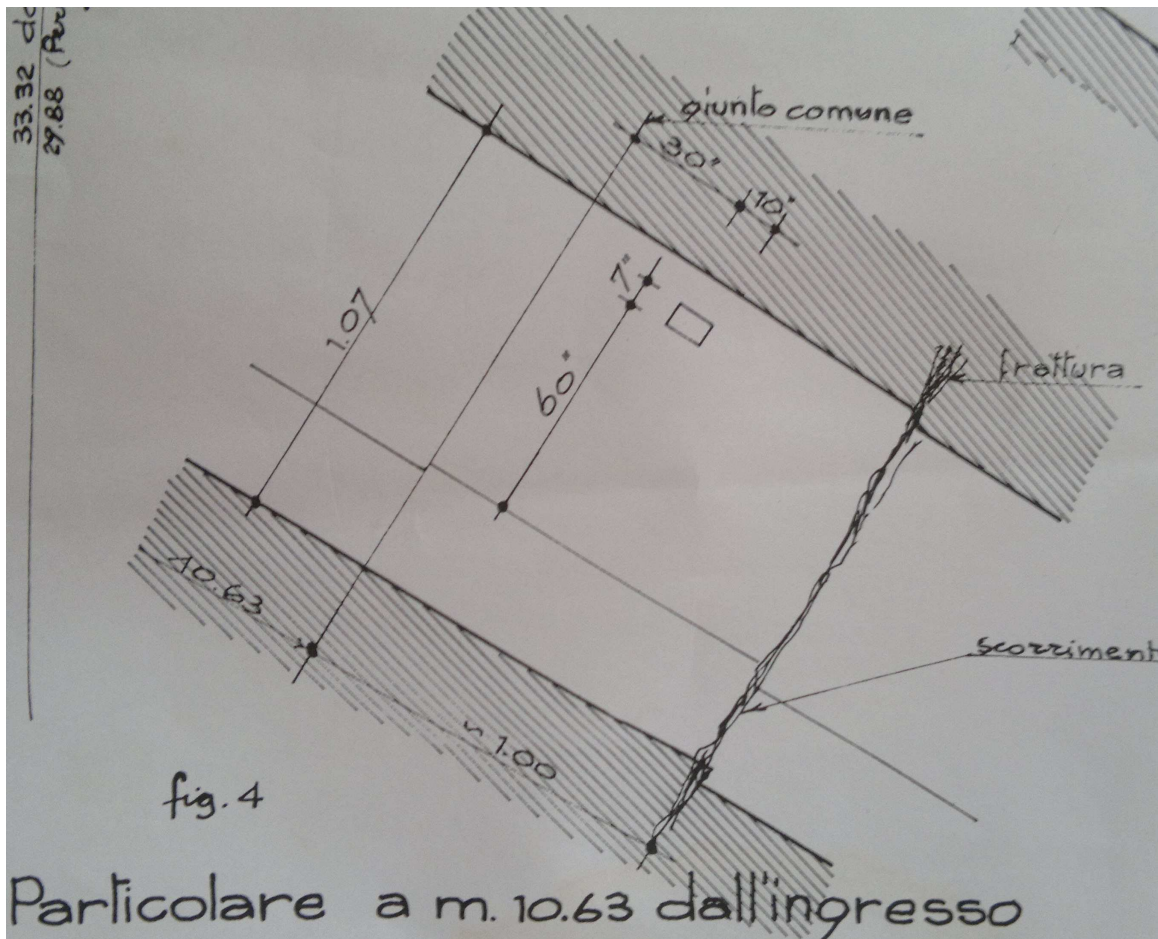
The above image from M&R's TAV13, showing the continuous joint, the rectangular hole and the so-called 5cm settlement, along with a perpendicular fracture that connects the settlement in the roof and the floor. Also of note is how they show the wall course joint to be also displaced by 5cm; even the wall joint by the continuous joint is drawn higher than its western neighbour. The problem with this drawing by M&R is that it appears not to reflect, what we see, in the pictures of this area.

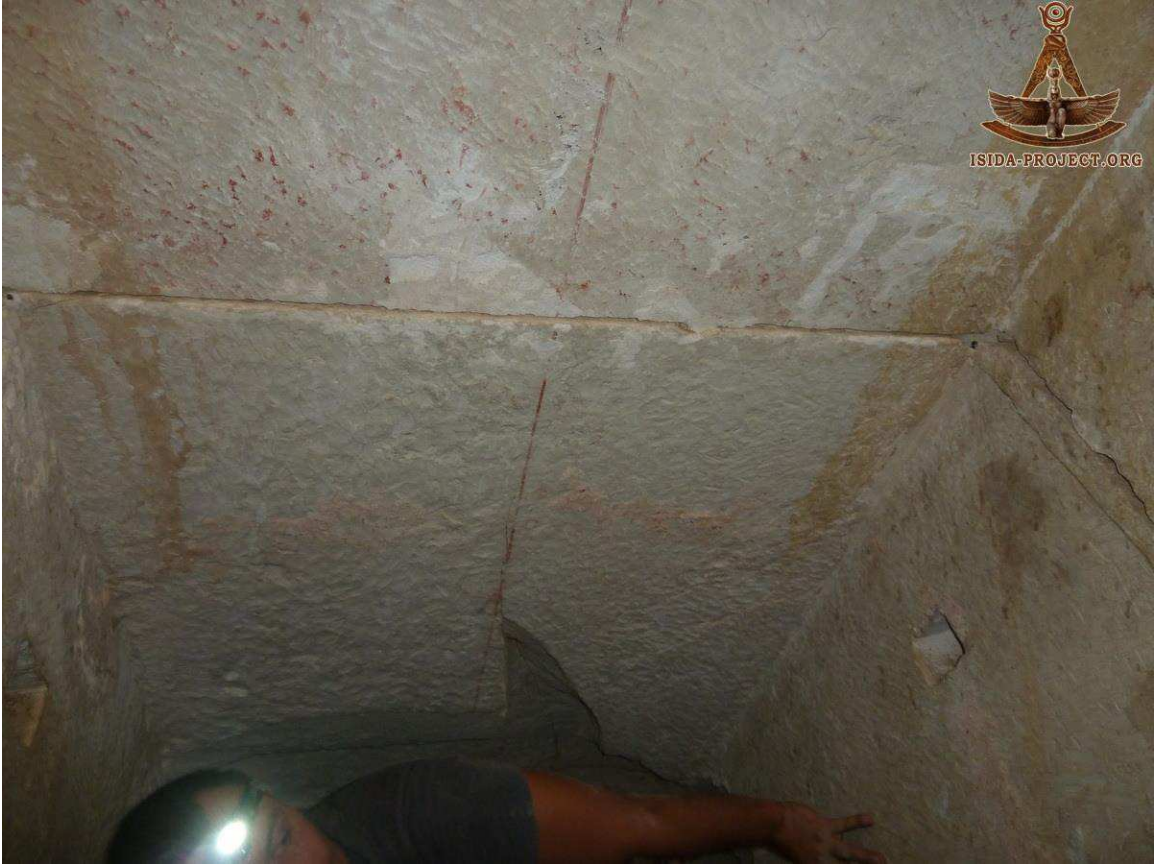
The continuous joint running along the ceiling, note red line defining axis of passage.

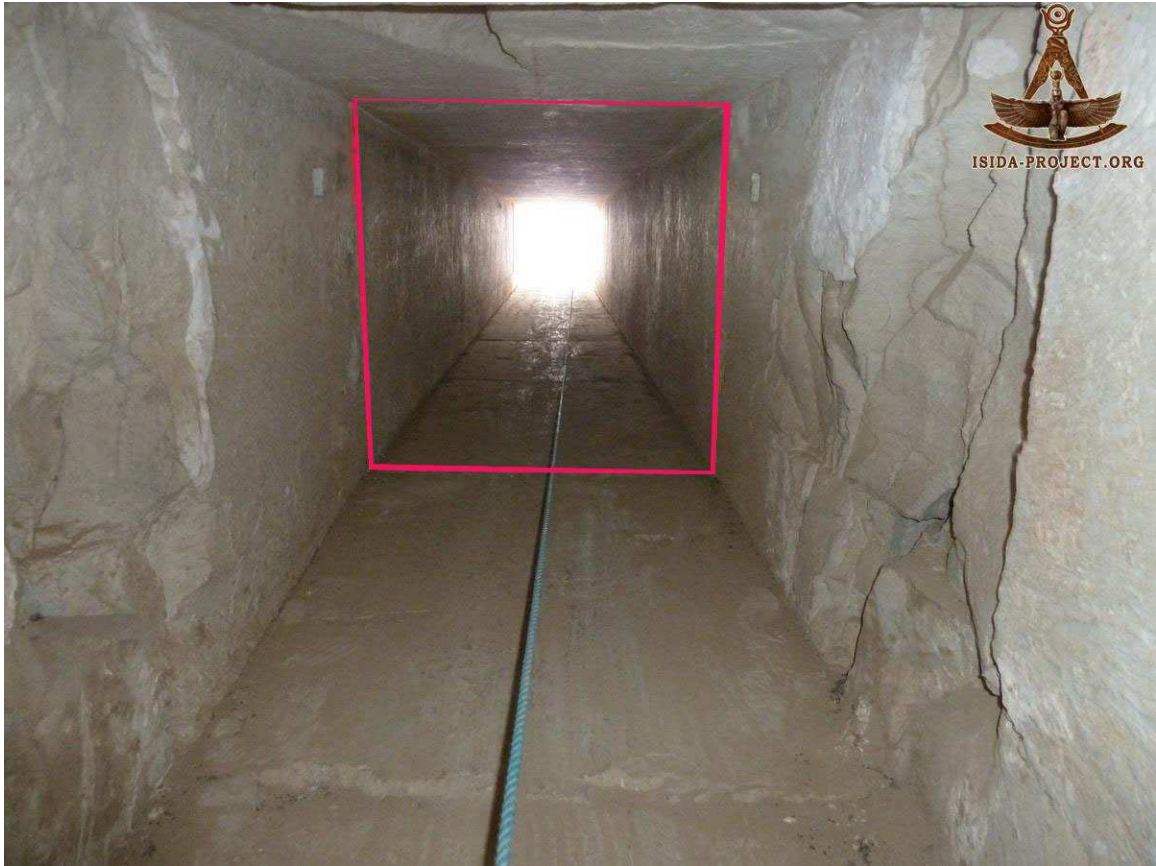
The floor of the corridor is smooth; no settlement is visible on the floor, we should expect the floor to be smooth and level as the corridor was plugged for a considerable part of its length. The red line denotes the continuous joint. The walls are damaged, similar to lower parts of the corridor, but whether the perpendicular fracture that M&R mention, exists, will required further scrutiny.

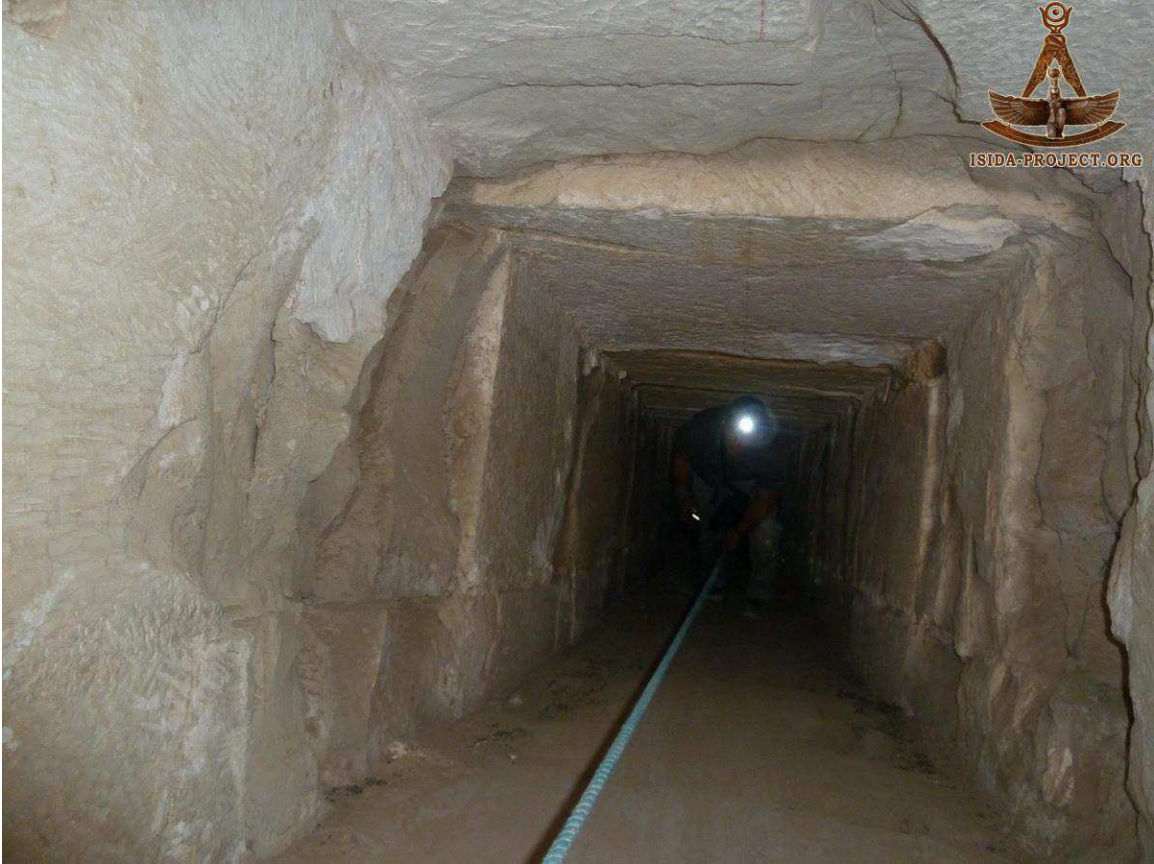
Looking down the corridor from the continuous joint; rectangular hole is in top left corner. Here we get a better view of the wall and ceiling damage. Along both walls we can see the wall course joint appear to run straight down the corridor with no sign of any settlement or noticeable break in the line. It follows that if the wall course joints and floor are level, it calls into question the 5cm settlement in the ceiling and if it exists. Clearly the whole area is in better need of scrutiny to determine if M&R's fig 4 is based on fact, or their imagination.

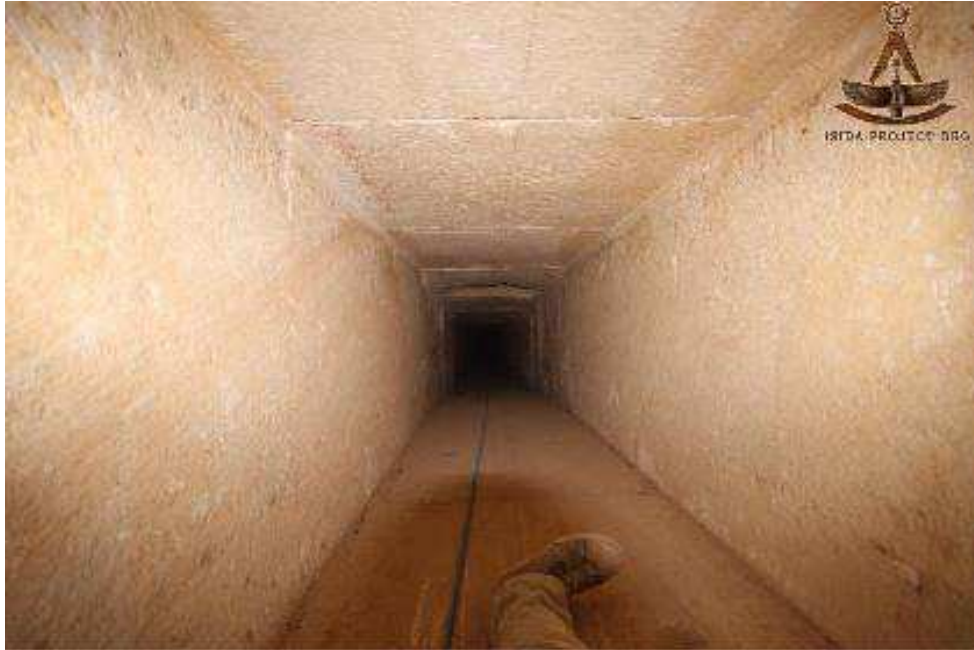
Contrast the well preserved beginning of the western corridor, to that found at the lower part of the western corridor. The lower part is a bit reminiscent of Petrie's description of the lower part of the Meidum pyramid, where the passage was practically blocked with sheets of stone that appear to have exfoliated of the corridors surfaces.

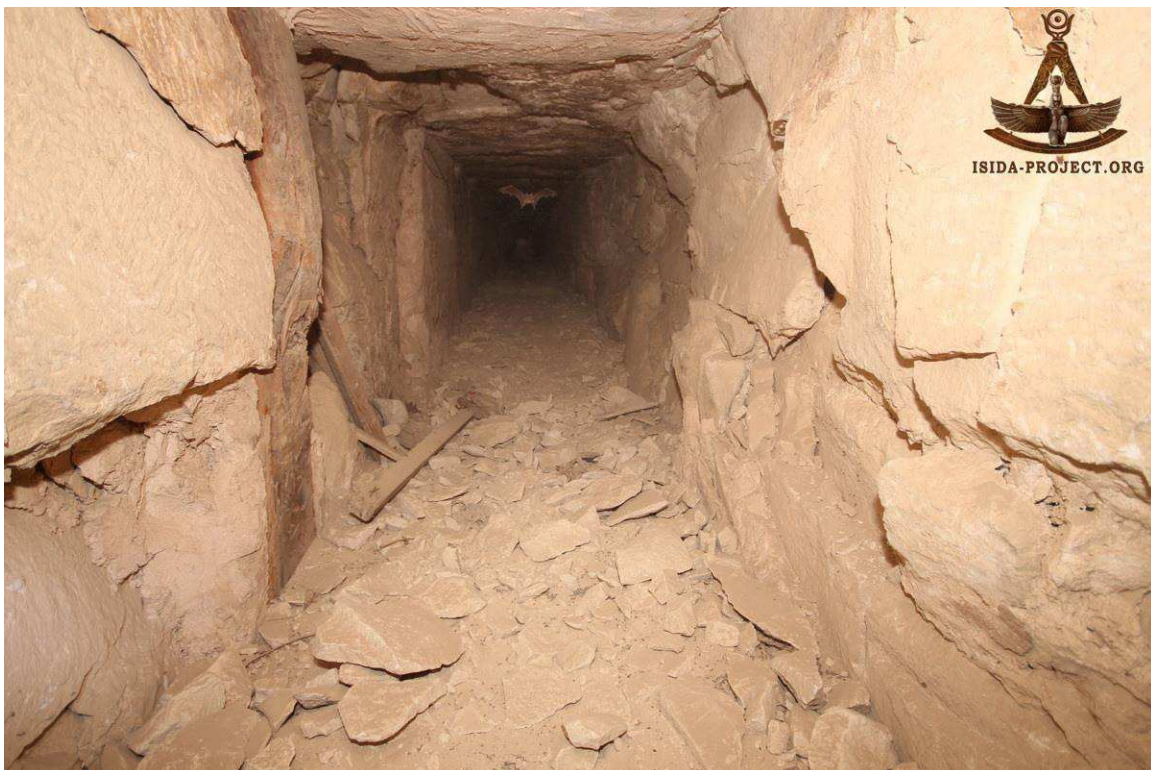
This degradation process is not well understood and I have not come across any report that gives a detailed explanation for what we find. In Meidum it has been suggested that as the lower part of the passage is built in the rock; moisture from the surrounding natural rock has caused salt crystals to form in the passages and over time causing sheets of stone to exfoliate. In the western corridor however, it is built in the superstructure away from the ground; maybe moisture laden air sinks to the lower parts, but how, when the corridor was mostly plugged, but we have the mysterious current of air, first noticed by Perring that rushed through the structure, even when the corridor was plugged for most its length. Obviously more research is required to understand the degradation processes we see.

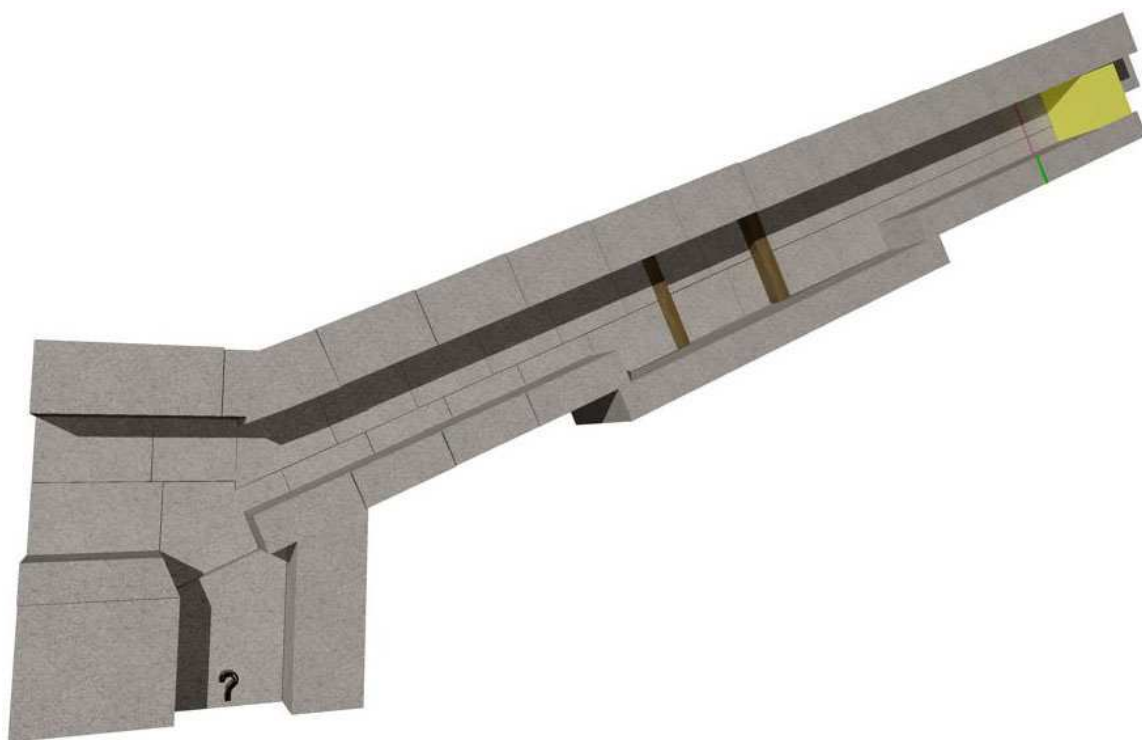
In the image above we have a section of the lower corridor, the pit is about 1.36m E-W, .51m N-S, leaving a significant ledge of 21 to 23cm either side of the pit to support a paving slab, the depth measured on the east wall is 1.48m, though possibly deeper as M&R leave a question mark on their drawing. Further up the corridor we come to the area of missing paving and it is in this area that we find the beams about 27cm wide and the south wall recessed about 25cm, this recess including the width of the beams is about 2.47m. The beams and recess appear to travel the full two course height of the corridor walls and not commence from the paving surface.

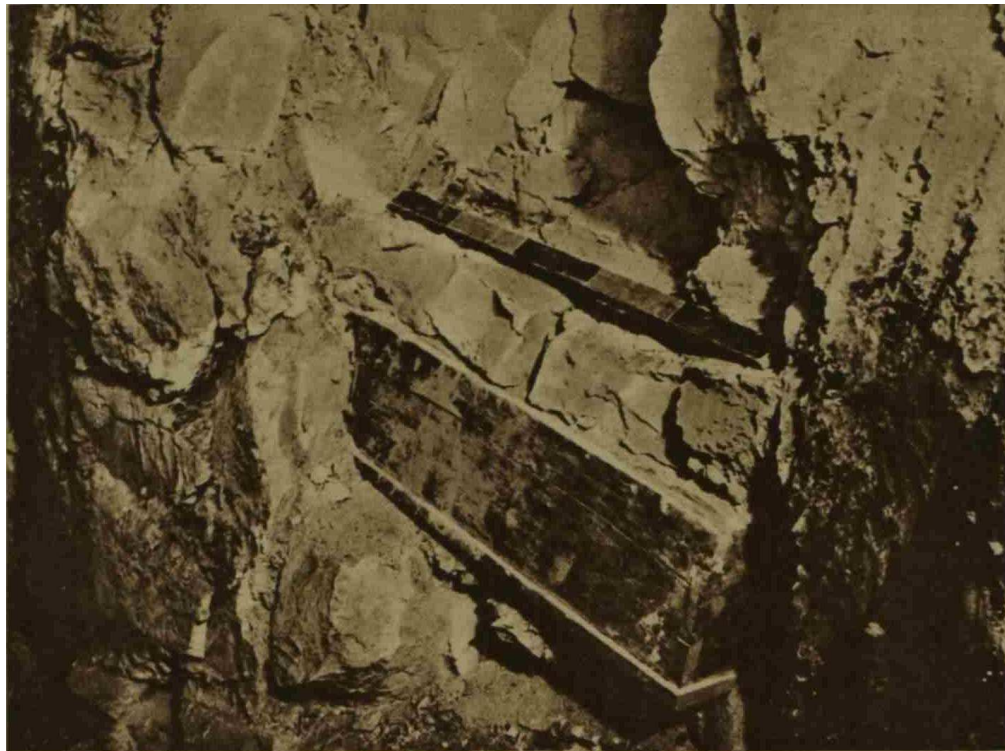
ANOTHER CLUE IN AN EGYPTOLOGICAL “ DETECTIVE STORY ” : A TINY COFFIN CONTAINING A MUMMY BEARING A HAWK SYMBOL, RECENTLY DISCOVERED IN A DAHSHUR PYRAMID.

The image on page 69 shows the 20 inch long box that held the mummified contents described in Batrawi's report. This image was published in the Illustrated London News, Jan 3, 1948. The image seems at odds with Batrawi's and Fakhry's description; the impression is of a box that has been walled up in some rough rubble wall, with mortar/plaster.

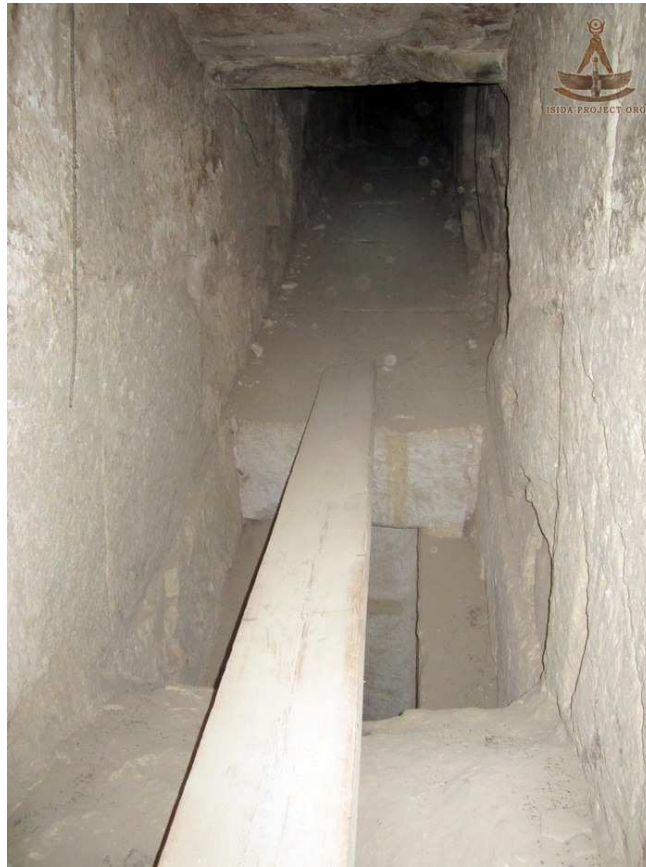
Pit in western corridor.

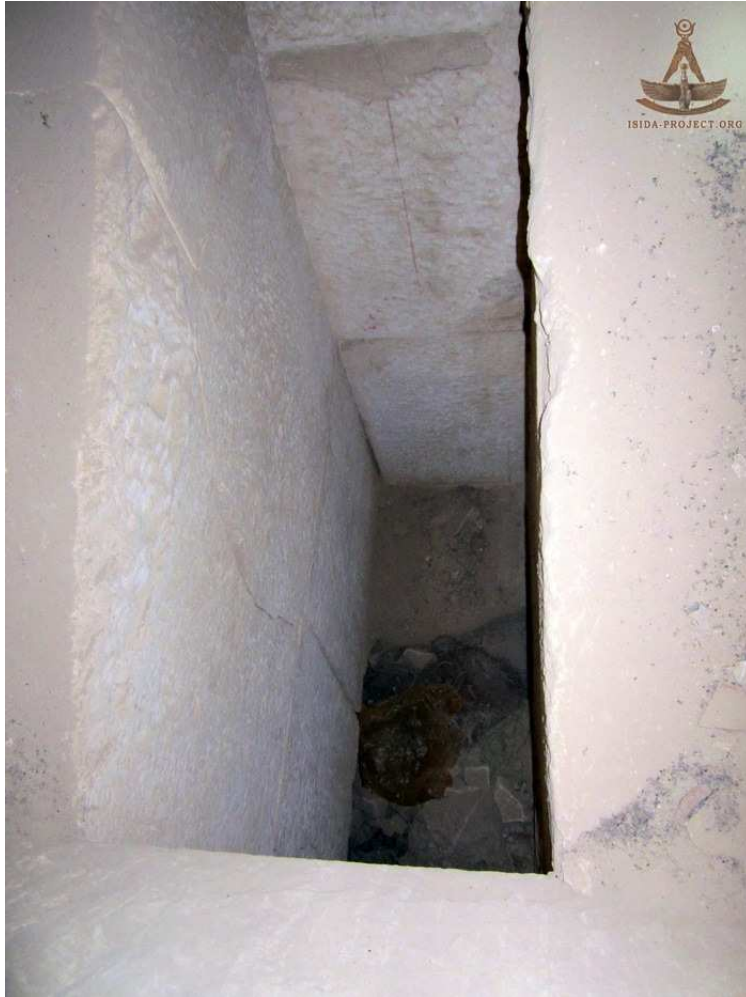
Looking down into the pit, a faint red line denoting axis can be seen on one of the blocks.

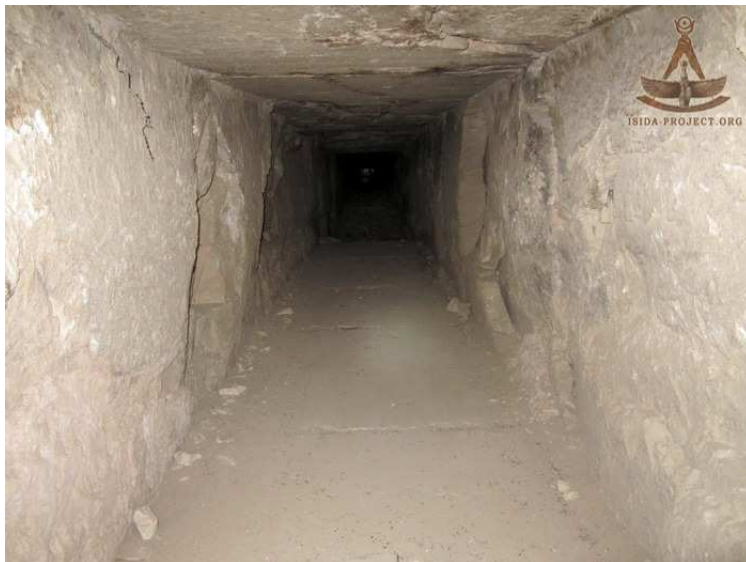
View up western corridor from the pit.

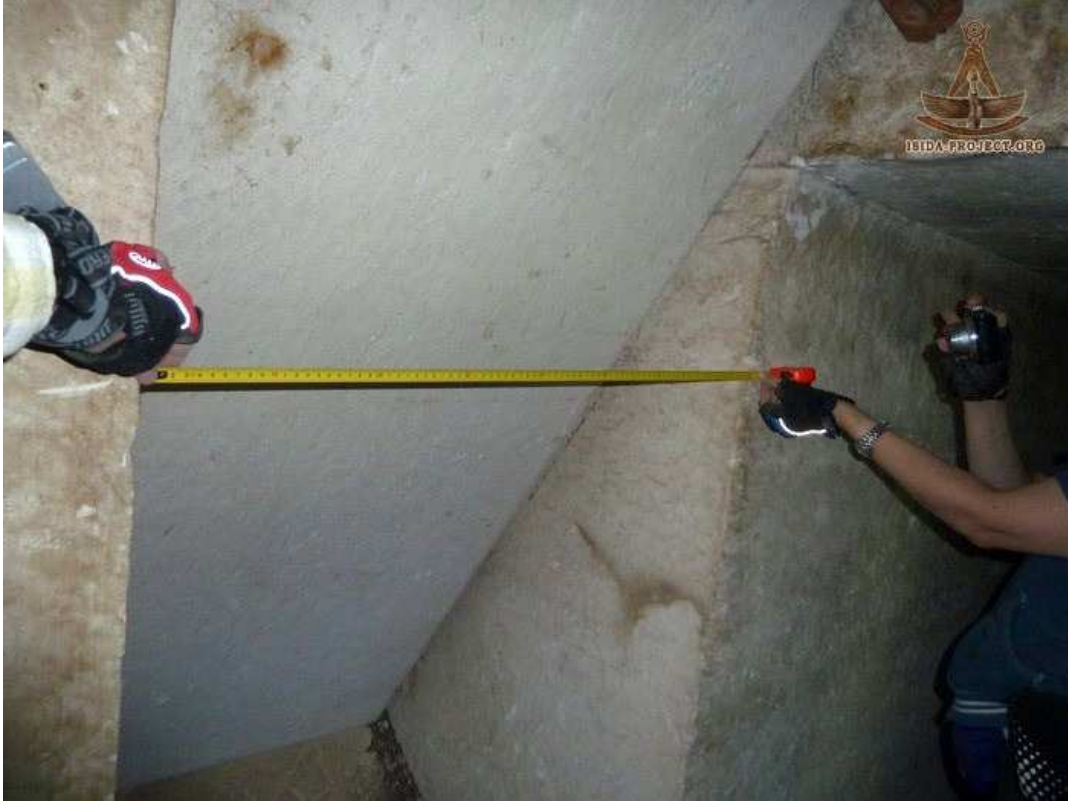
Eastern portcullis in stored position

On the ISIDA website they took some images of the eastern portcullis and housing, along with measures.

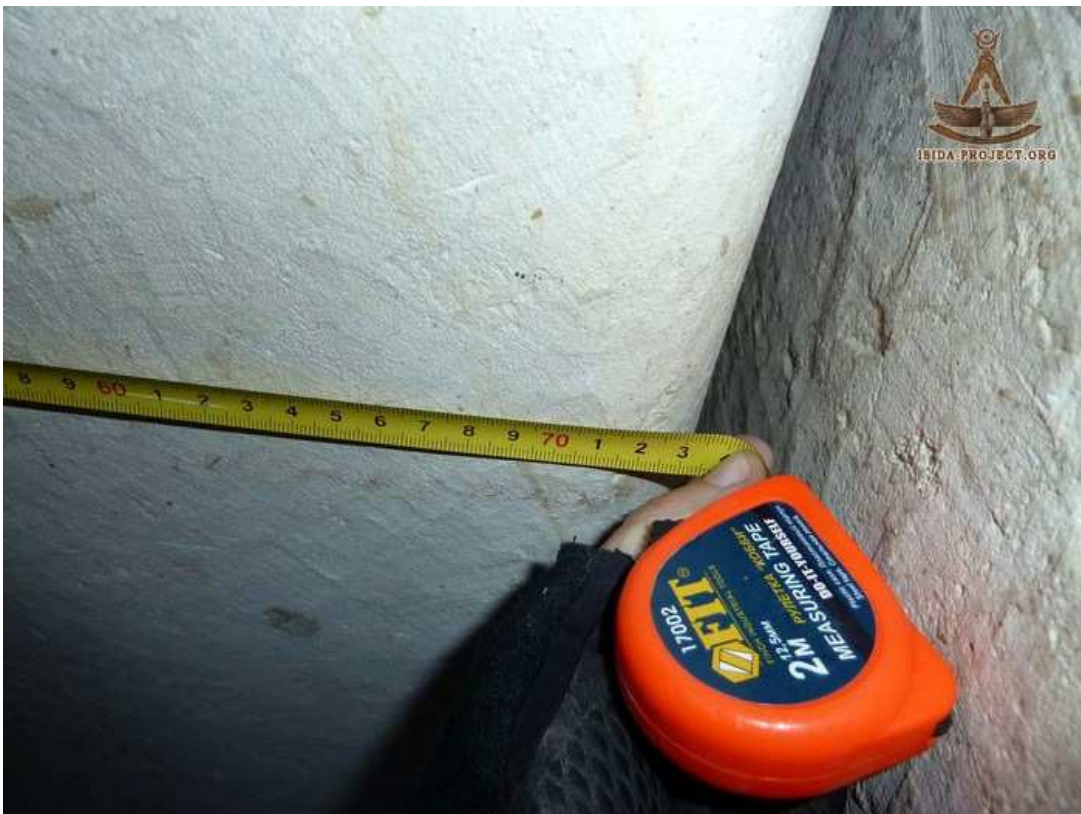
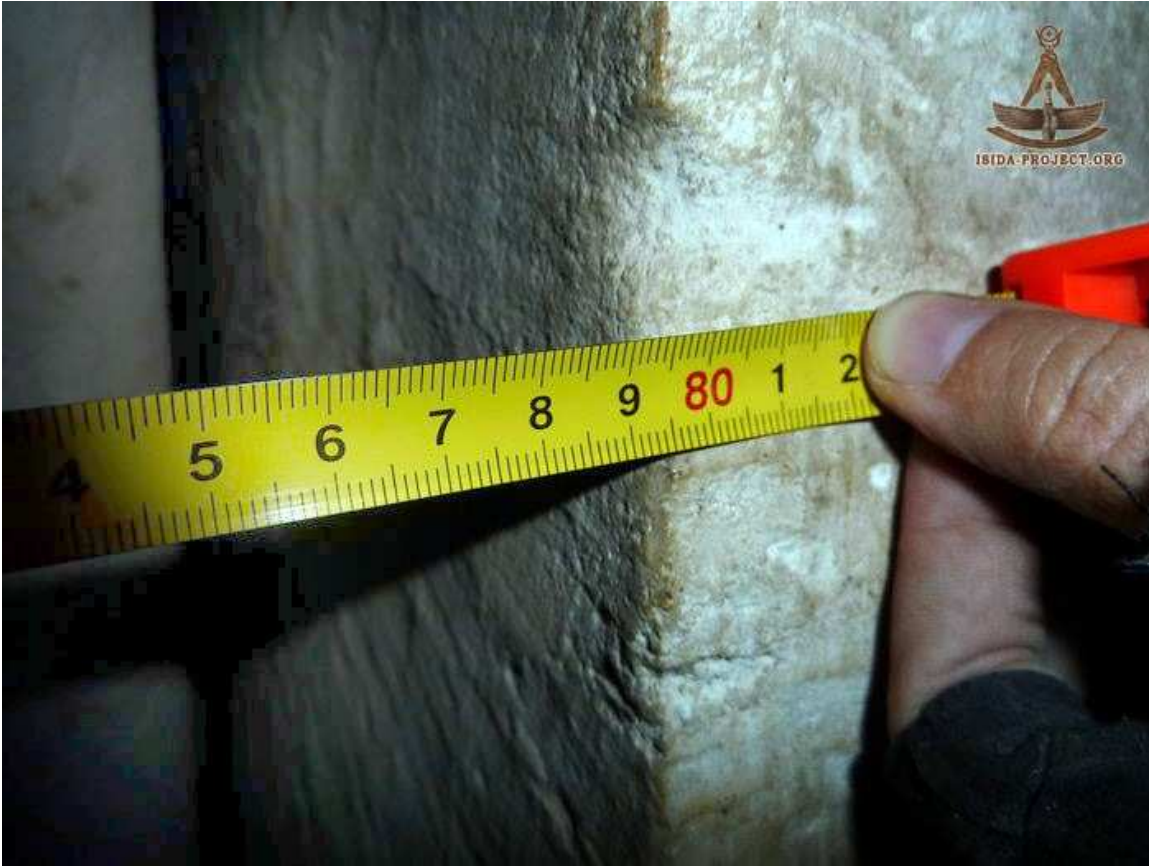
Width of eastern housing and width of actual portcullis block suggest a clearance of about 6cm.

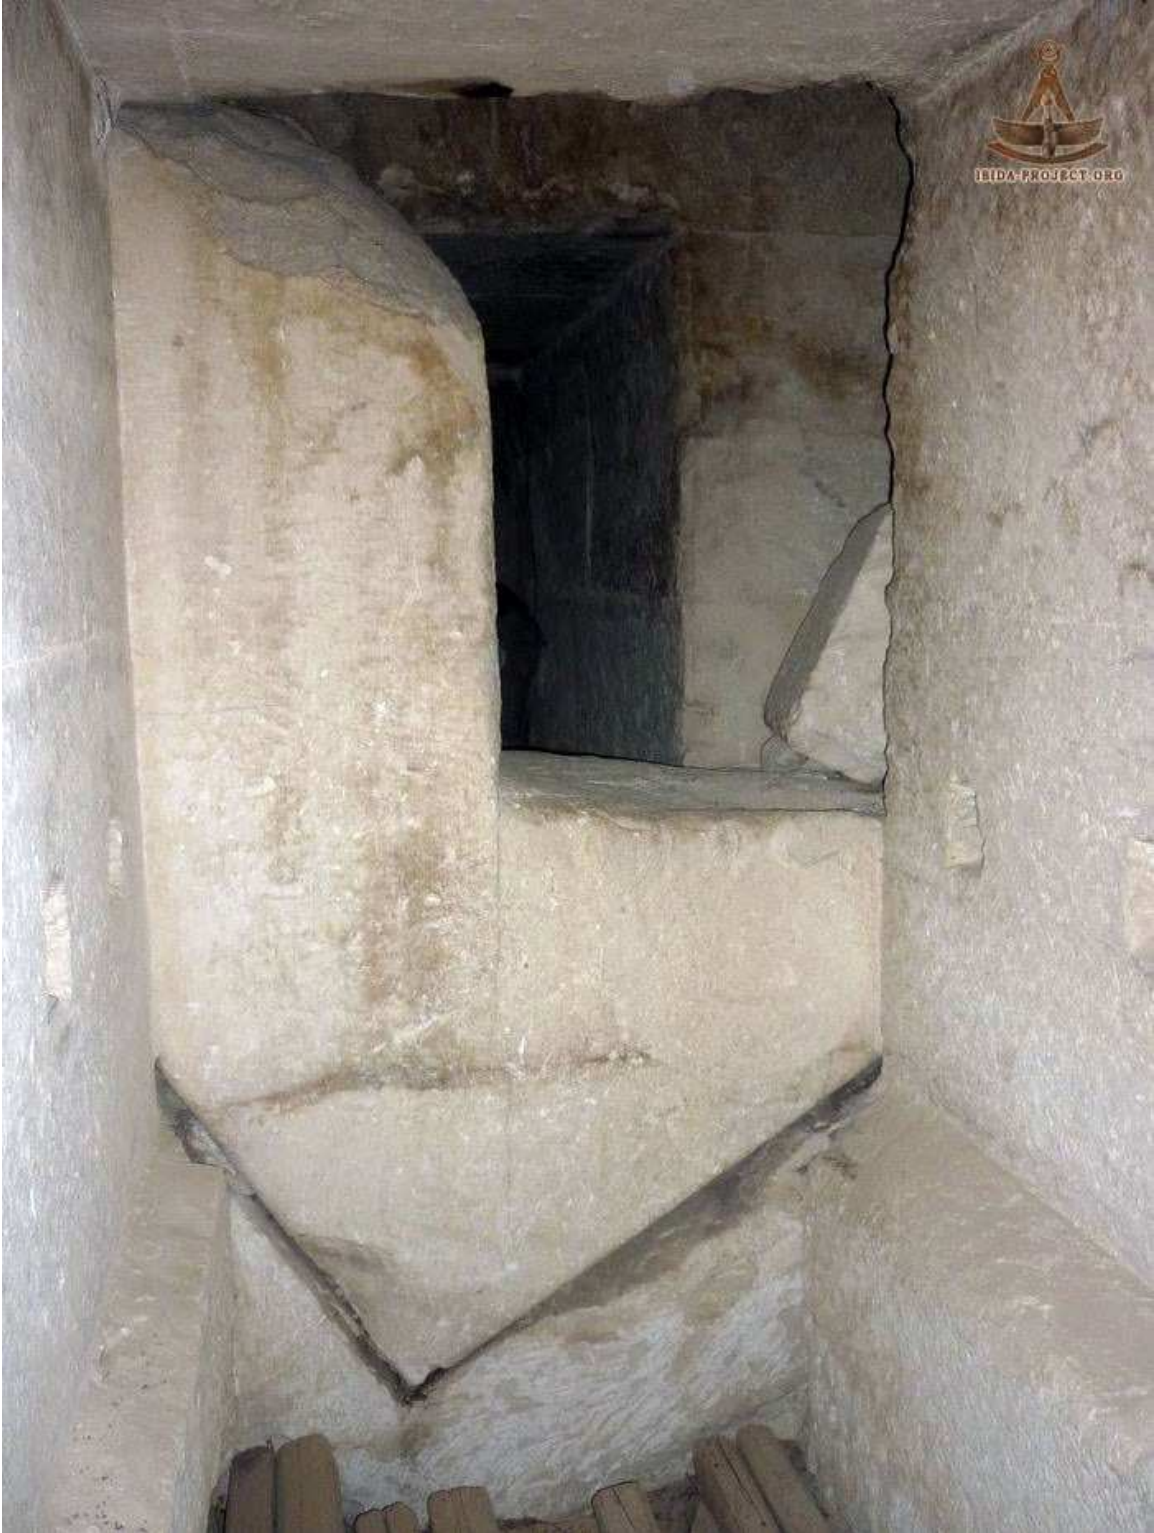
The lowered western portcullis, the neat cutting of the block was done by Hussein in order to improve access. Note also the cutting in the corridor floor, the square holes and ledges in the walls. At this point the horizontal corridor is 1.25m wide.

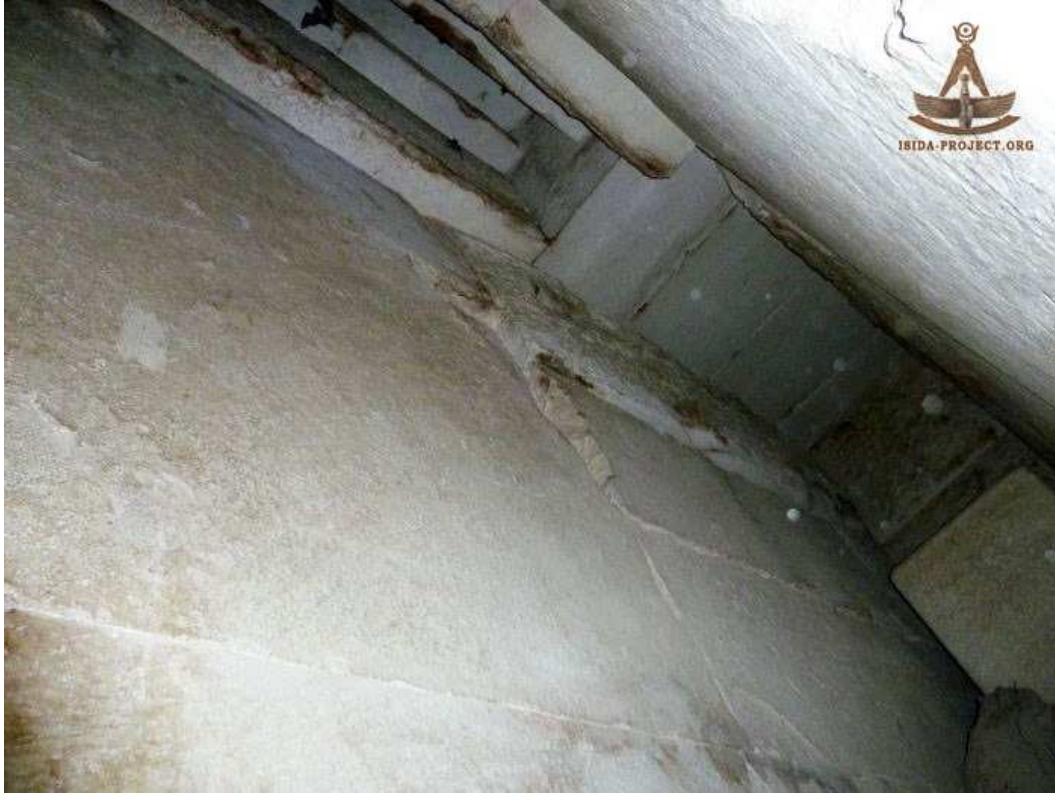
Views looking up into the western portcullis housing, the square block in Perring's drawing is visible to the right.

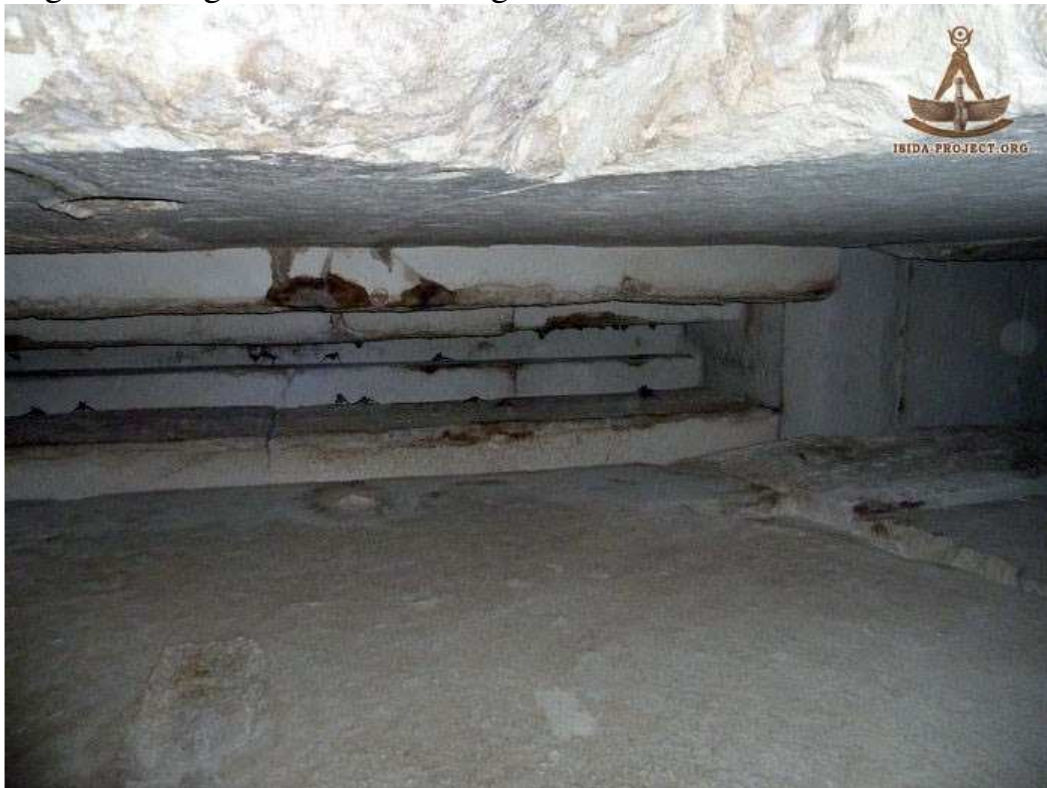
It is not exactly clear how the portcullis was stored in its housing, M&R mention “*there are holes and cuts where some small beams had been fixed*” In one of their drawings it appears that the square block at the back of the housing acted as a back stop, which was the limit of the portcullises upward travel and that the block was restrained from sliding down by a beam in a slotted hole that caught the top edge of the block. Its possible that on closure, the portcullis block was somehow levered, taking the pressure of the holding beam, so that it could be removed from the slotted hole and allow the block to slide down.

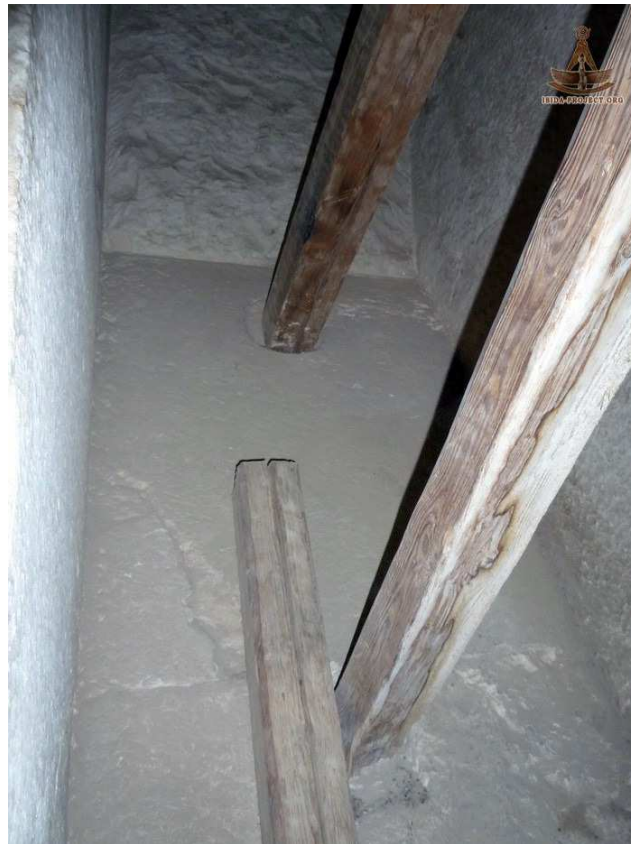
Eastern portcullis supported by modern beams.
