The Bent Pyramid

A Layman's Guide part 1

Keith Hamilton. 15 July 2017

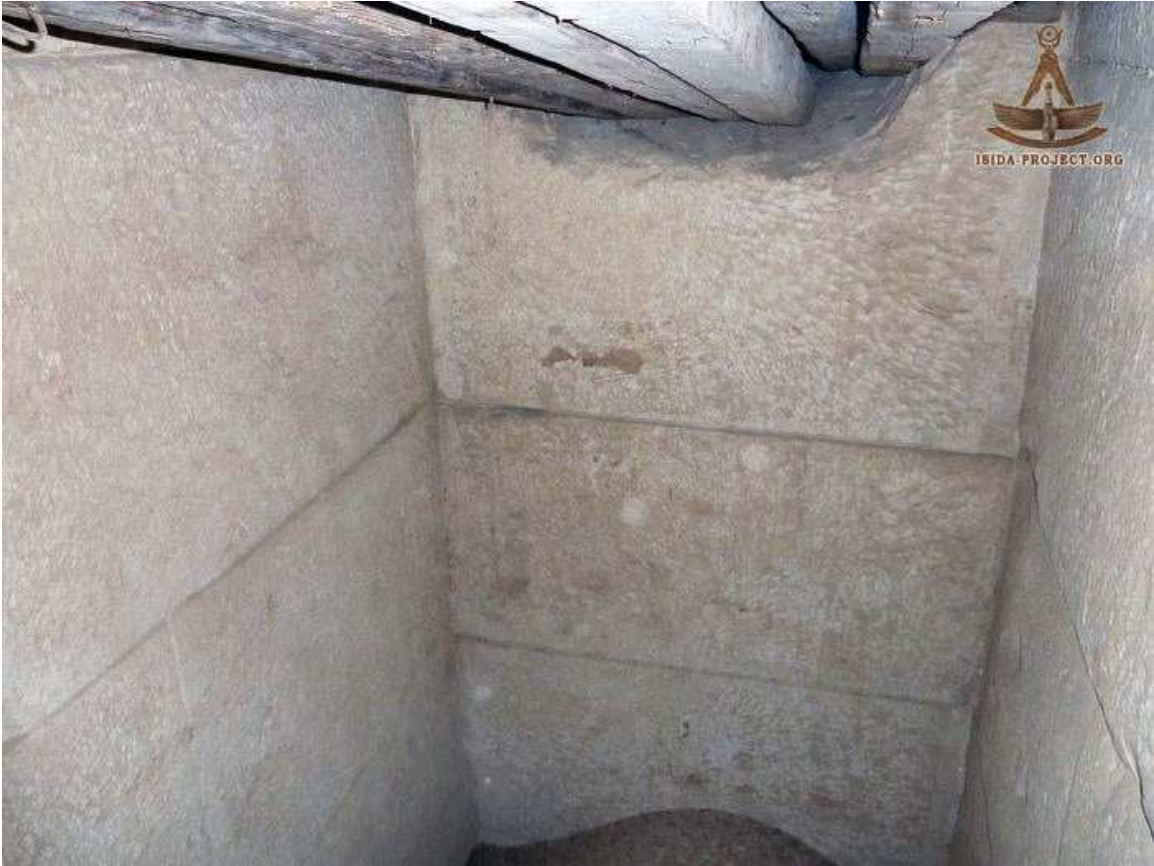
Looking at the west wall of the shaft with its top edge rounded.

On top of the shafts west wall, there is a noticeable rounding of its edge, which appears not to exist on the opposite wall. The paving is missing from this area and may have been 1 cubit thick, with the paving level being aligned with the ledges. The impression one gets is that all these features are

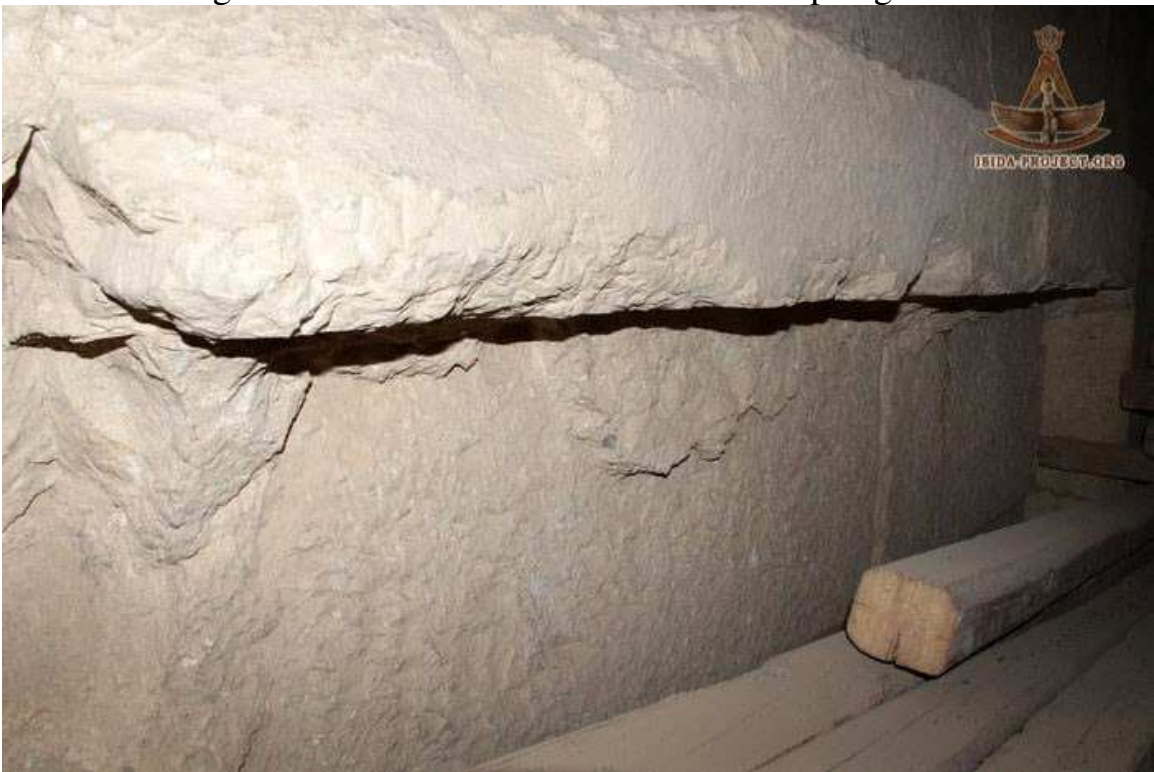
The width of the shaft undercuts the walls.

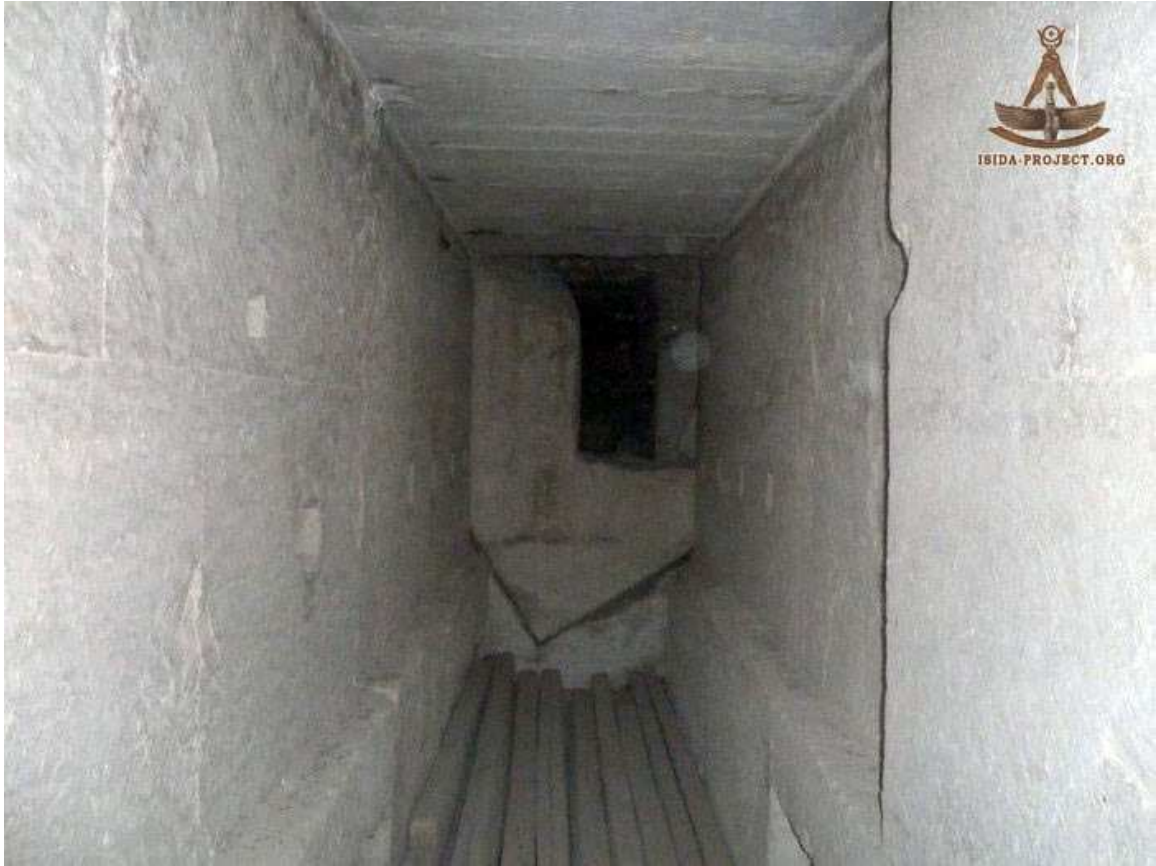
Looking towards portcullis and repositioning of north wall right.

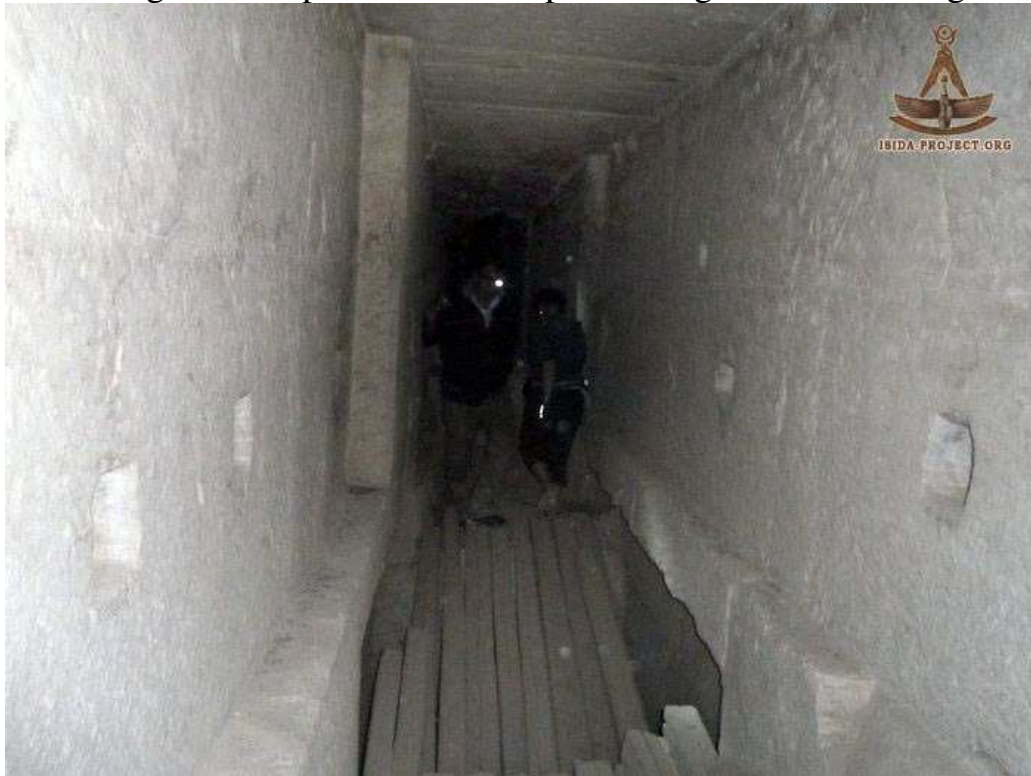
View looking east, wooden planks cover shaft.

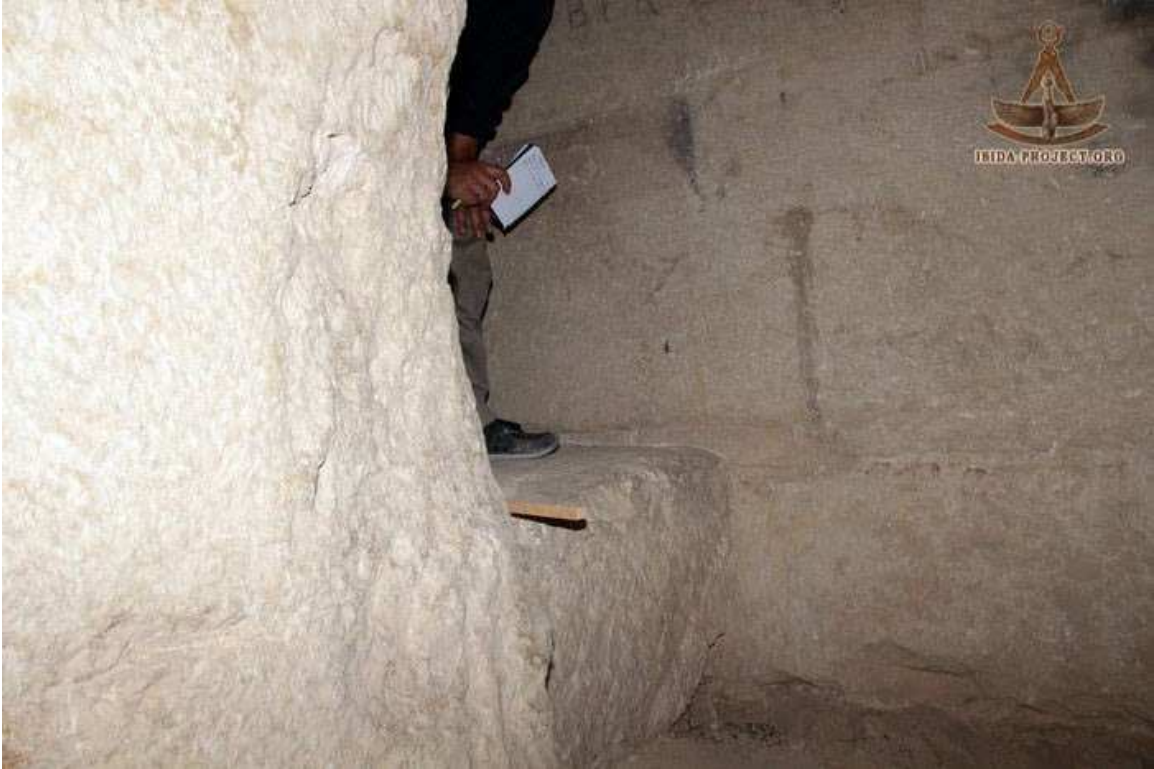
View from tunnel entrance showing thickness of paving stones.

M&R's drawing of this corridor is misleading; the missing paving is represented by a dashed line and they suggest a thickness of 23cm to the underlying masonry. This dashed line and underlying masonry 23cm below is drawn from the western portcullis to just east of the tunnel entrance on their TAV13, but as can be seen from the images it is much thicker, the top image on page 89, were the paving stops just east of the tunnel entrance, is clearly more than 23cm. M&R appear to have confused the height of the ledge that is undercut by the wider shaft, as they give that height as 23cm, but it is clear that the underlying masonry that the paving lay on was much lower.

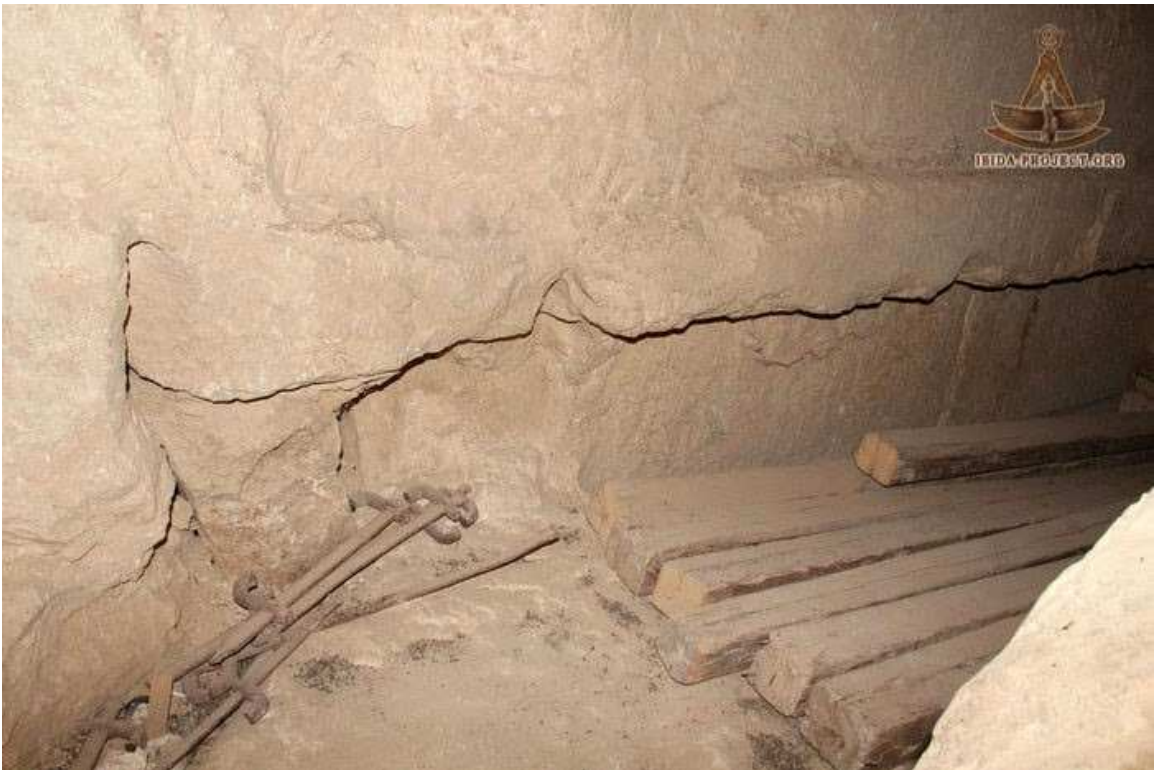
View from tunnel entrance with shaft to the right.

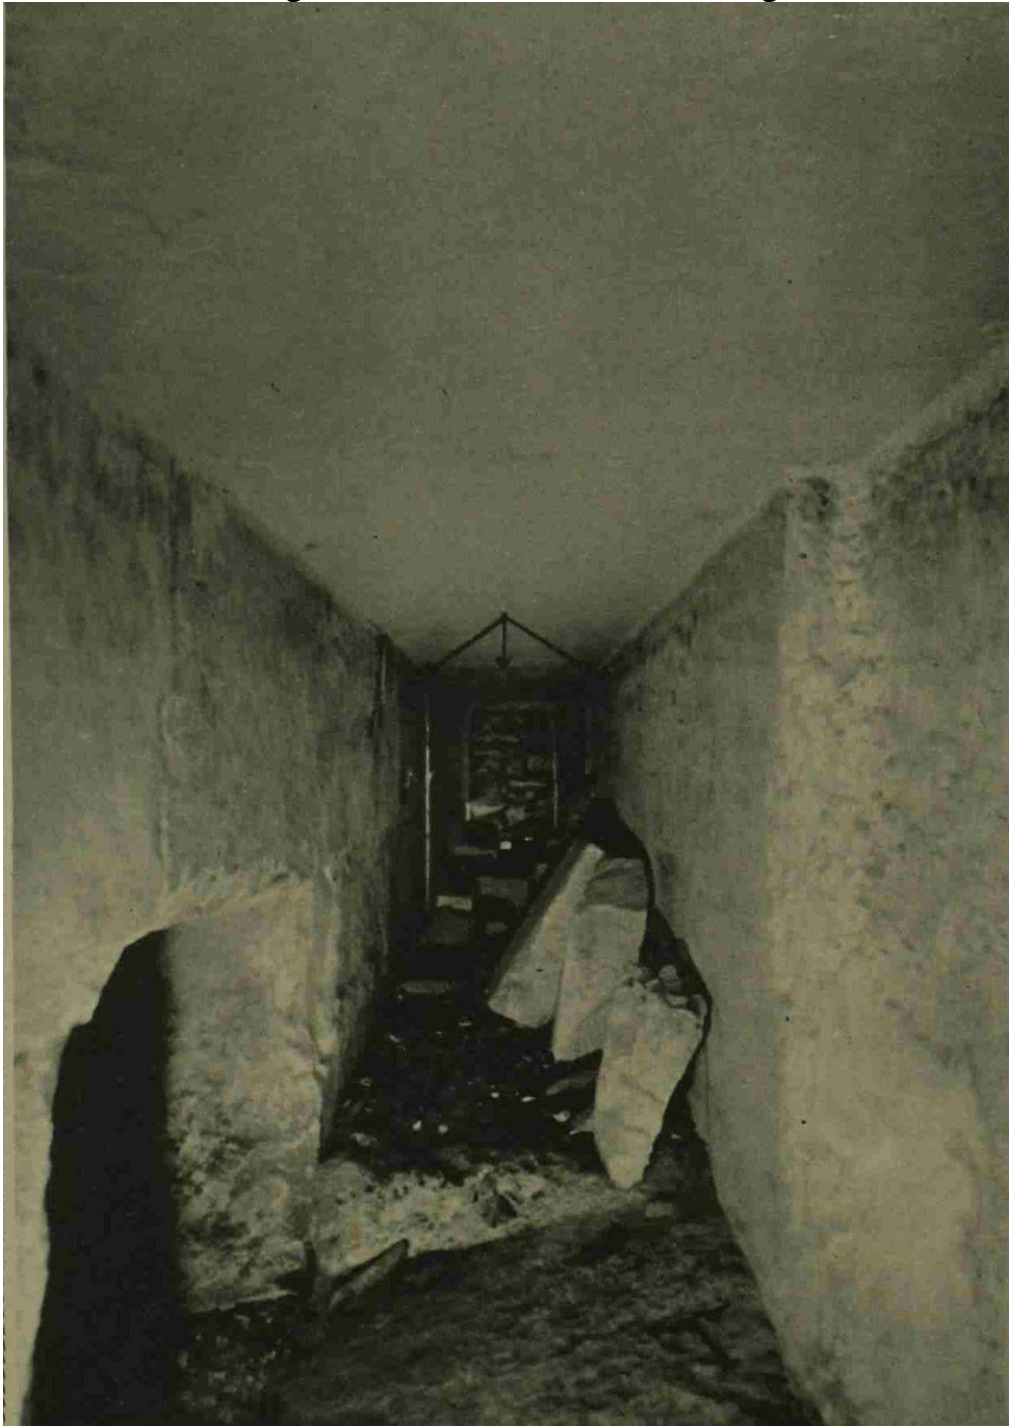
FIG. 6. LEADING TO THE UPPER CHAMBER: THE UPPER PASSAGE, WITH (LEFT, FOREGROUND) THE FORCED ENTRY FROM THE LOWER CHAMBER SYSTEM, AND (ARROWED) THE SLOT WHICH CARRIED THE PORTCULLIS STONE.

We also see the repositioning of the south wall. The tunnel entrance floor is not aligned with the pavement surface, but below, as if an error had been made, which is not surprising as M&R say of this tunnel;

corridor, an excavation has been made about 1.3m to 2.25m from the chamber entrance. In the image below from the Illustrated London News, March 22, 1947, looking east, we see the tunnel entering in the north wall.

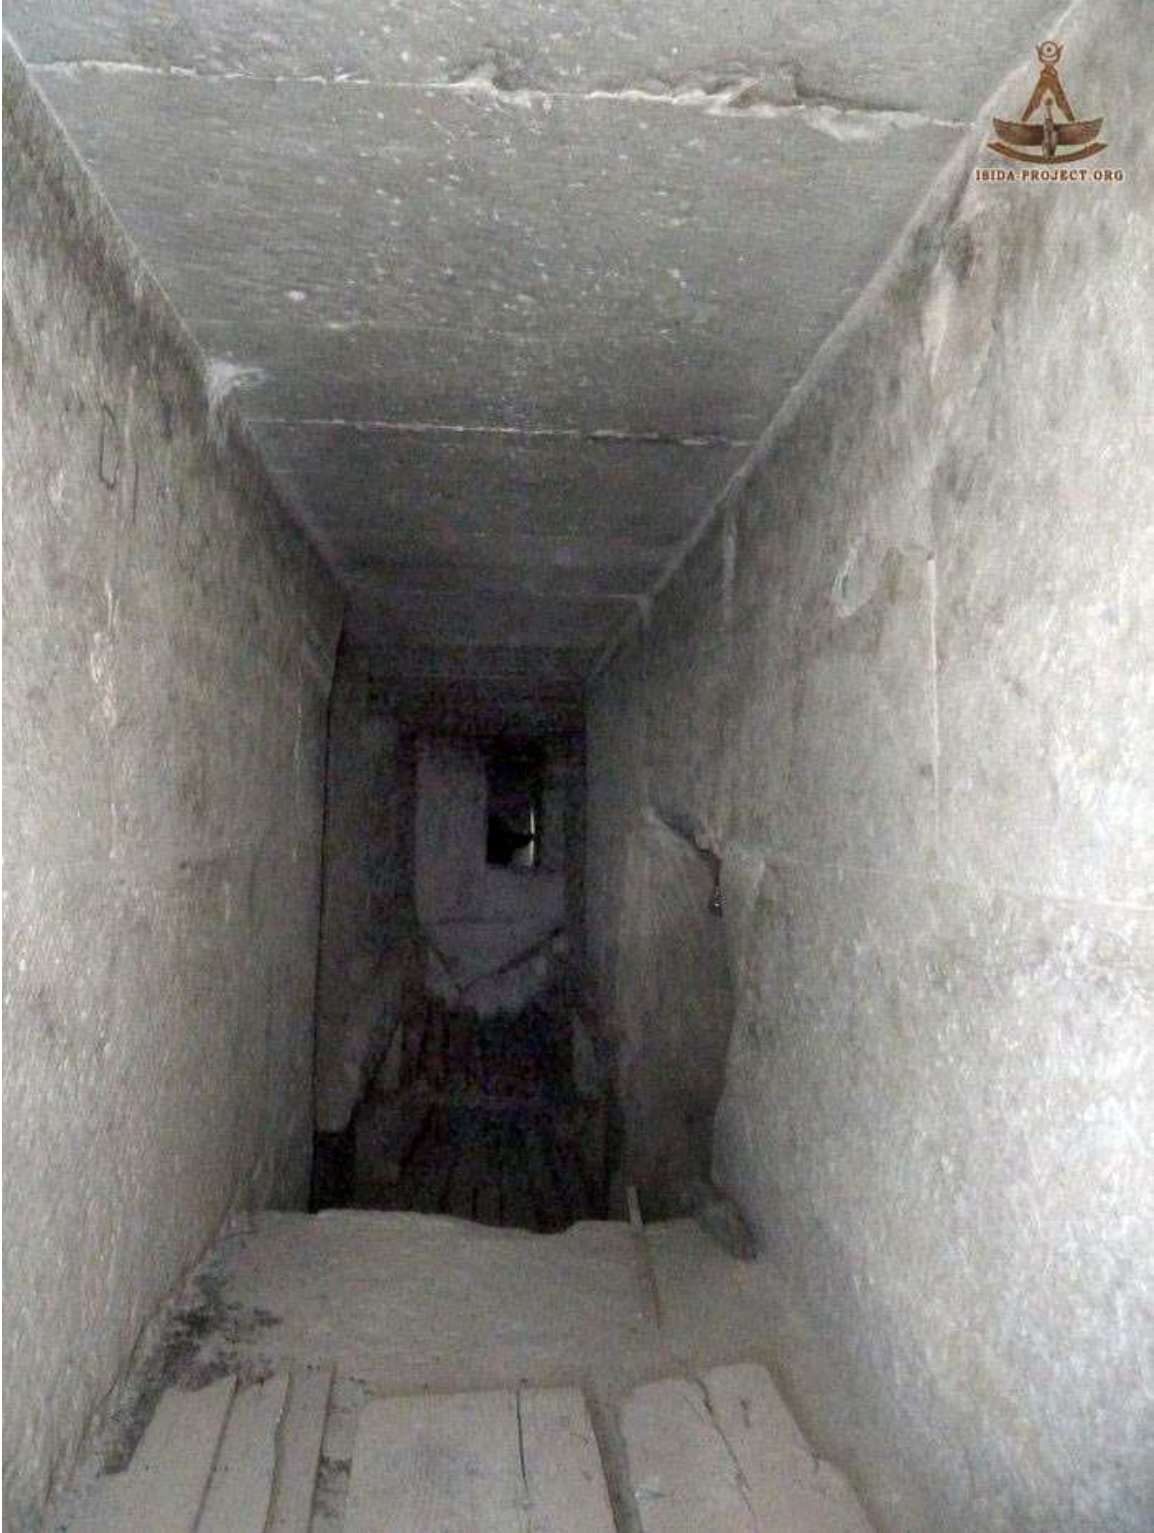
View looking west.

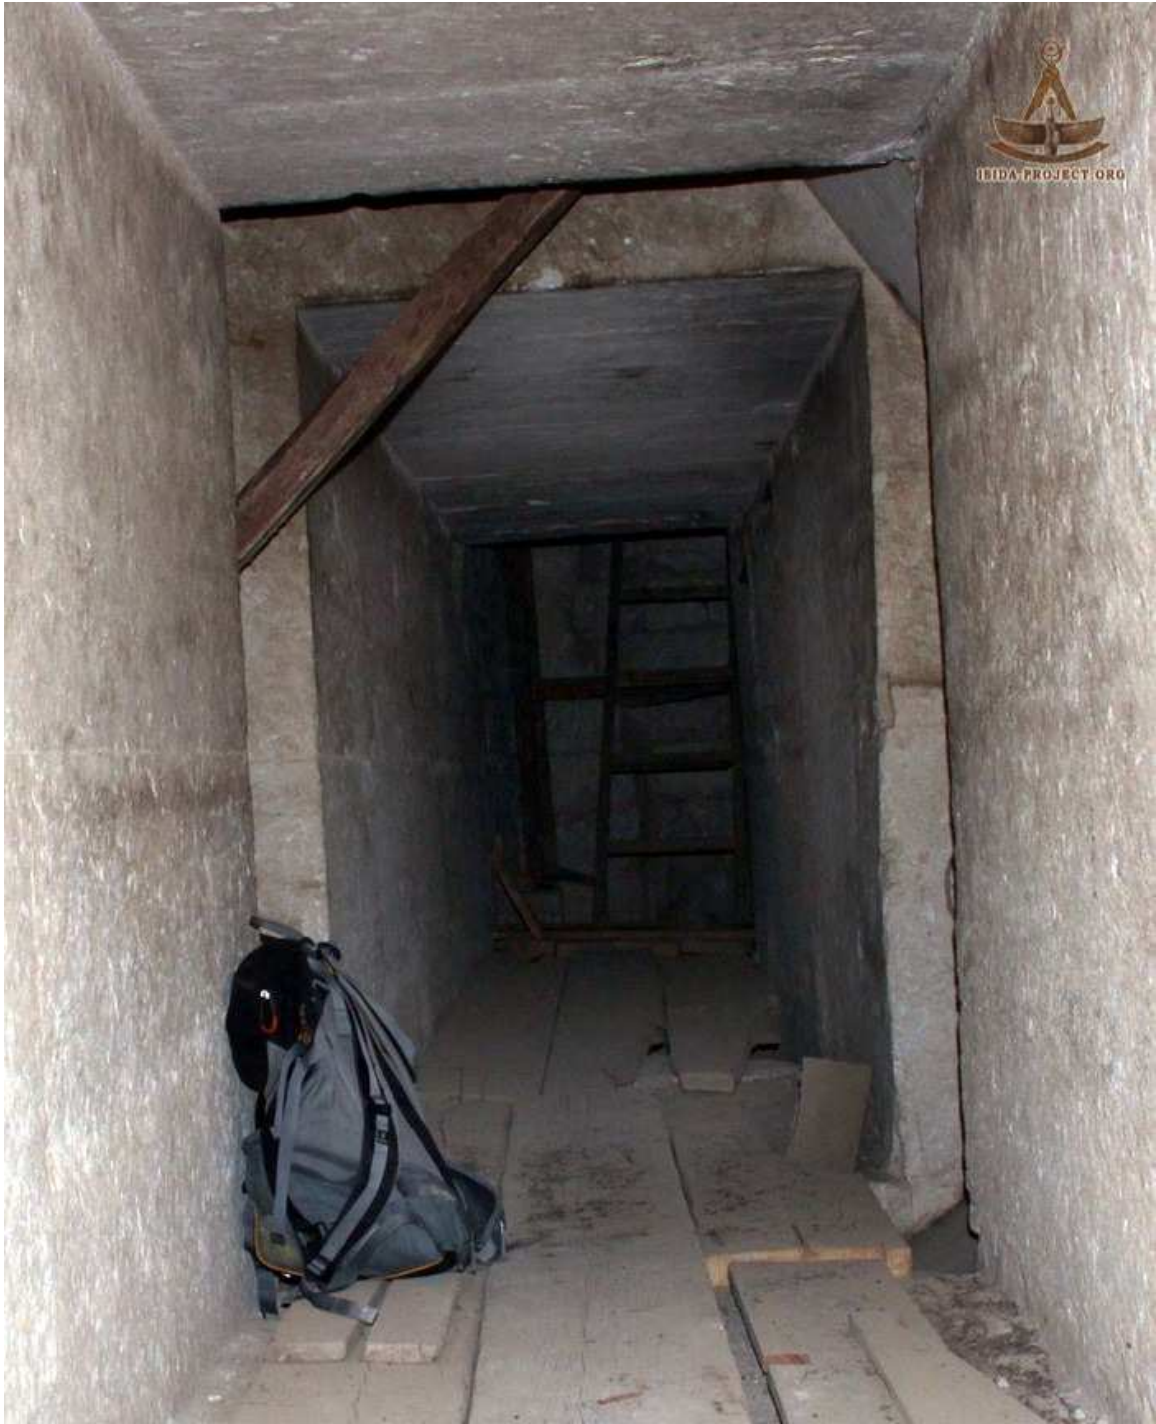
View looking east, with portcullis in stored position; the ladder in the background, leads to the top of the masonry massif, that was built inside the upper chamber.

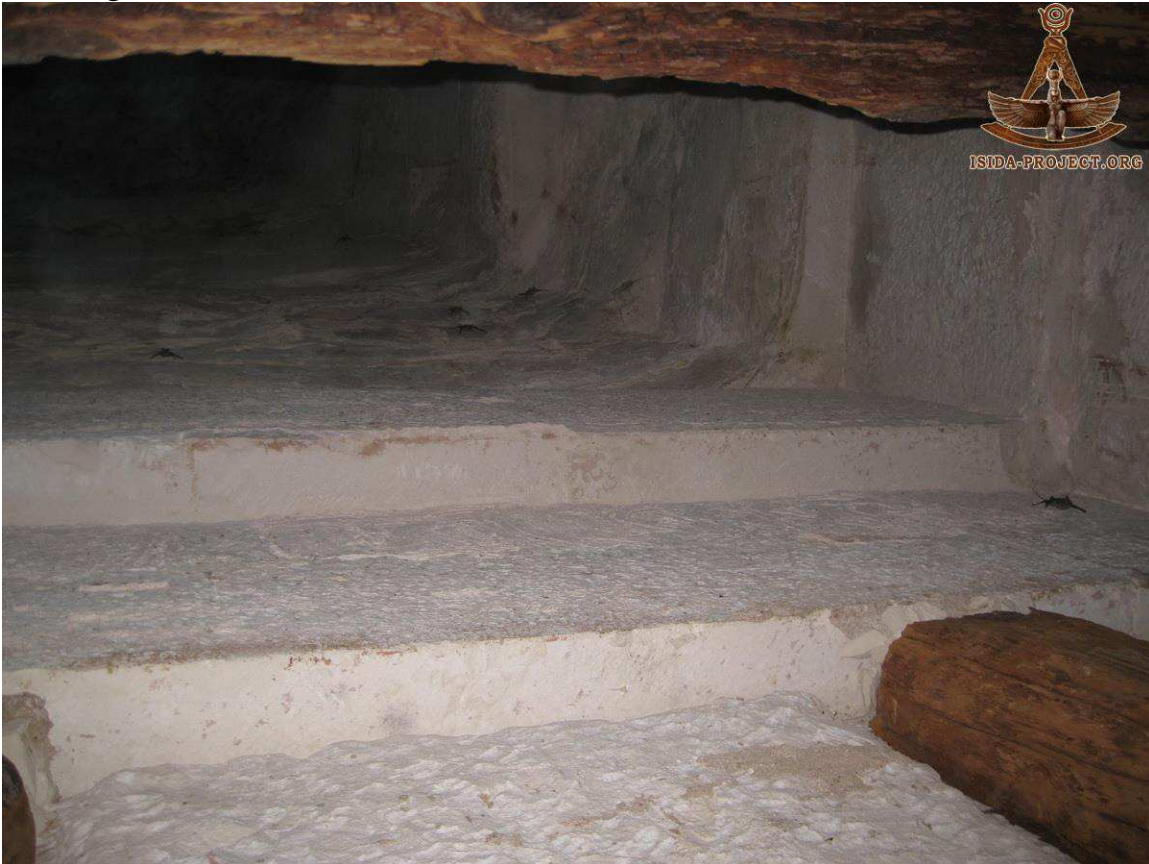
In the image above, we can just make out two beams, under the corbel, the left one appears to have a considerable gap which appears to be filled with mortar. The walls of the chamber also appear to have been dressed down to create a channel for the beam to sit in.

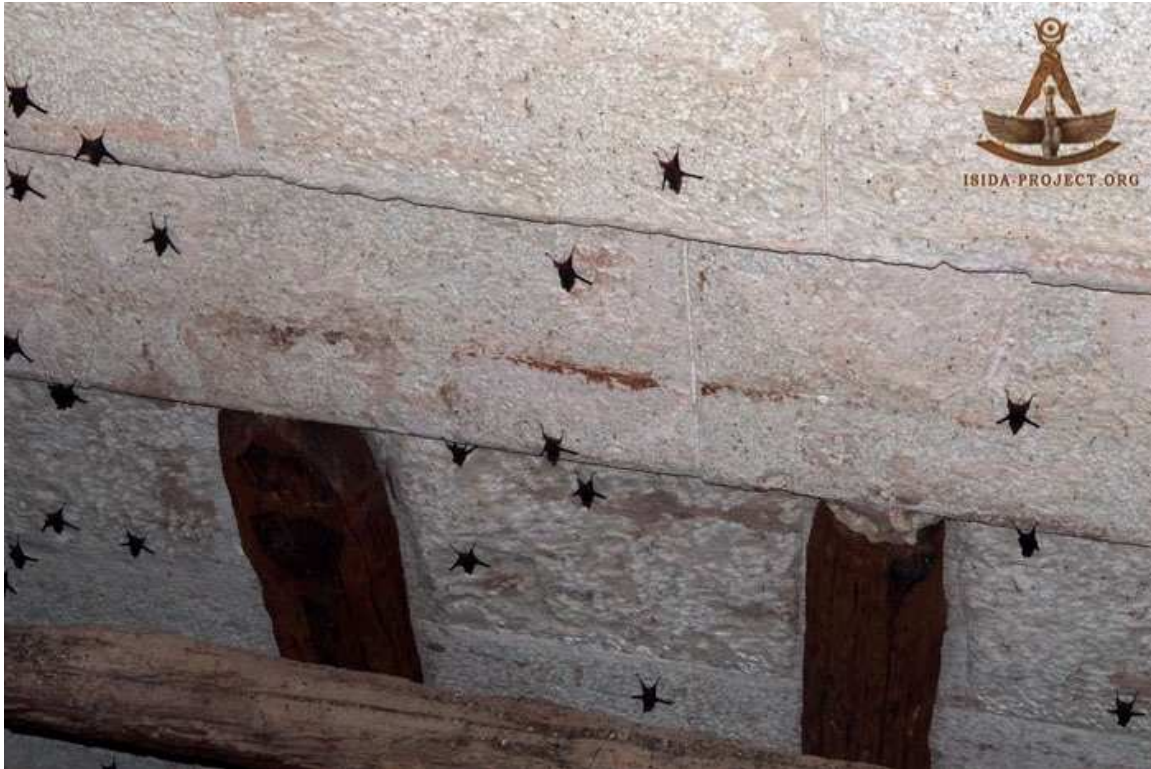
In the image above we see another pair of beams, the right one exhibiting mortar in the space, and the walls appear to have been channelled for the beams. In some images the chamber walls appear well finished and in others slightly rough. M&R were unable to determine if this was rough work or caused by corrosion and stone flaking.

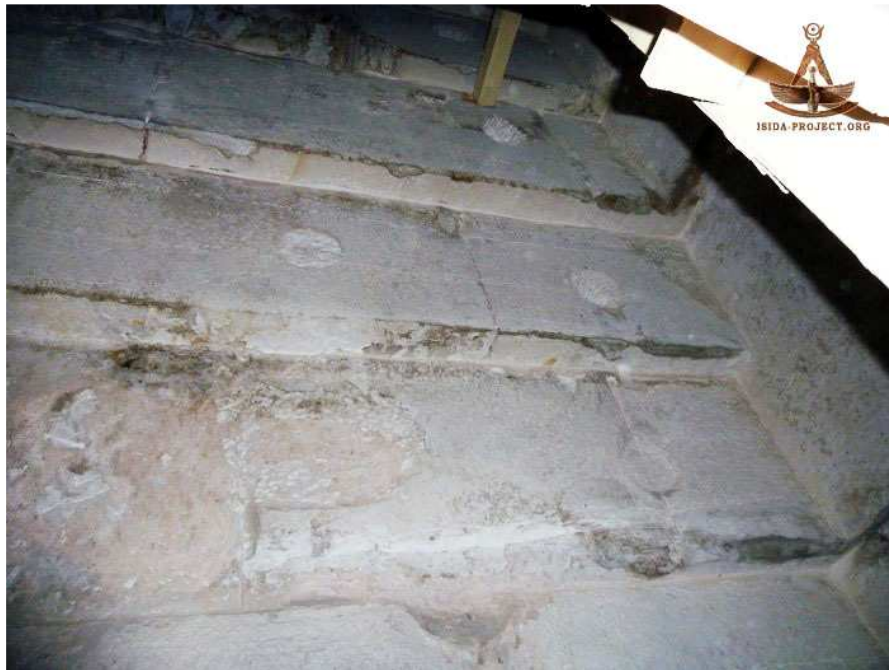
Circular impressions on corbel blocks

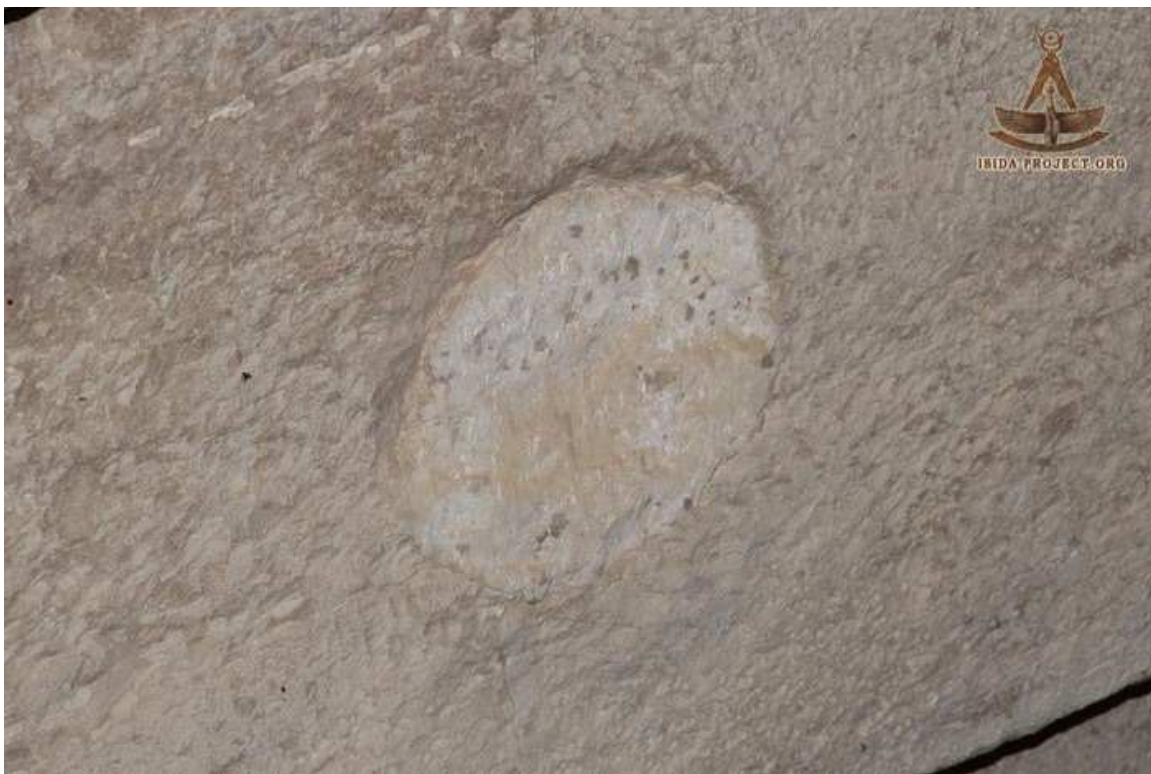
Close-up of circular depression

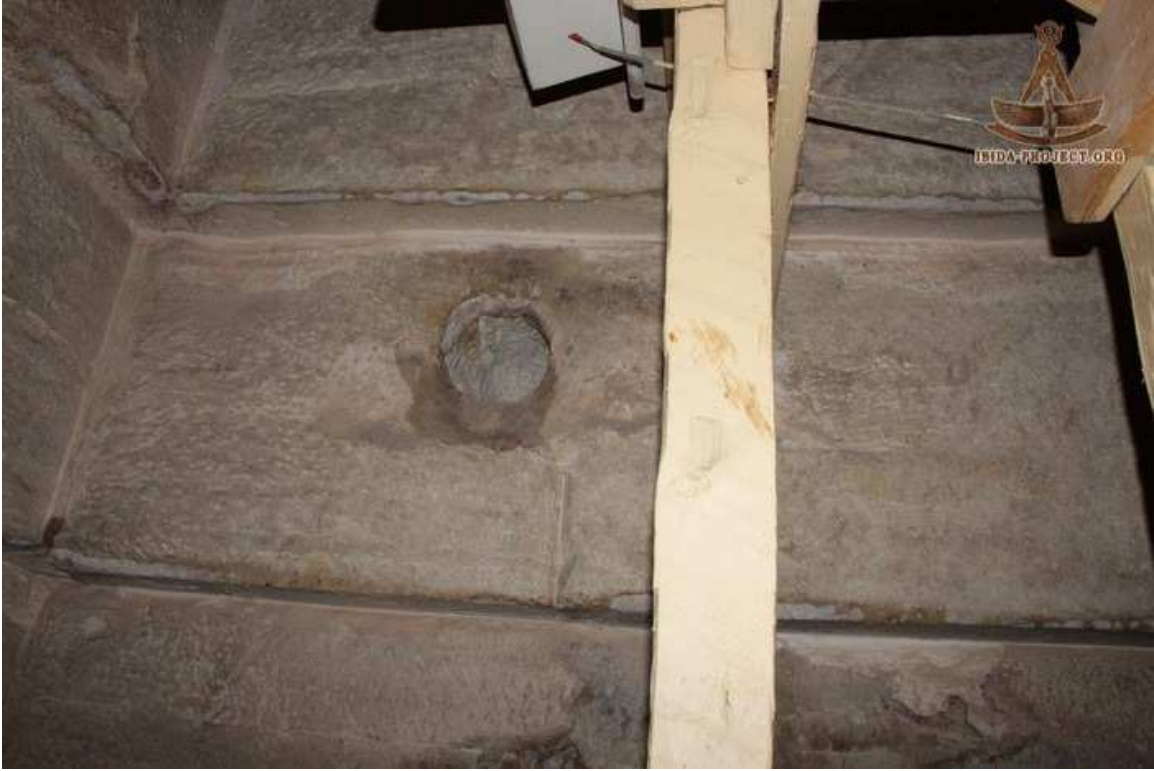
Hole filled with mortar?

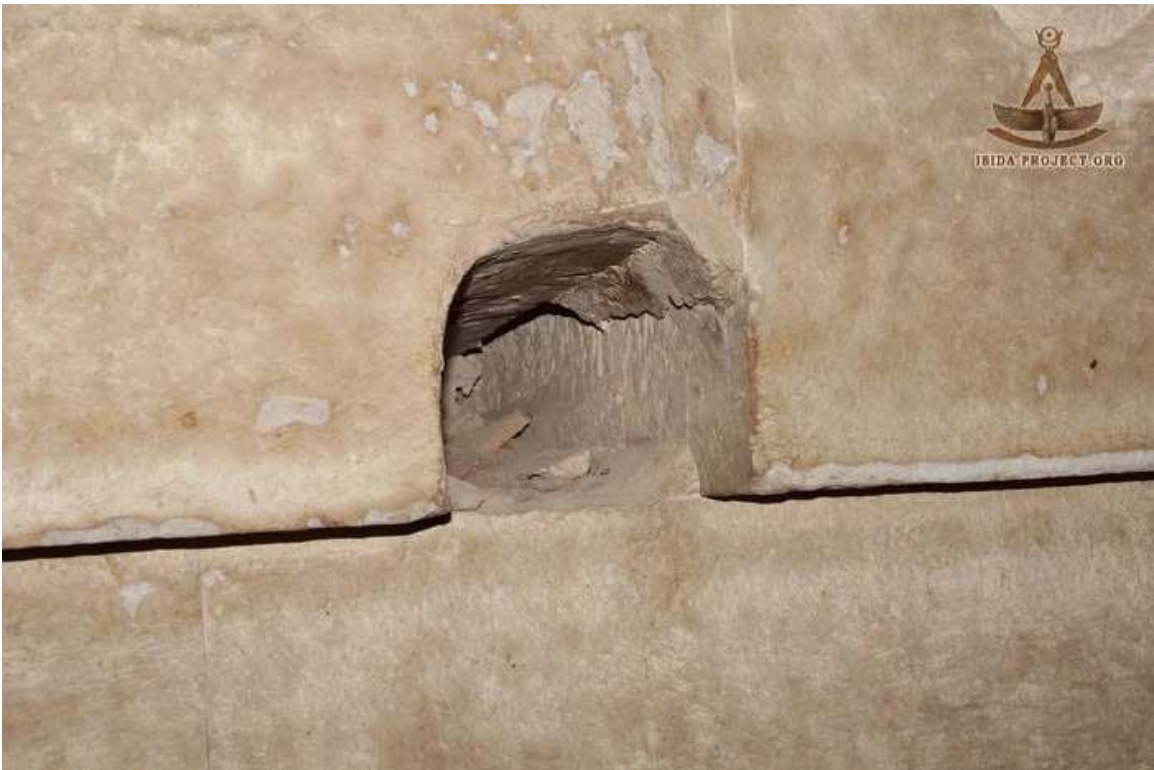
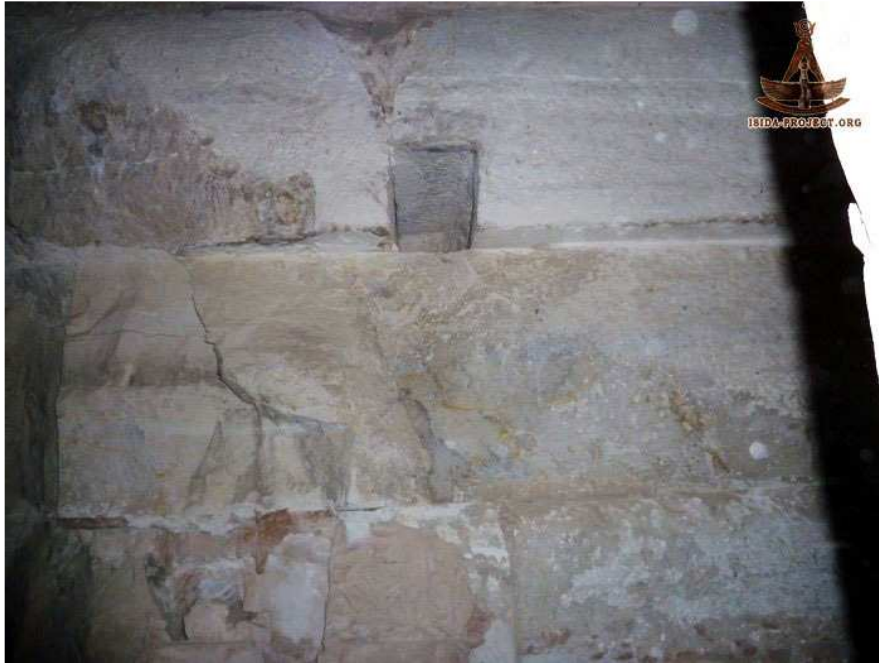
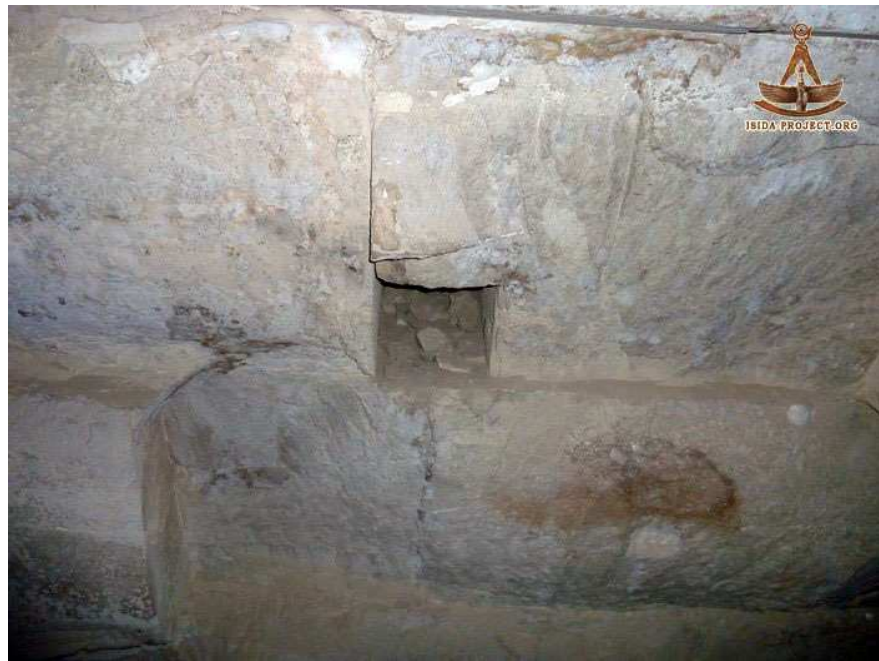
Examples of square holes

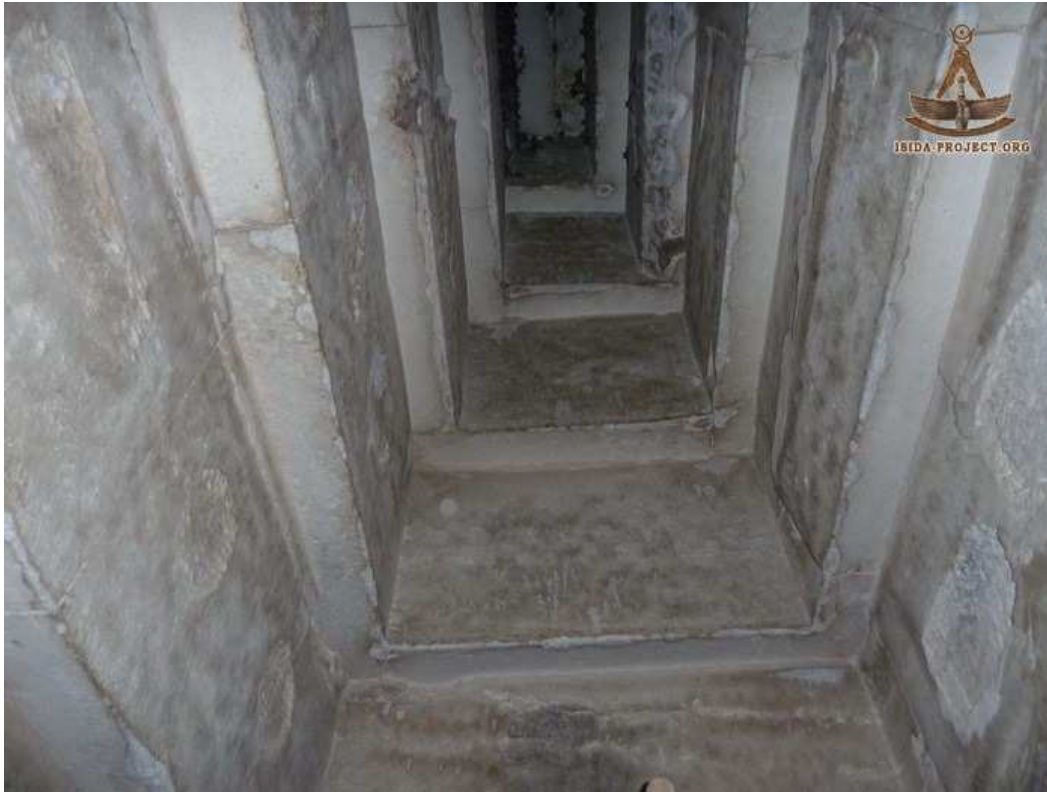
In the image above we seem to have circular impressions on one side and rectangular on the other,

There are so many holes and depressions throughout the lower chamber that they really all need to be catalogued, measured and exact locations given if we are to stand any chance of understanding their roles in this chamber.

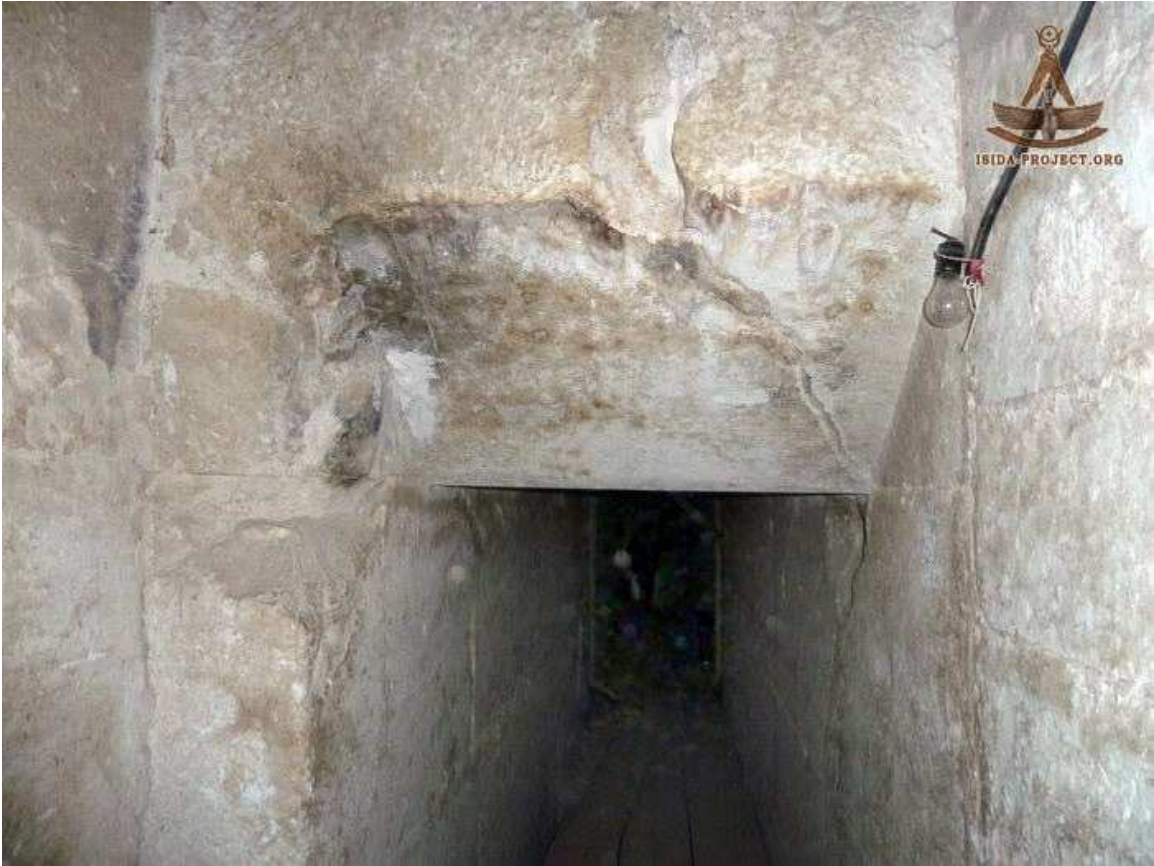
Looking west from inside the upper chamber, the large block over the door has an angled cut and it has been suggested that this was modified to aid access to the massif. Like in the lower chamber, the entrance is offset from the wall by 27cm. The masonry massif can be seen on the right and is aligned with the corridors north wall.

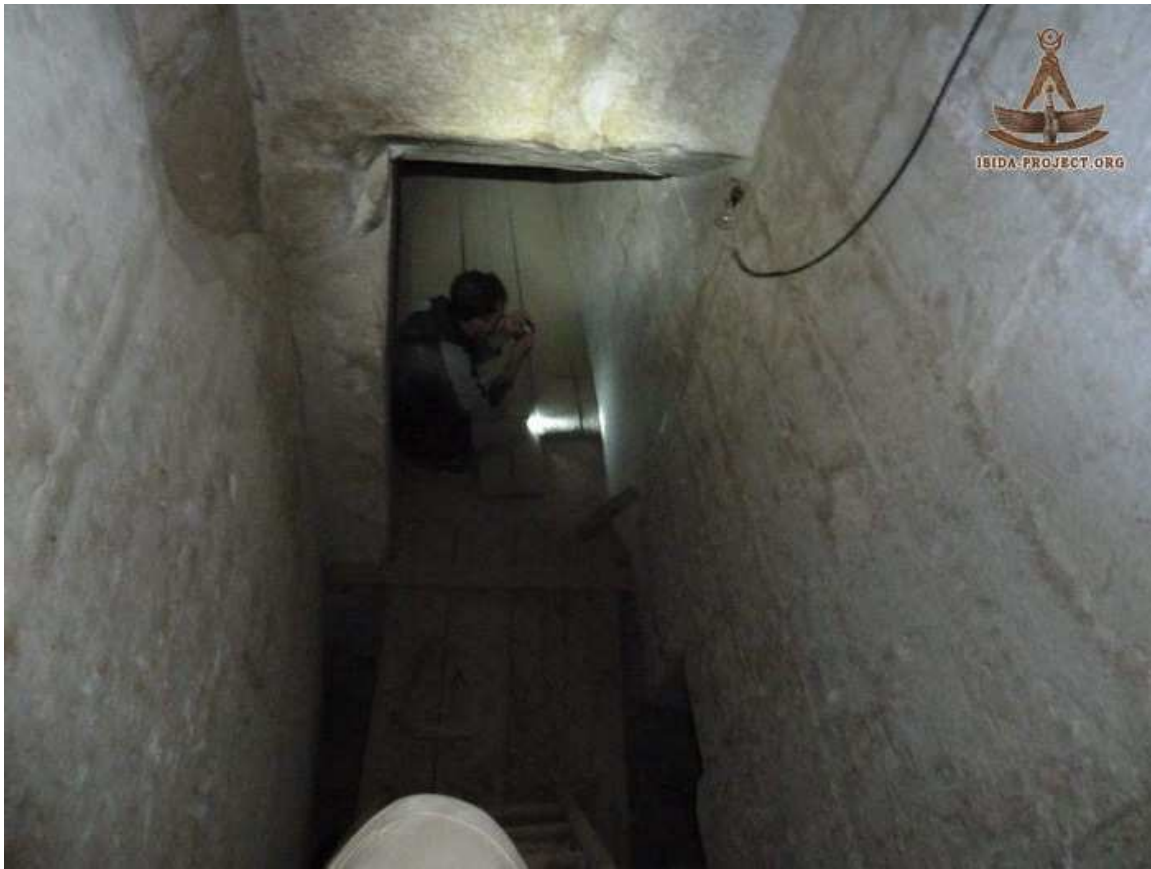
In this view further back and taken from a modern ladder leading to the top of the massif, we get a better view of the south wall of the massif. These blocks are well squared and laid with mortar. Whether this construction method was used elsewhere is not clear, the loss of Hussein's notes is a severe blow on the blocks found in the other chambers; we can only hope that some old photographs may emerge that can help.

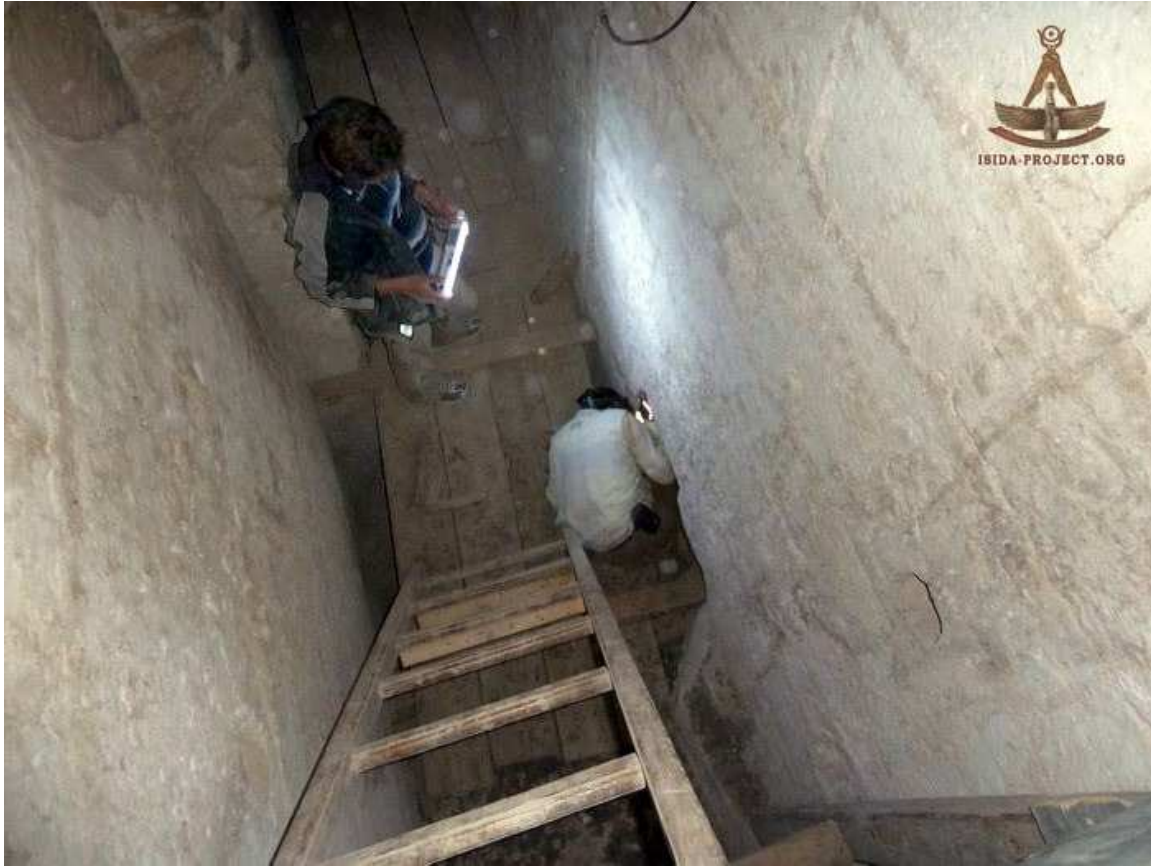
In this view a person lays by a hole that leads to an excavation under the massif, which heads in a northward direction for over 2m and about .9m deep below chamber floor level and about 1m above floor level; the excavation believed to be by violators, only extends into the massif a short distance, the greater part is in the floor of the chamber Note the round hole in the massif wall and what appears to be a circular depression opposite in chambers south wall. In this excavation was found the only cartouche of Sneferu inside the pyramid, below floor level and painted upside down on the side of a block.
