The Bent Pyramid

A Layman's Guide part 1

Keith Hamilton. 15 July 2017

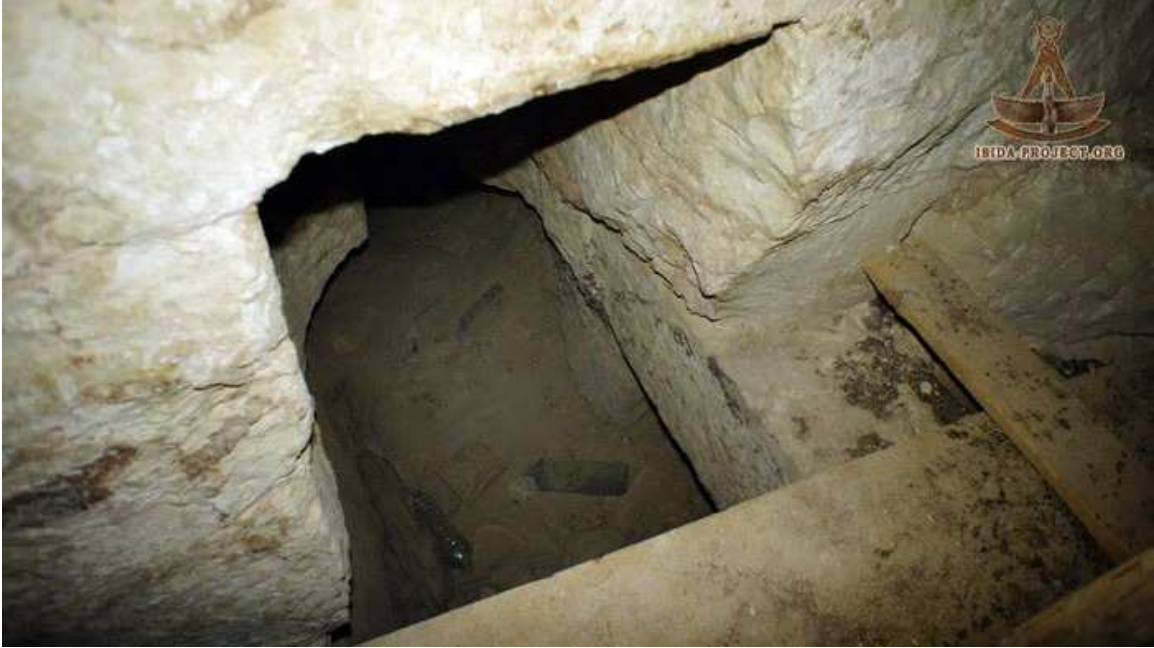
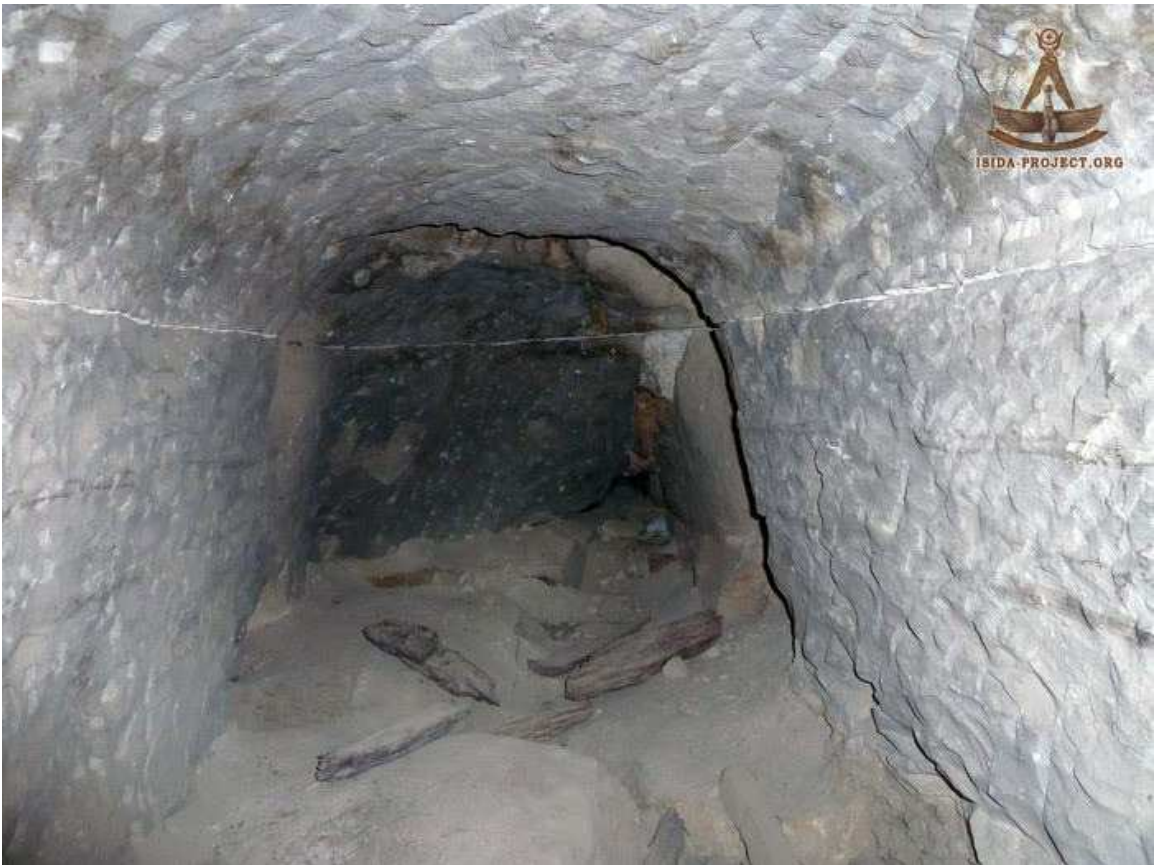
Looking down into the excavation under the massif and below, image of the excavation under the massif looking north.

In this view a person lays by a hole that leads to an excavation under the massif, which heads in a northward direction for over 2m and about .9m deep below chamber floor level and about 1m above floor level; the excavation believed to be by violators, only extends into the massif a short distance, the greater part is in the floor of the chamber Note the round hole in the massif wall and what appears to be a circular depression opposite in chambers south wall. In this excavation was found the only cartouche of Sneferu inside the pyramid, below floor level and painted upside down on the side of a block.

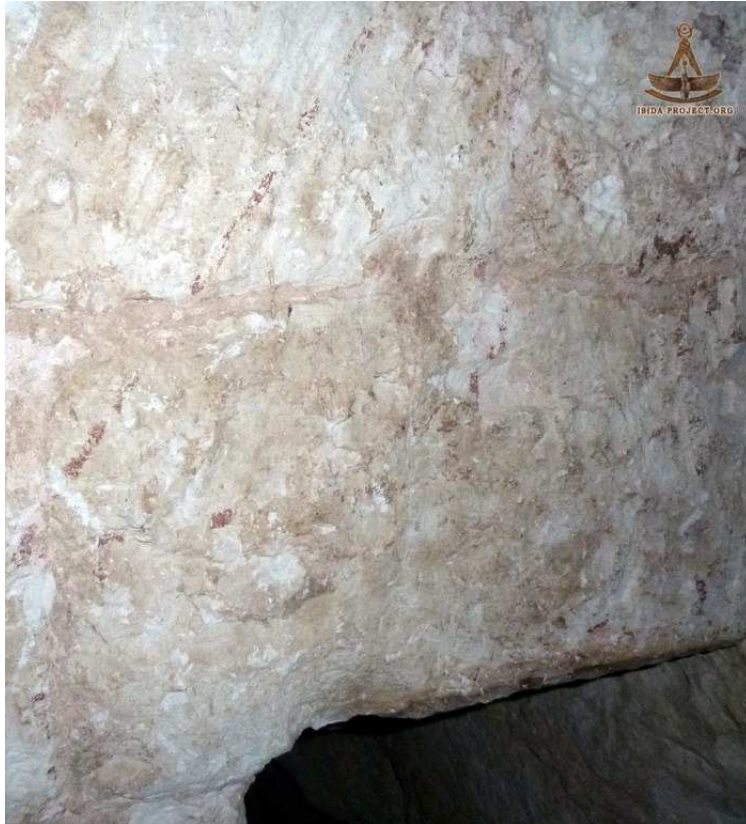
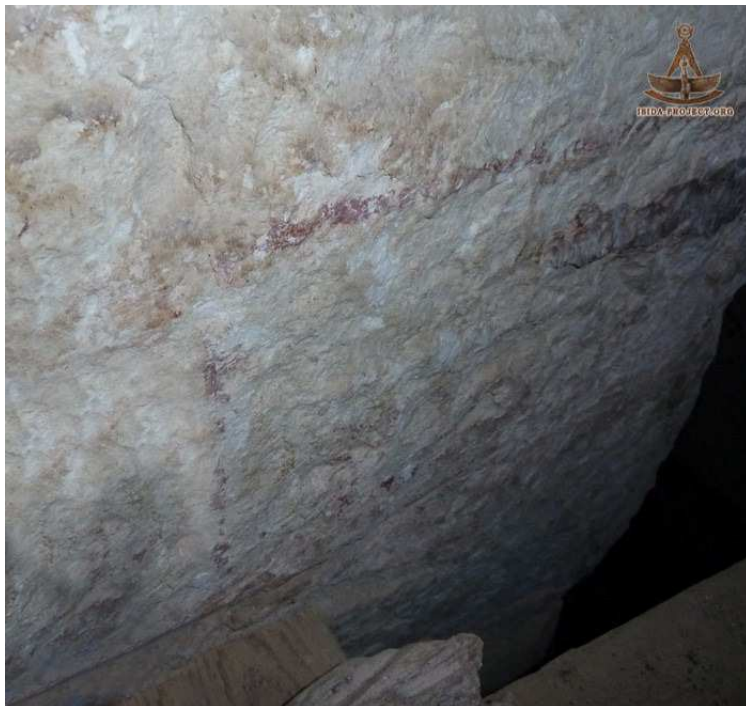
Why this spot was chosen for excavation is not known, but it's interesting to see faint traces of red lines visible near it.

These blocks contain many mason and graffiti marks and some lines cross blocks, suggesting that these were made after the blocks were laid. Some drawings and photographs of these markings are in Fakhry's volume 1, no further information is given on them other than Fakhry's statement; *"Needless to say, all these quarry marks and graffiti which were embedded in the masonry are from the same period i.e. from Sneferu's reign, the time of construction of this pyramid."* On plate VI image A. there is a good picture of the stone blocks removed from the pyramid, piled in a large heap outside the north entrance.

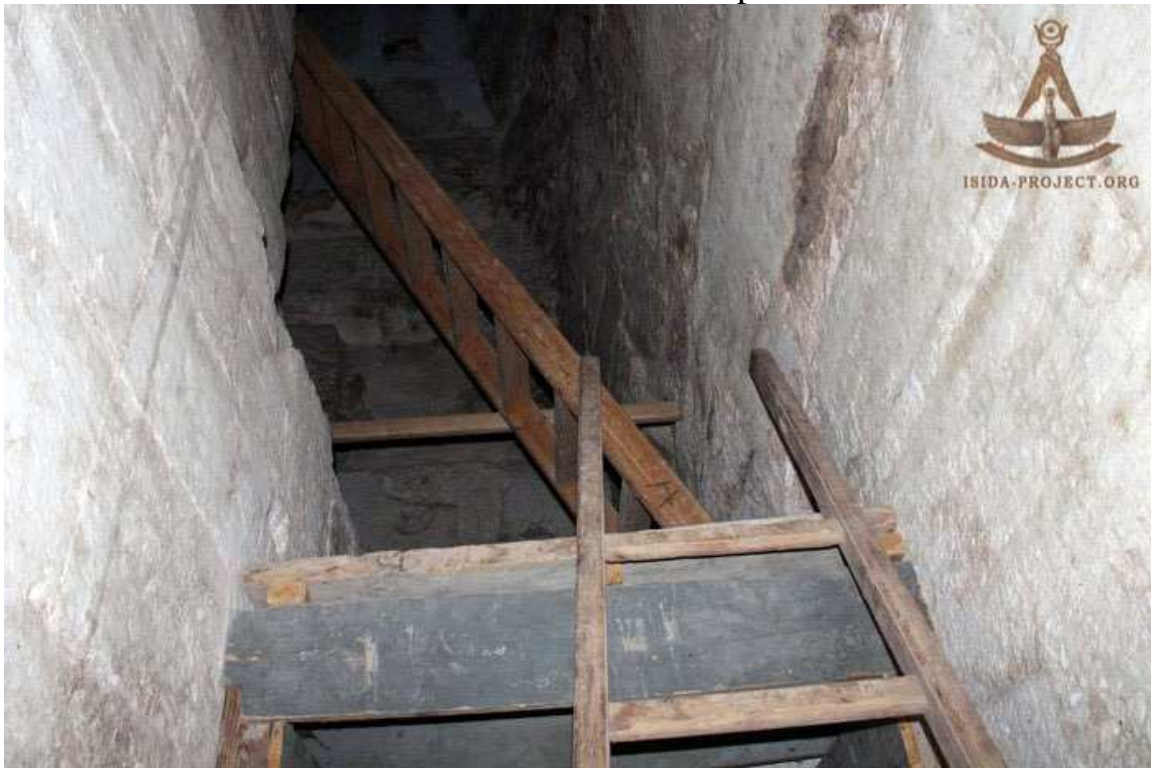
With the rubble ramp removed, we see the modern ladders and platform that provide access to the top of the massif.

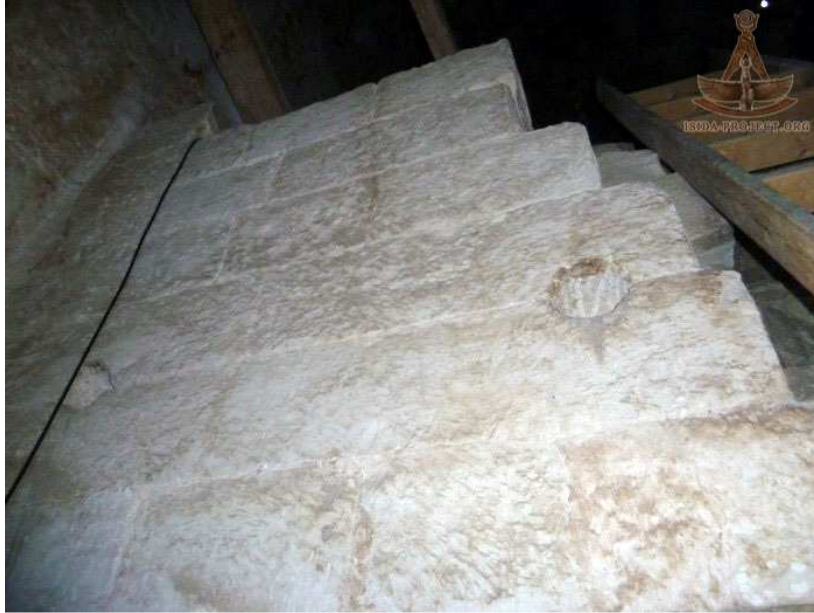
Looking up the massif south wall, ladder to the right and the presence of two holes.

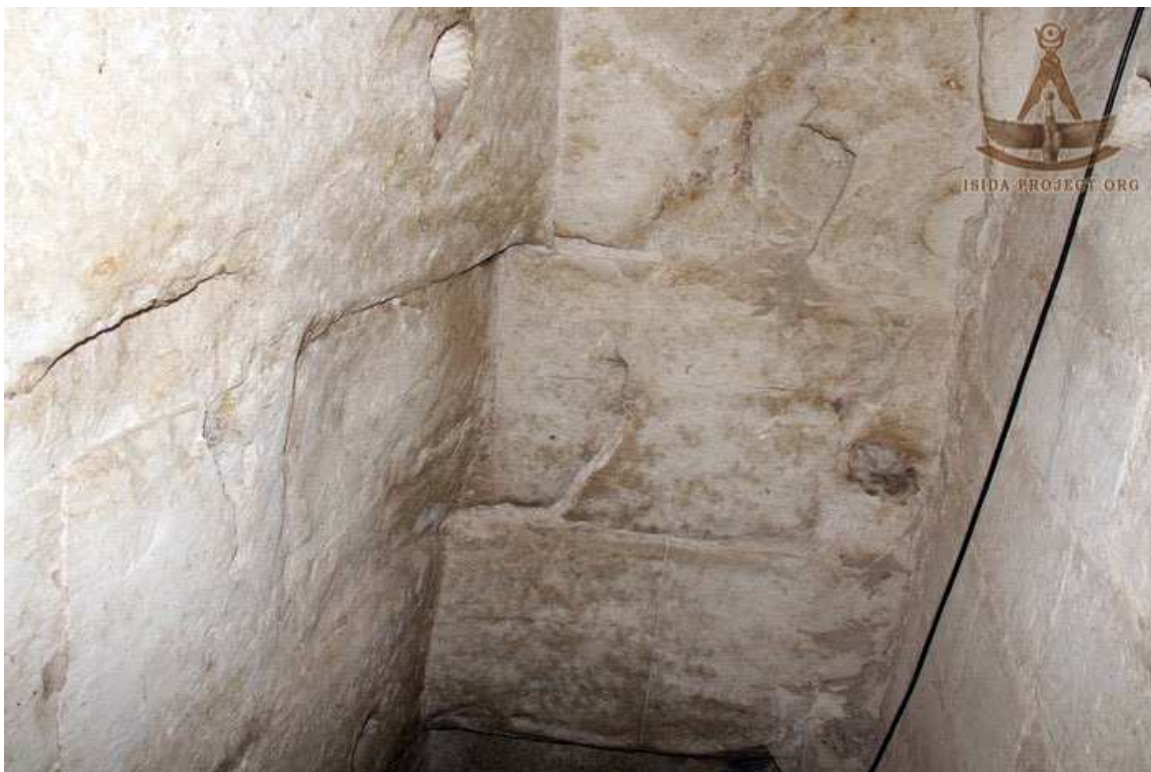
This view looking west, massif to right, chambers west wall in front and south wall left, note hole in south wall that appears to be paired with the hole in the massif wall.

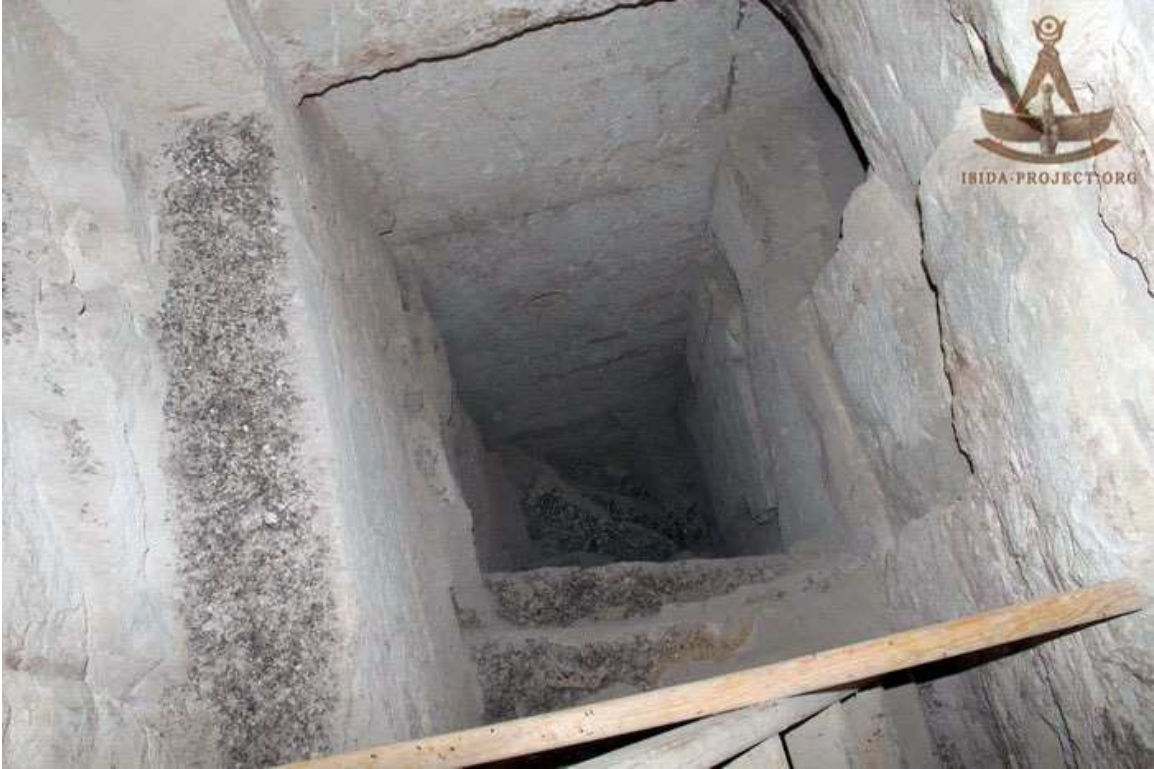
Looking down the so-called shaft that looks like it has been made by massif blocks, an excavation can be seen in the chambers south wall and a circular hole is visible on the chambers east wall.

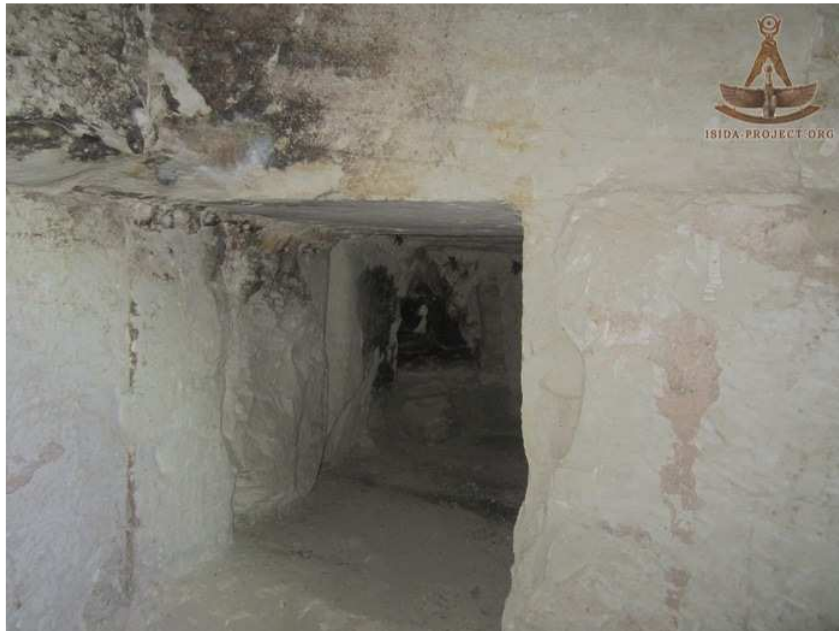
Looking into the excavation made in south east corner. A more detailed examination of this area is required to determine its true make up.

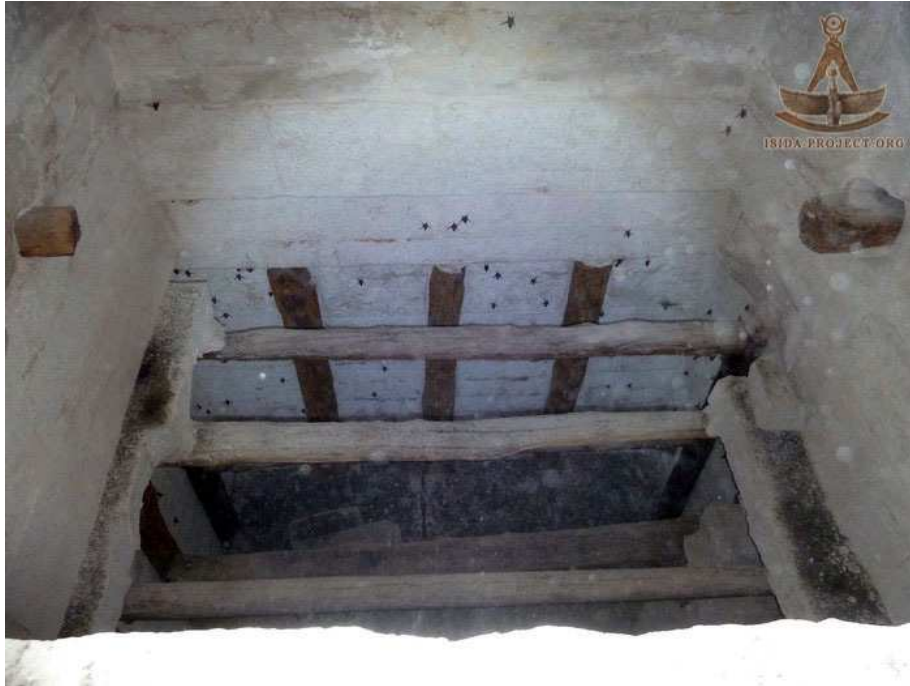
This view looking down from on top of the massif, we see the area cleared of stone blocks by Hussein, what we have left is the wooden beams. The horizontal beams span the distance between the east and west walls and from the drawings it appears that two of these beams were inserted, between each pair of vertical beams on the east and west walls; the uppermost beams are placed just below floor level of P2 while the lowermost beams are around 1.4m above the chamber floor. We can also see some of the original paving of P2 on top of the horizontal beams. Against the north wall we see three vertical beams that appear to have no function, maybe horizontal beams ran from them into the massif masonry, that have since been removed, during the dismantling of the massif; a closer examination of these beams would be useful to see if there is any witness marks on them.

The remnants of beams higher up on the east and west walls are in the area of P3 extension, but they could have been used in construction of P2, for example the hoisting of materials for the upper parts of P2. They appear to be located midway between the two floor levels of P2 & P3, currently we have two pairs, but like the beams below more may be buried in the remaining massif. Did these upper beams span the chamber? They have the appearance of being cut through, but when? Given the loss of Hussein's notes it might be beneficial to further remove some of the upper massif and see if an intact beam exists.

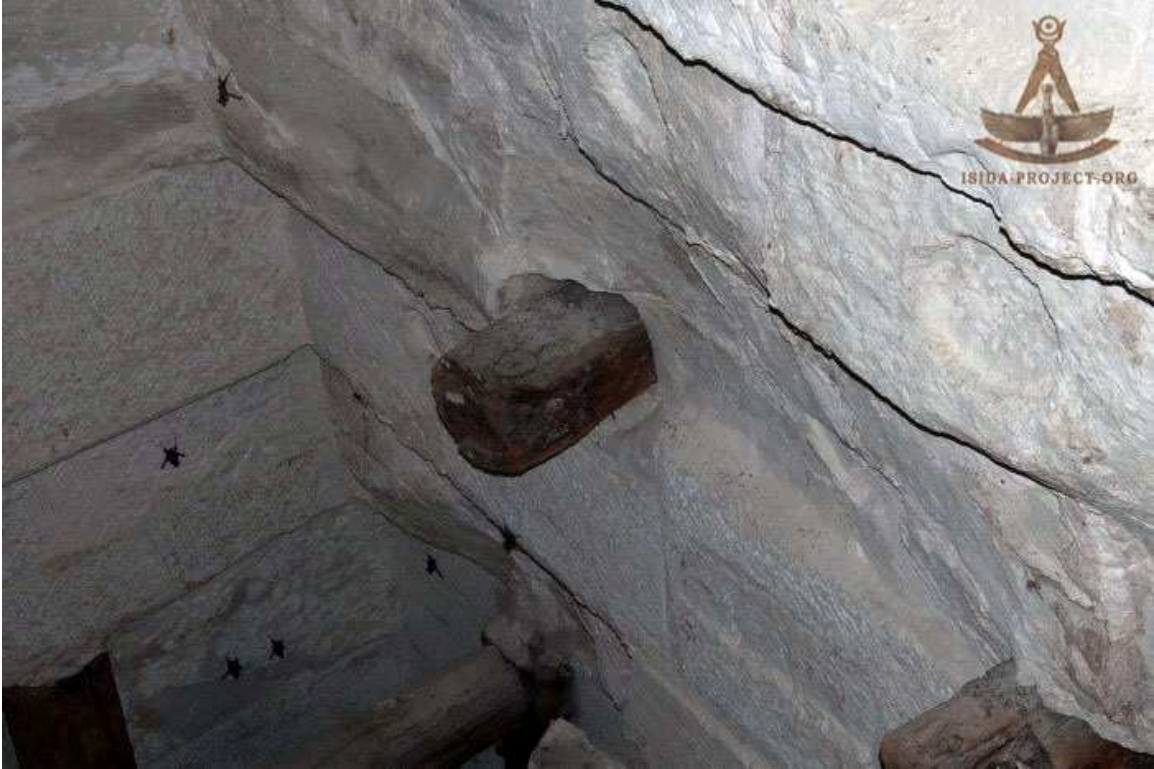
In this image we have a closer look at the remnants of the upper beams and if you look above we have two circular depressions; and like the lower chamber a thorough investigation is required to locate and catalogue all these holes etc, if we are to stand any chance of determining what has been going on in this chamber.

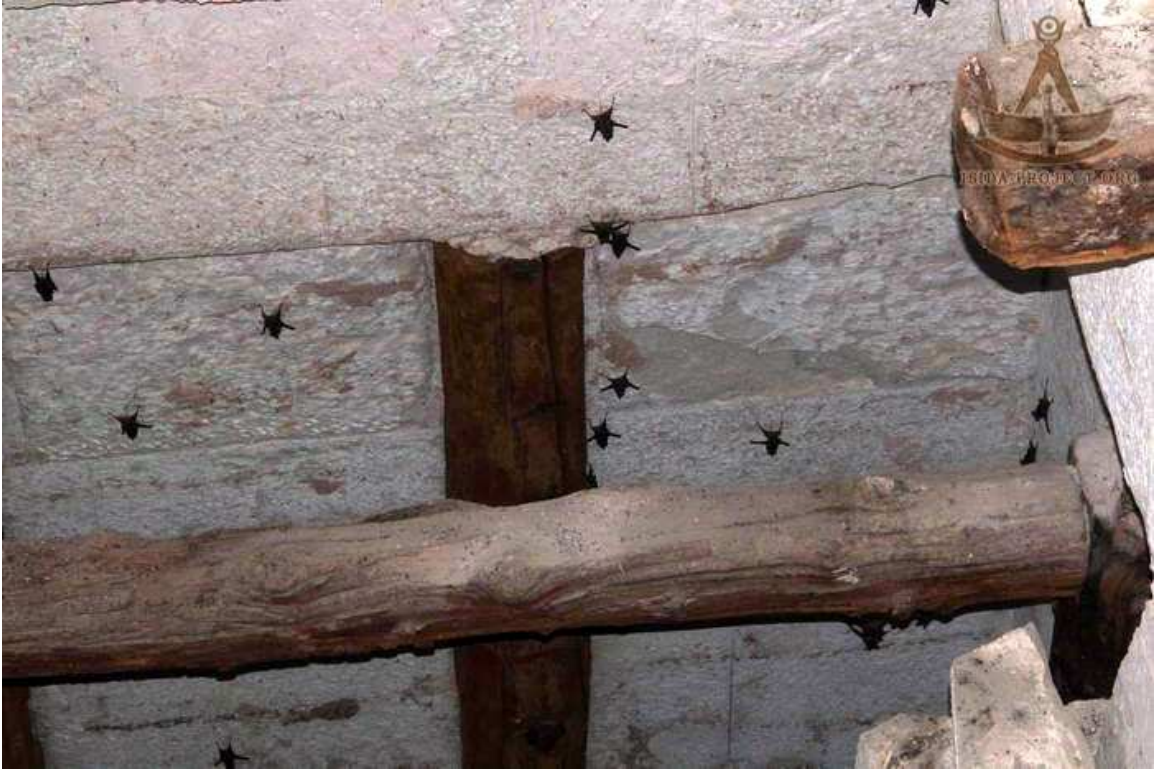
Here we see the horizontal beam abut against the vertical beam, how it is fixed is not known; it may have been banged in to create an interference fit.

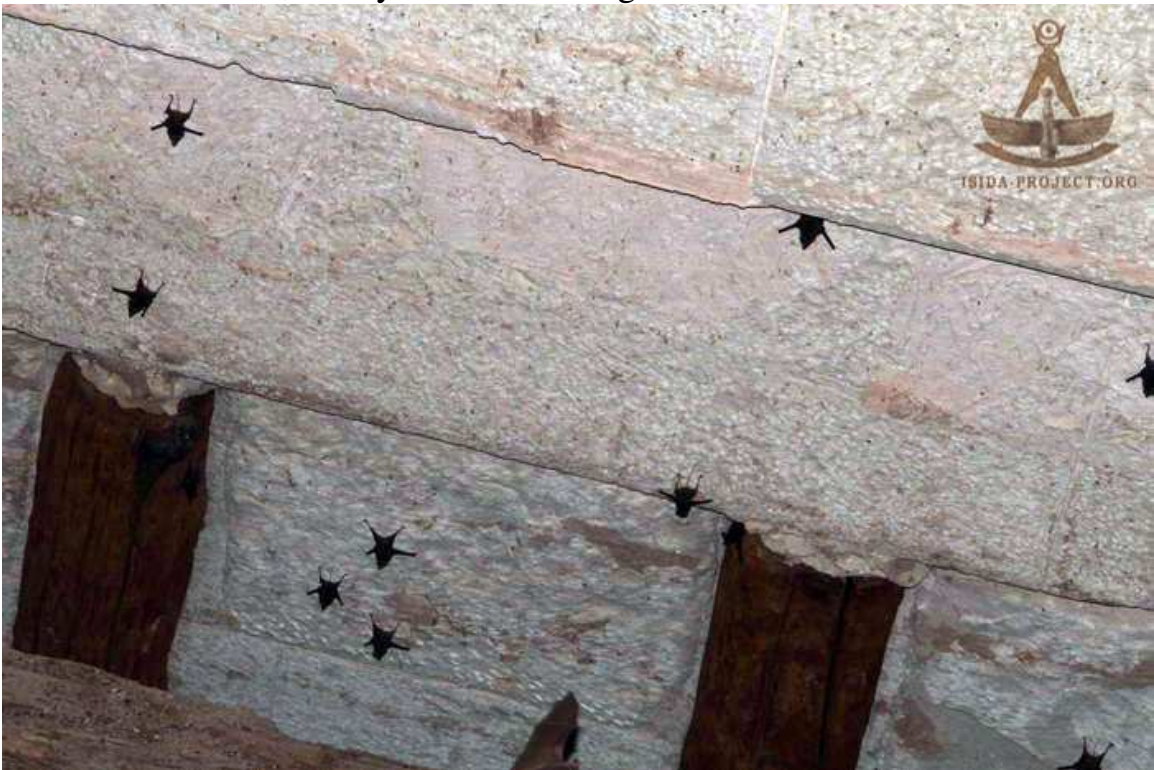
In this view, the walls appear to be chased in for the beams and the gap between the corbel and beams filled with mortar.

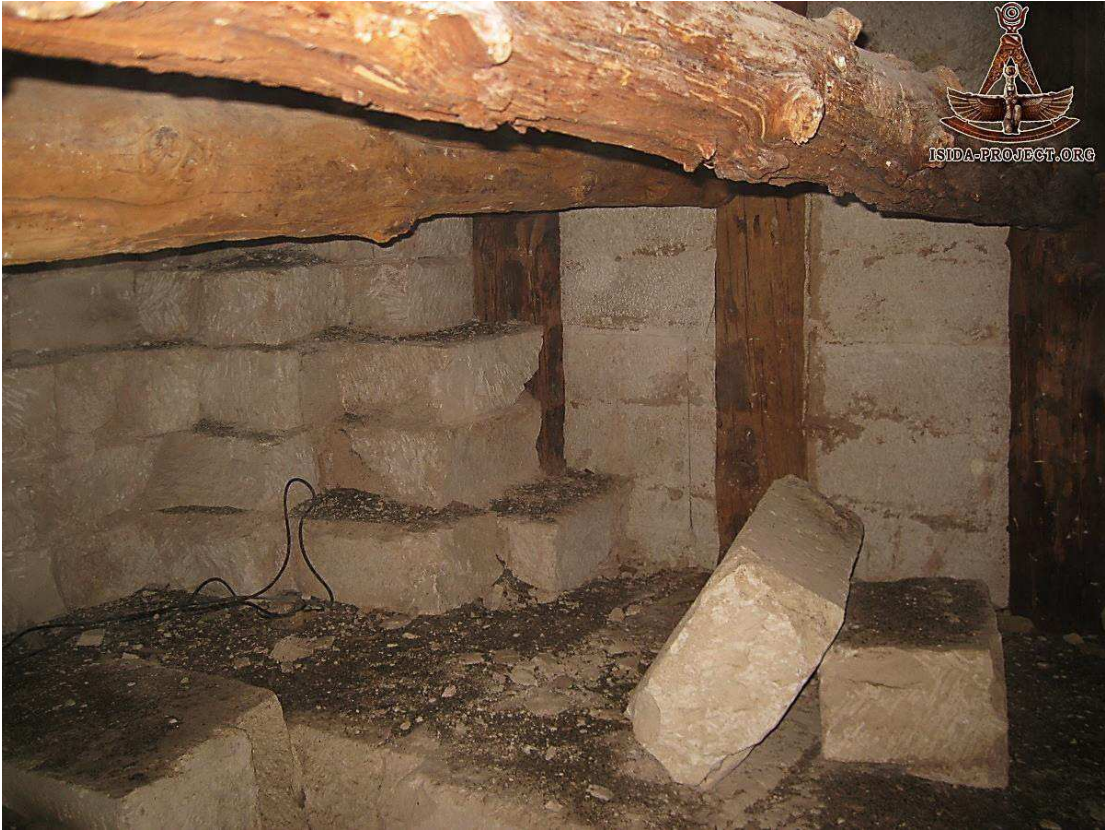
Blocks resting on chamber floor and good condition corbels

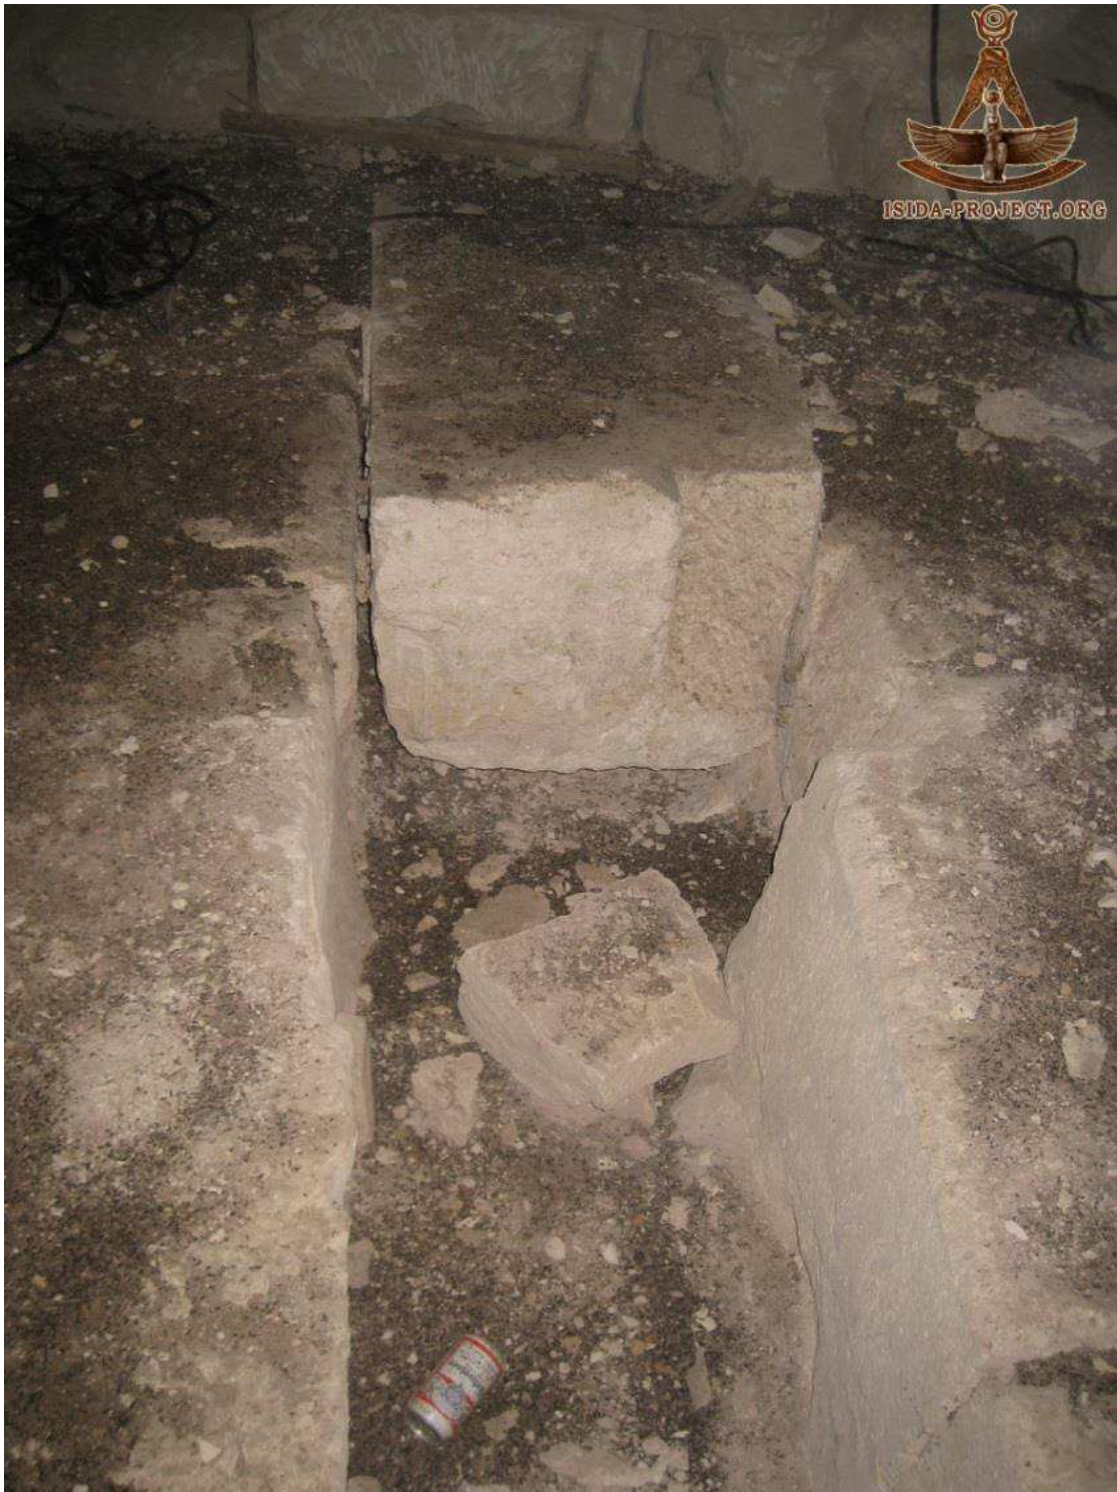
This picture is of the chamber floor and where the can is, should be the L-shaped keystone that Fakhry mentions, the area appears much damaged when you compare it to the pictures in Fakhry's plate XV.

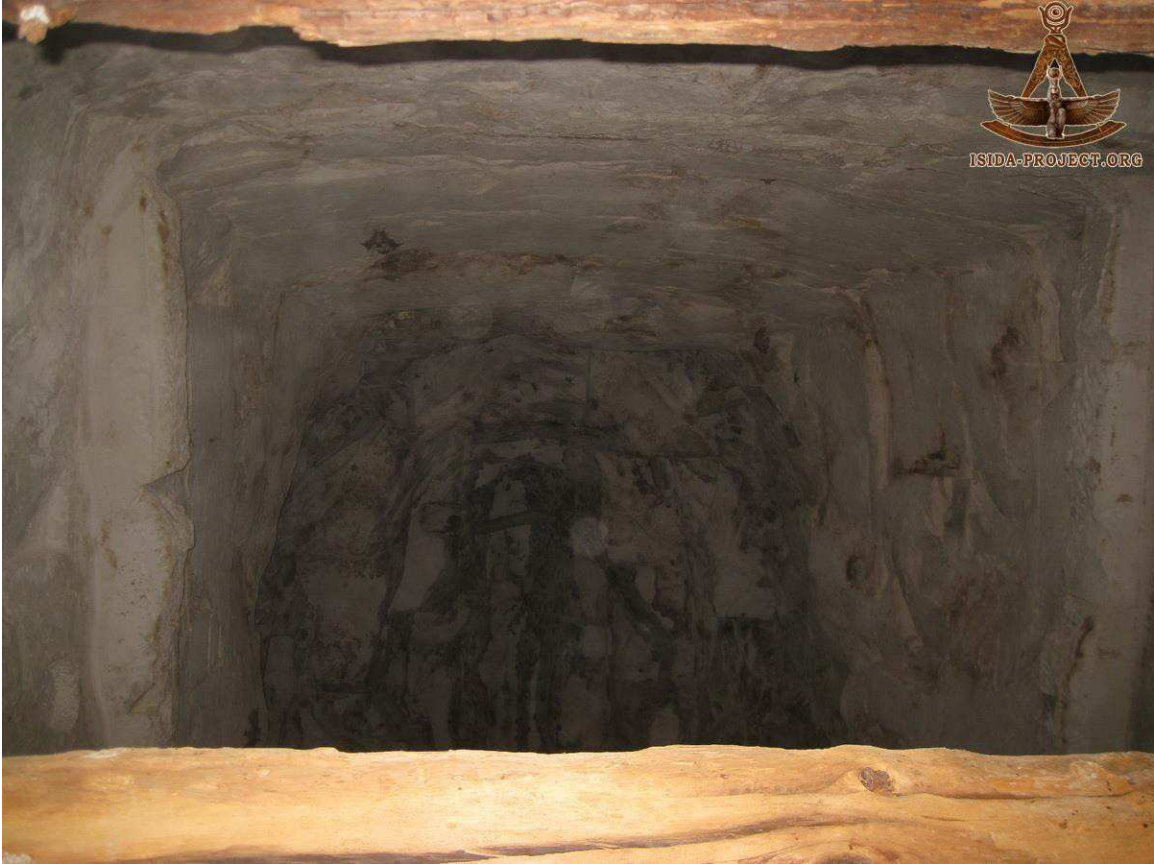
Looking through the beams at the damaged ceiling.

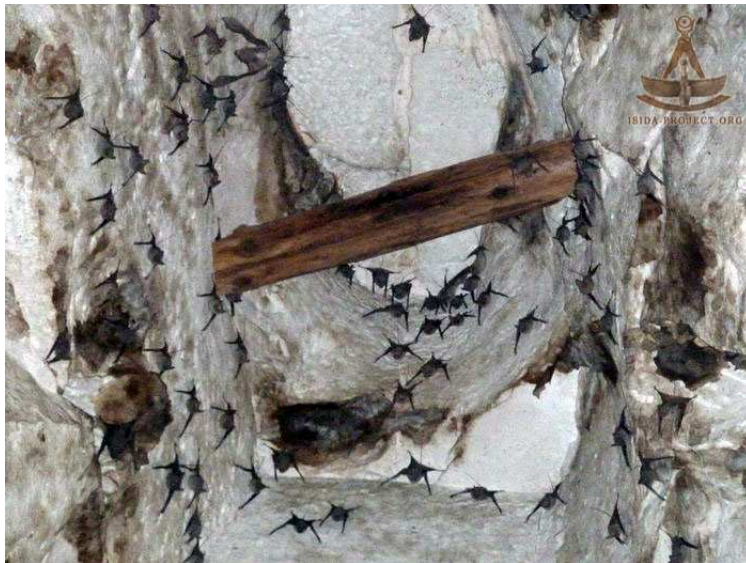
A lone beam sits towards the top of the ceiling

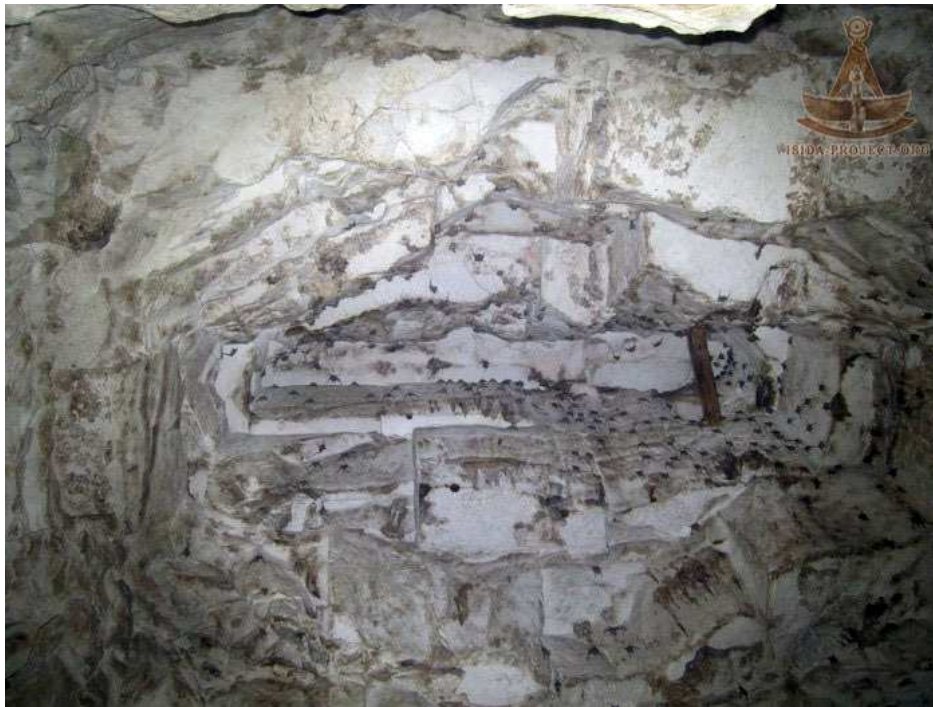
A faint glimpse of surviving corbelling exists at the top

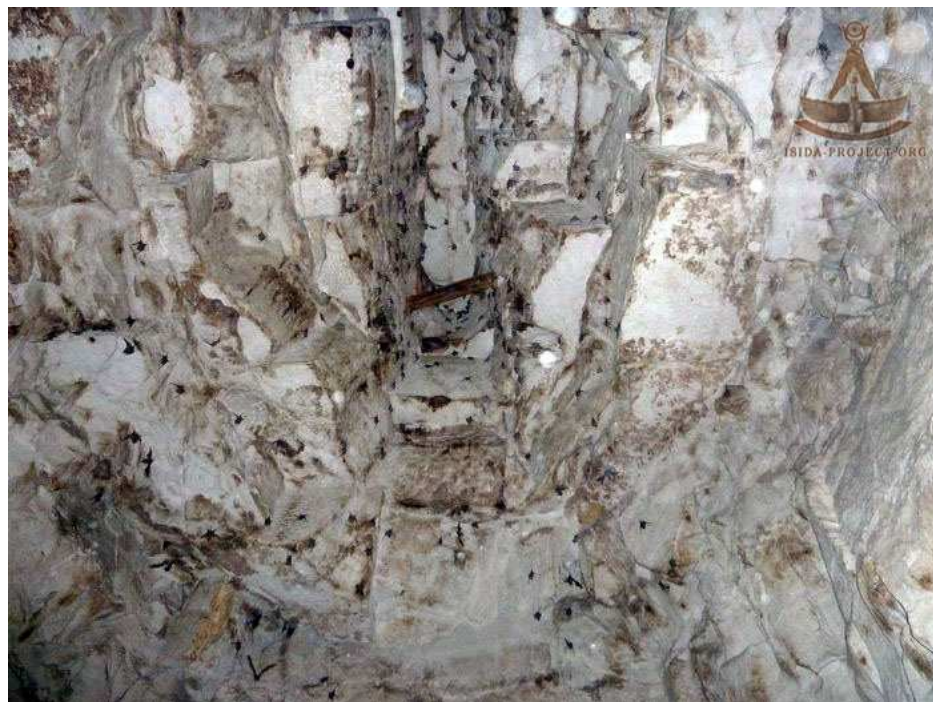
The damage is quite extensive

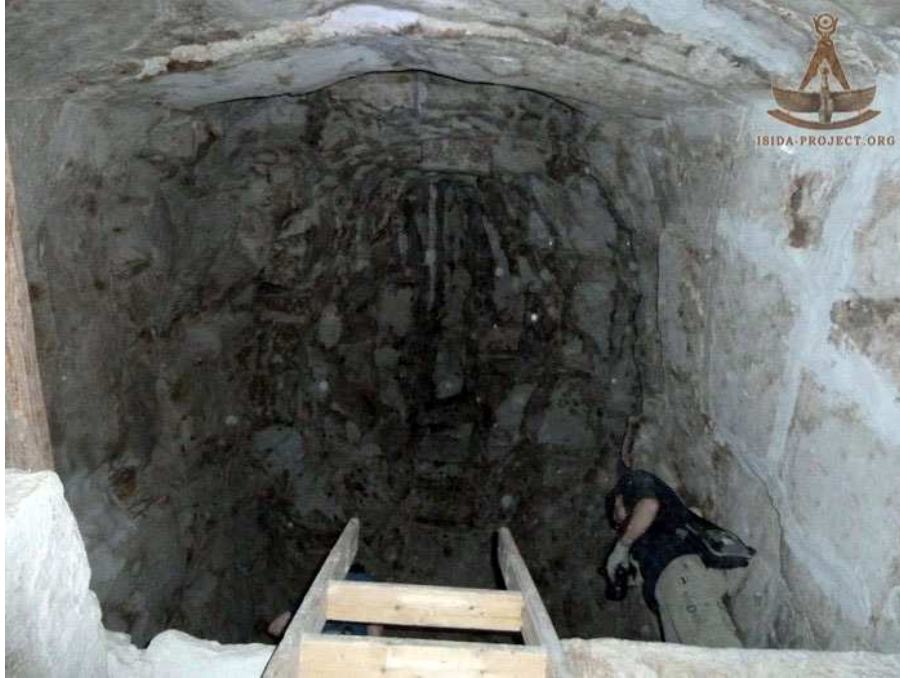
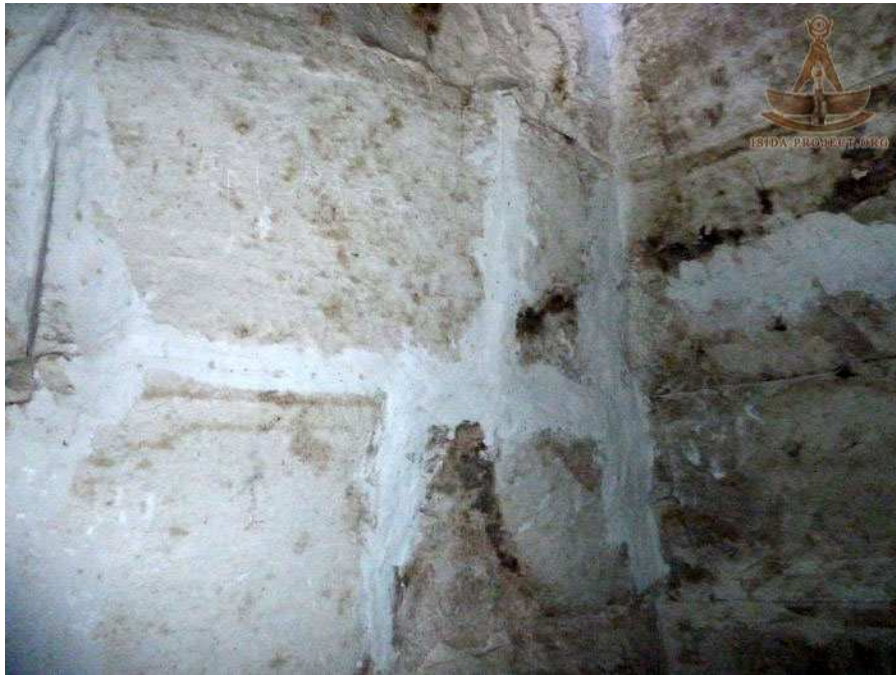
Views of plaster repairs

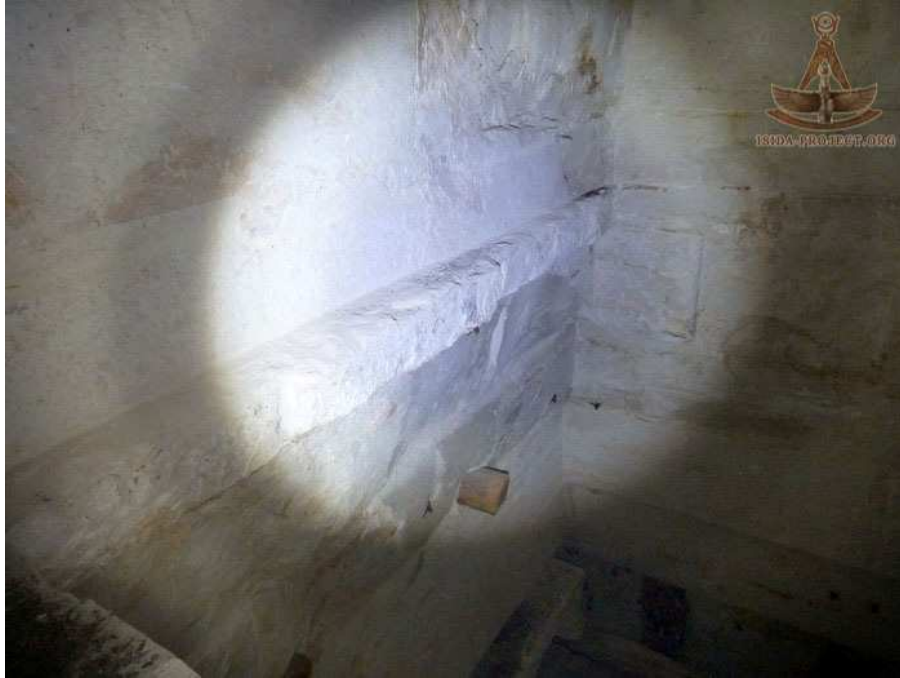
View of what is thought to be remnants of P3 floor level

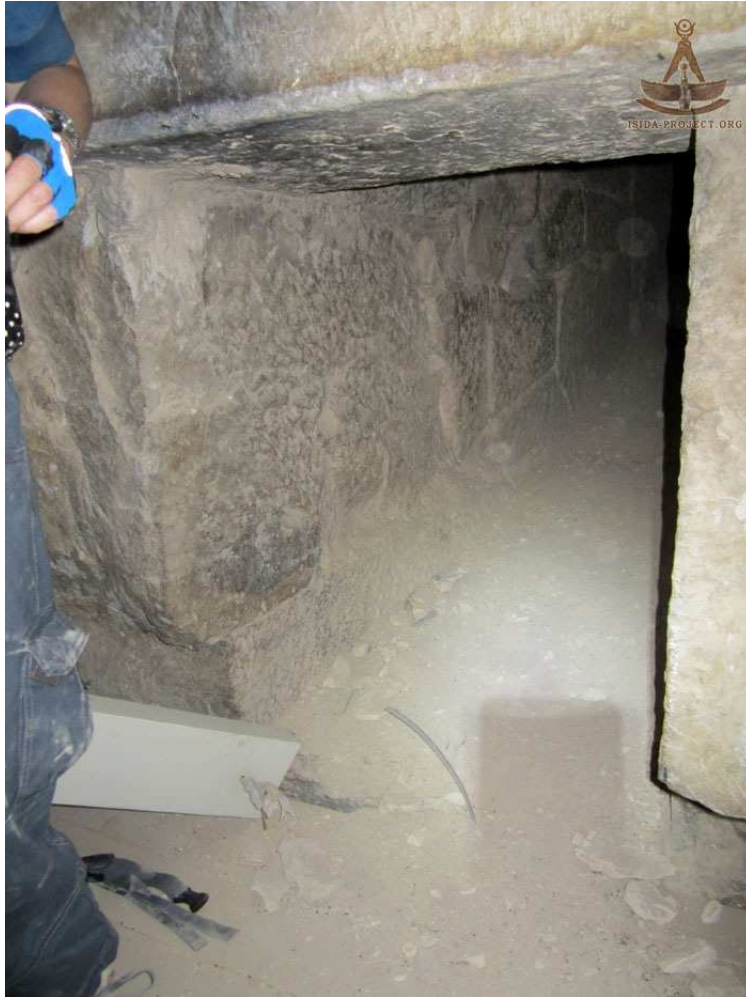
In this image we are looking into the entrance of the tunnel. The 10th corbel is completely cut through for a width of 74cm; the top of the corbel below has also been cut through to a depth of 23cm. It would be beneficial for the joints to be carefully examined in this area, this tunnel affords us the chance to see how they laid the corbels, their depth back into the wall and supporting masonry behind, this can help us better assess the damage to the upper chamber ceiling. A tunnel was cut into the niche of the Queens Chamber in the Great Pyramid; this went through some 7m of well dressed and squared limestone blocks and was followed by the usual nucleus masonry which were roughly dressed.

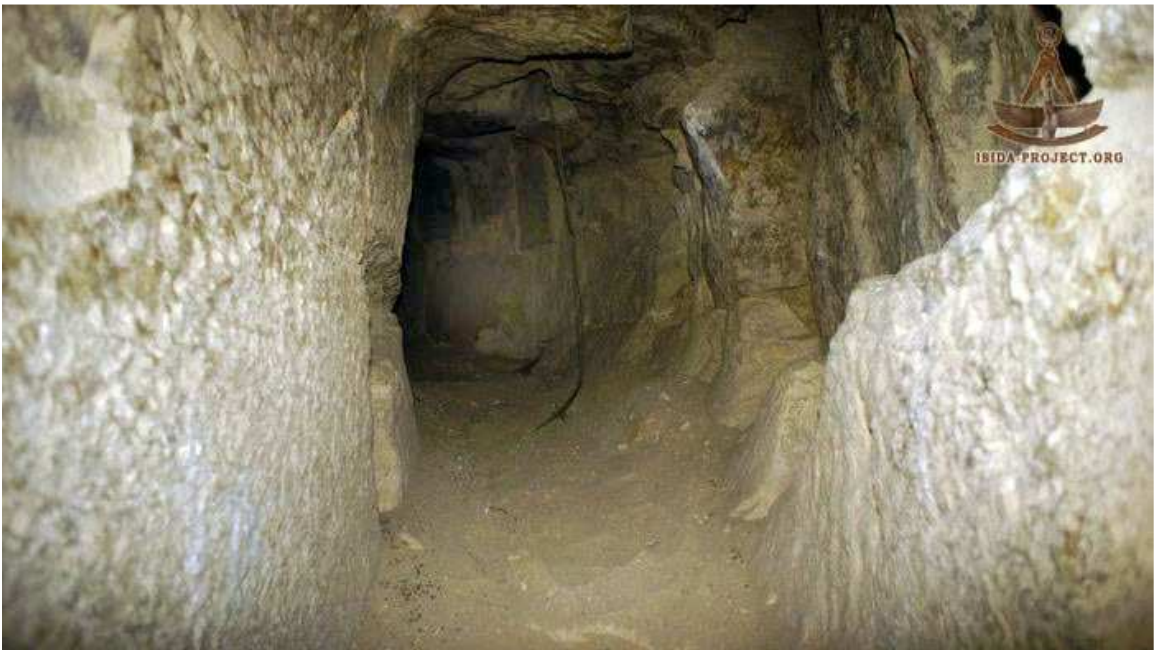
In the image above we are looking down the tunnel to the entrance and the scaffold in the lower chamber

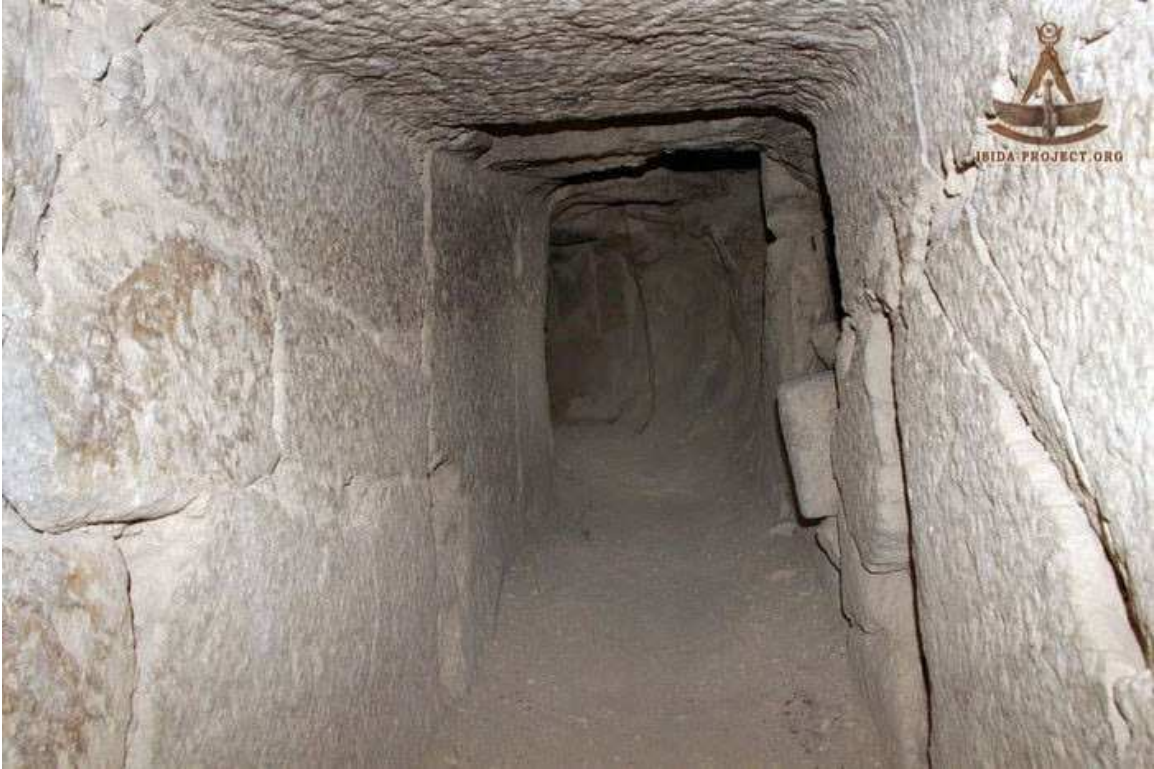
In this image we turn around and face south, the cutting in the wall to the right is the cutting we see in the left of the top image. Here we see the tunnel veer to the east.

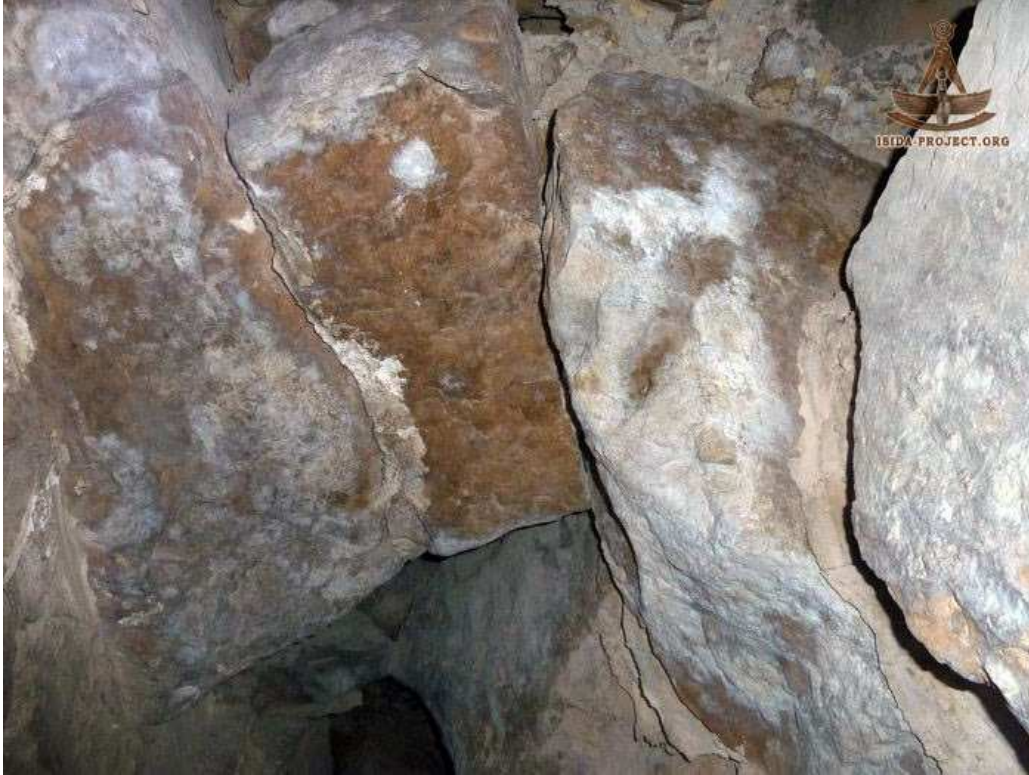
In the image above, location unknown inside the tunnel, we see rough masonry with generous use of mortar to fill the spaces. Below we see the tunnel exit, and again close examination of the masonry needs to be done.
