The Bent Pyramid

The curious case of the 60 degree pyramid.

Keith Hamilton 1st June 2017

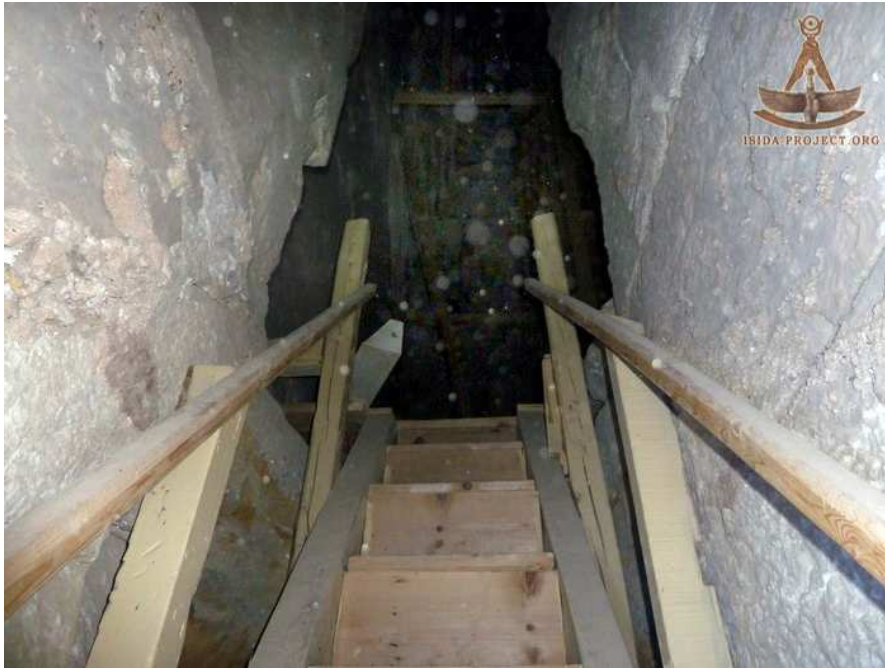
This view looking up from the antechamber and the entrance into the lower chamber.

This modern staircase prevents us from seeing the vertical south wall of rock, some 6.75m high. According to M&R's drawings this south wall of the antechamber is in line with the north wall of the lower chamber above. The lower part of the descending passage show similar deteriorating processes that we see at the Meidum Pyramid.

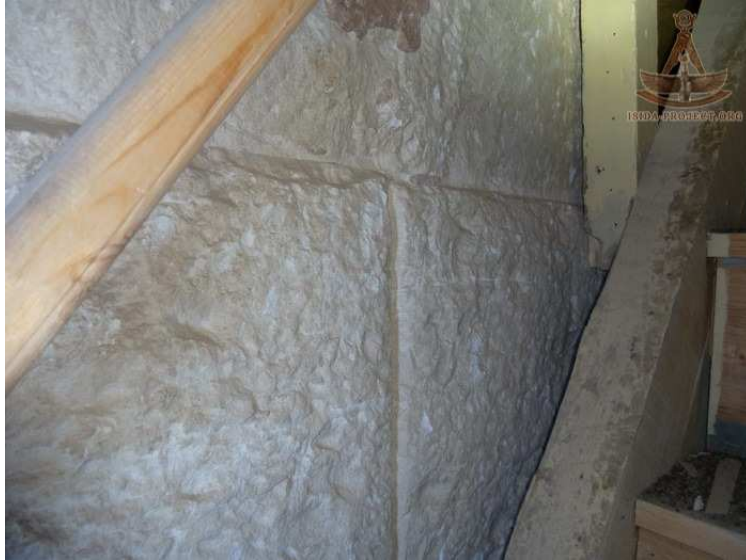
A closer view of a better preserved part of the Antechamber east wall.

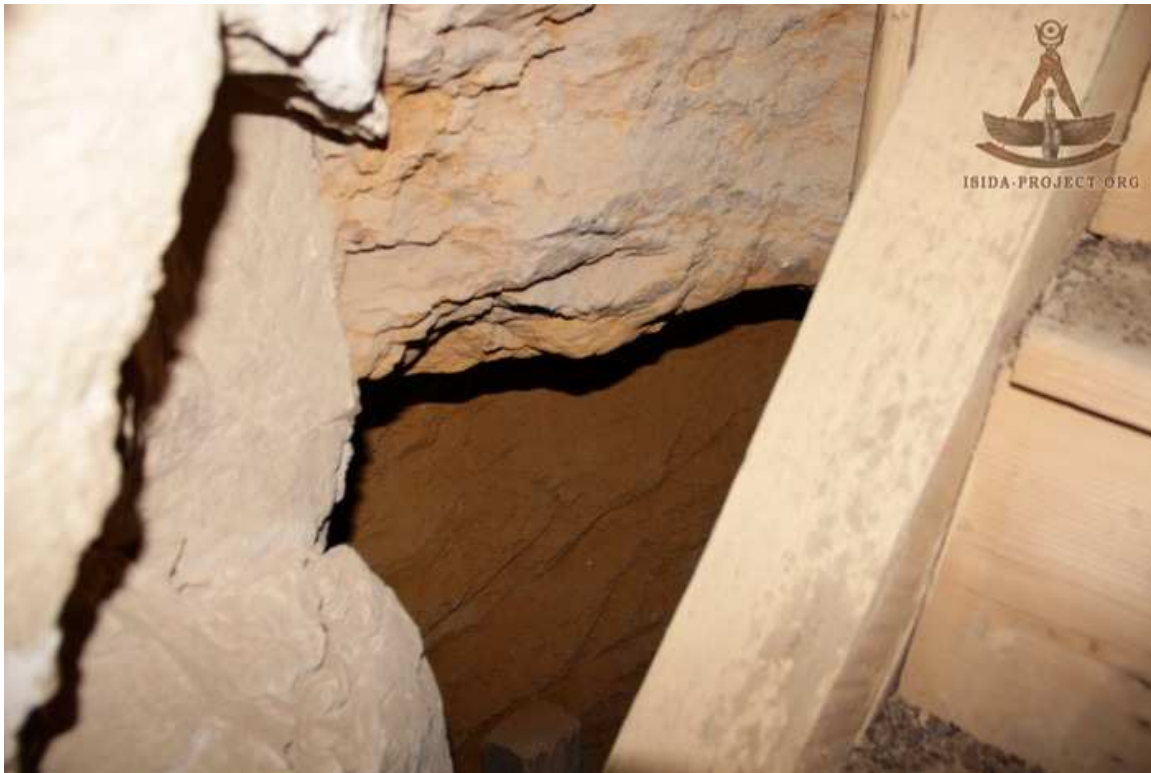
The image above is interesting and needs closer scrutiny, are the walls of the antechamber tiled? In my previous work, *The Medium Pyramid*, we see how the builders tiled the walls of the vertical shaft leading to the main chamber. Its use in the Bent Pyramid should therefore come as no great surprise, indeed it would make sense; the Main chamber at Meidum has quite thick tiles that are clearly observable in the south wall breach.

It is quite probable that the corbels of the antechamber are laying on the natural rock and that the walls of the chamber are simply tiled. The advantages of this approach is using the natural strengths of the rock as a foundation, less excavation and a stronger construction; further the end of the descending passage is probably well buttressed against the natural rock. The tiles therefore are not really a structural feature. M&R's view that the south wall never had stone, should be looked at in a new light, for I feel it could have been tiled. Let us now look at the lower chamber.

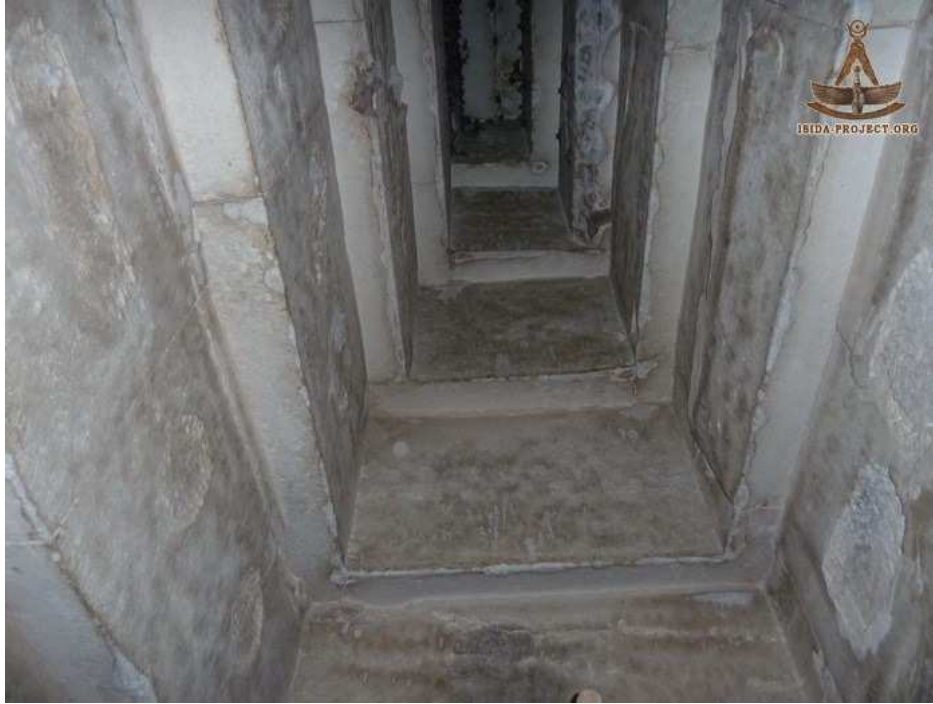
This close up view of the lower chambers corbelled roof is again in very good condition.

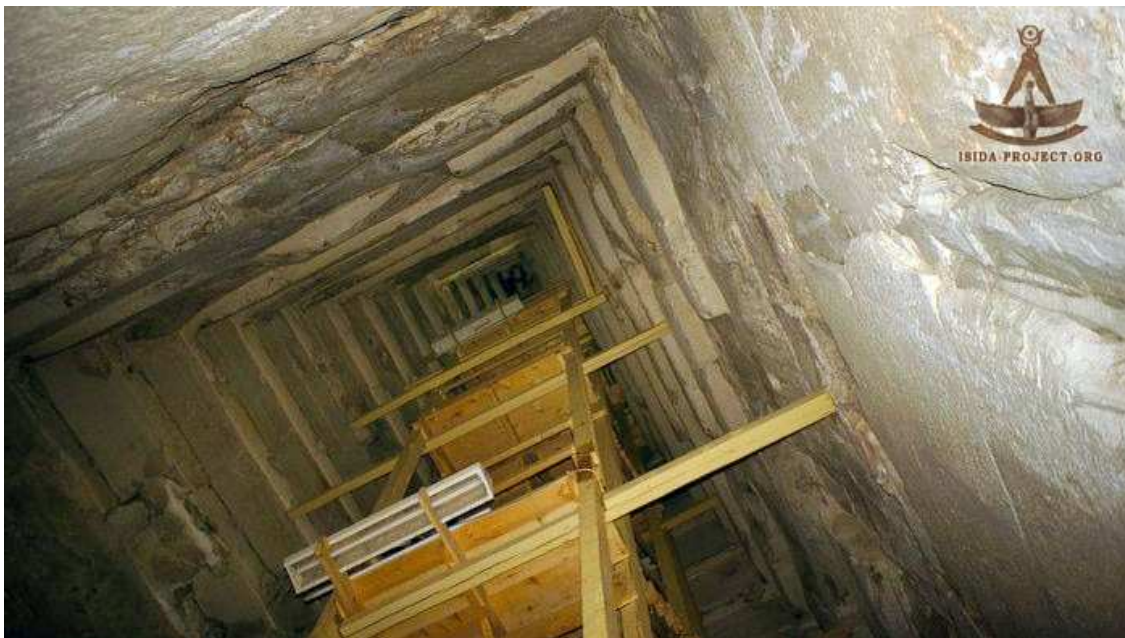
Despite its great age, the corbelled roof is in remarkably good condition, and no evidence of structural failings that I can see.

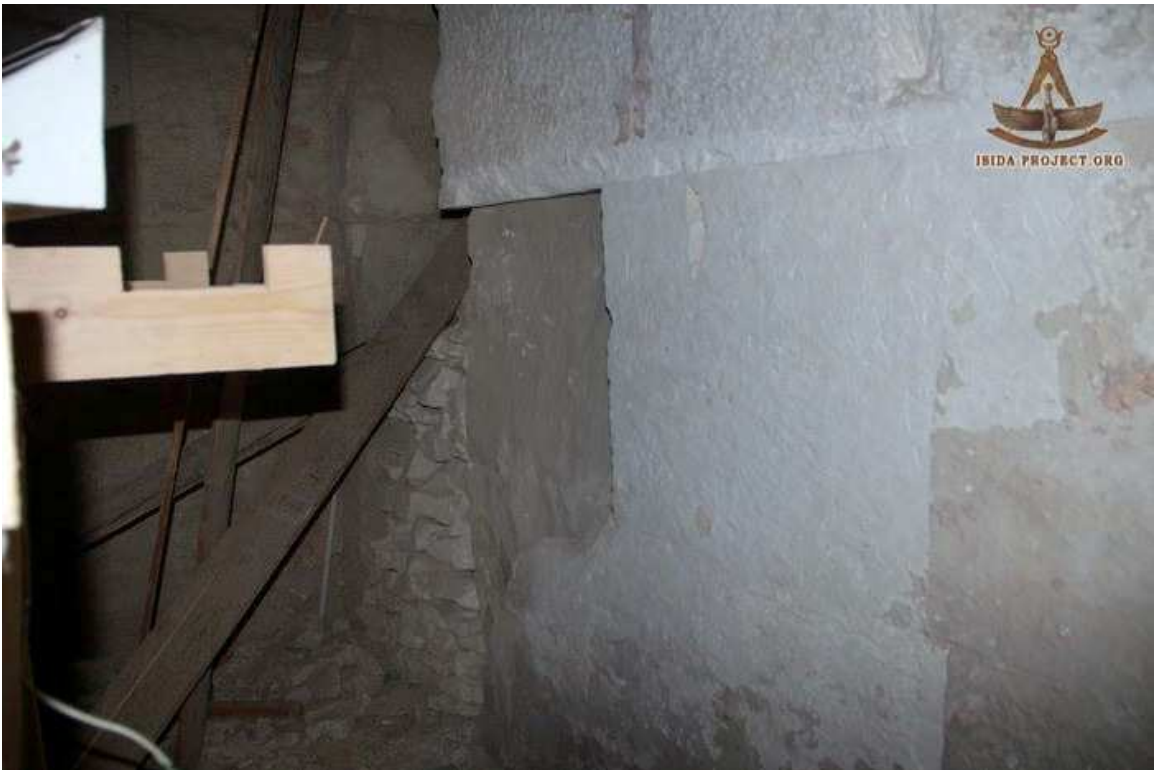
View along south wall towards chimney entrance, and again are we looking at tiling?

This tiling would have no real structural strength, and therefore those superficial cracks that I have observed in some pictures are more probably a result of natural deterioration processes spanning some 4500 years. Certainly there is nothing that I have seen, that I would describe as subsidence; the chambers are remarkably intact and in good condition.

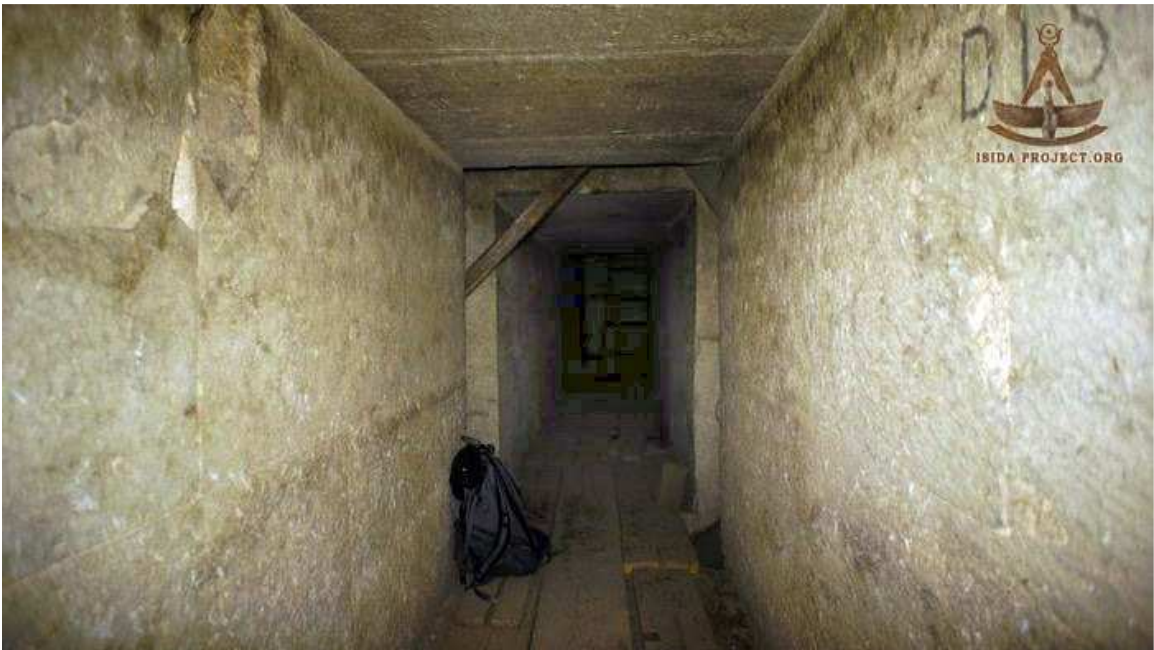
Looking east toward the upper chamber. The wooden prop is supporting the second portcullis.

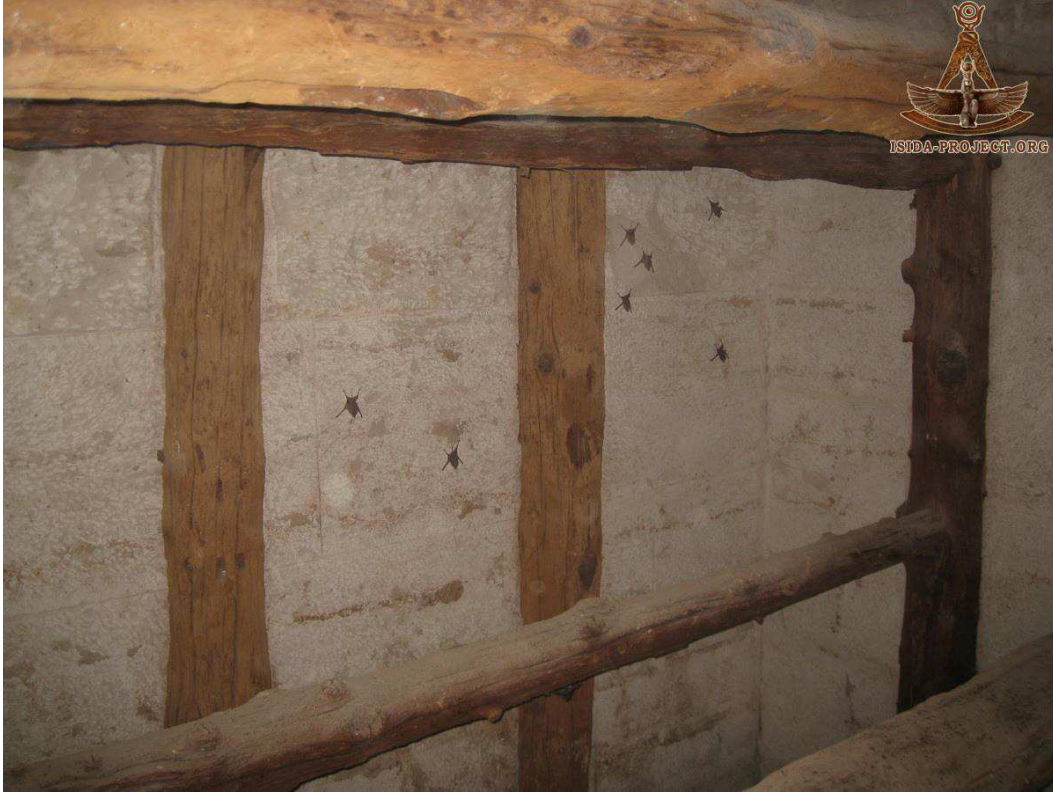
The chamber walls, were visible, are in excellent condition.

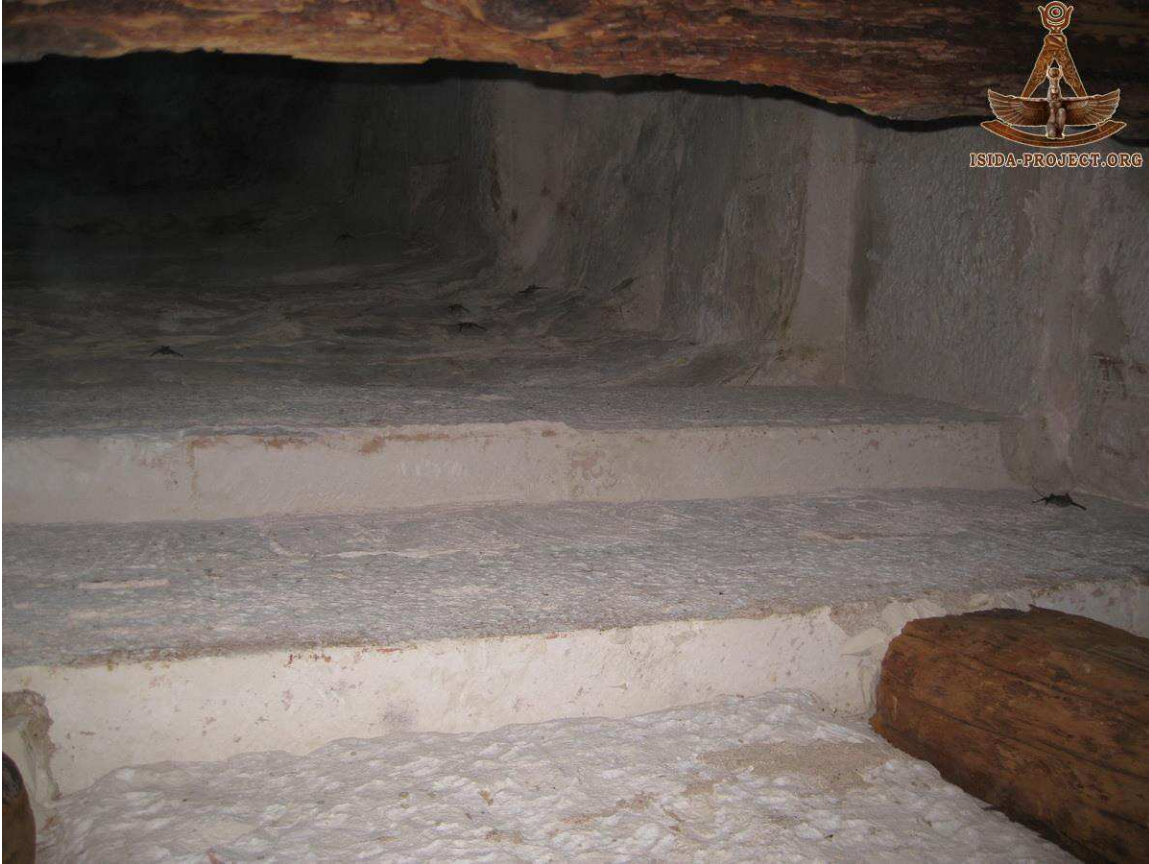
Surviving Corbels, hint at the grandeur and quality of work.

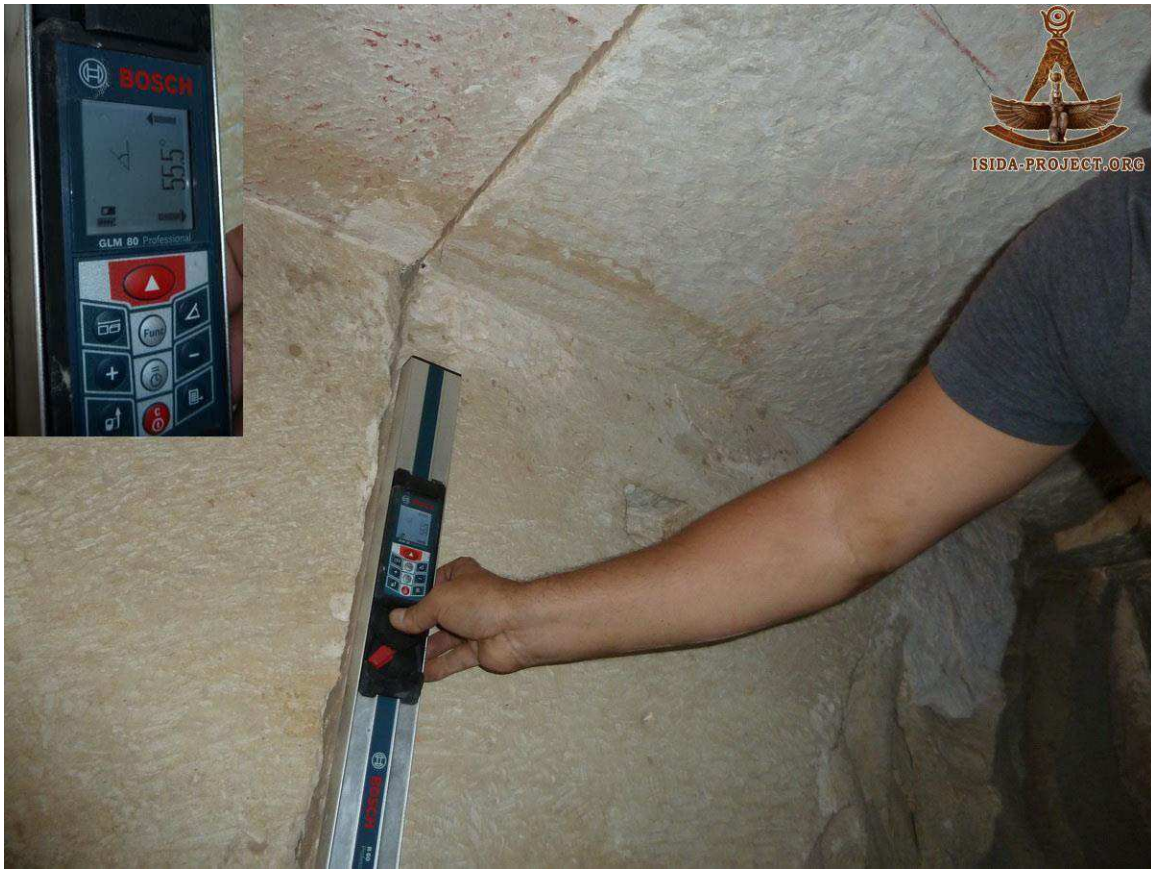
View of the continuous joint in the western passage measuring 55.5 degrees, north wall.

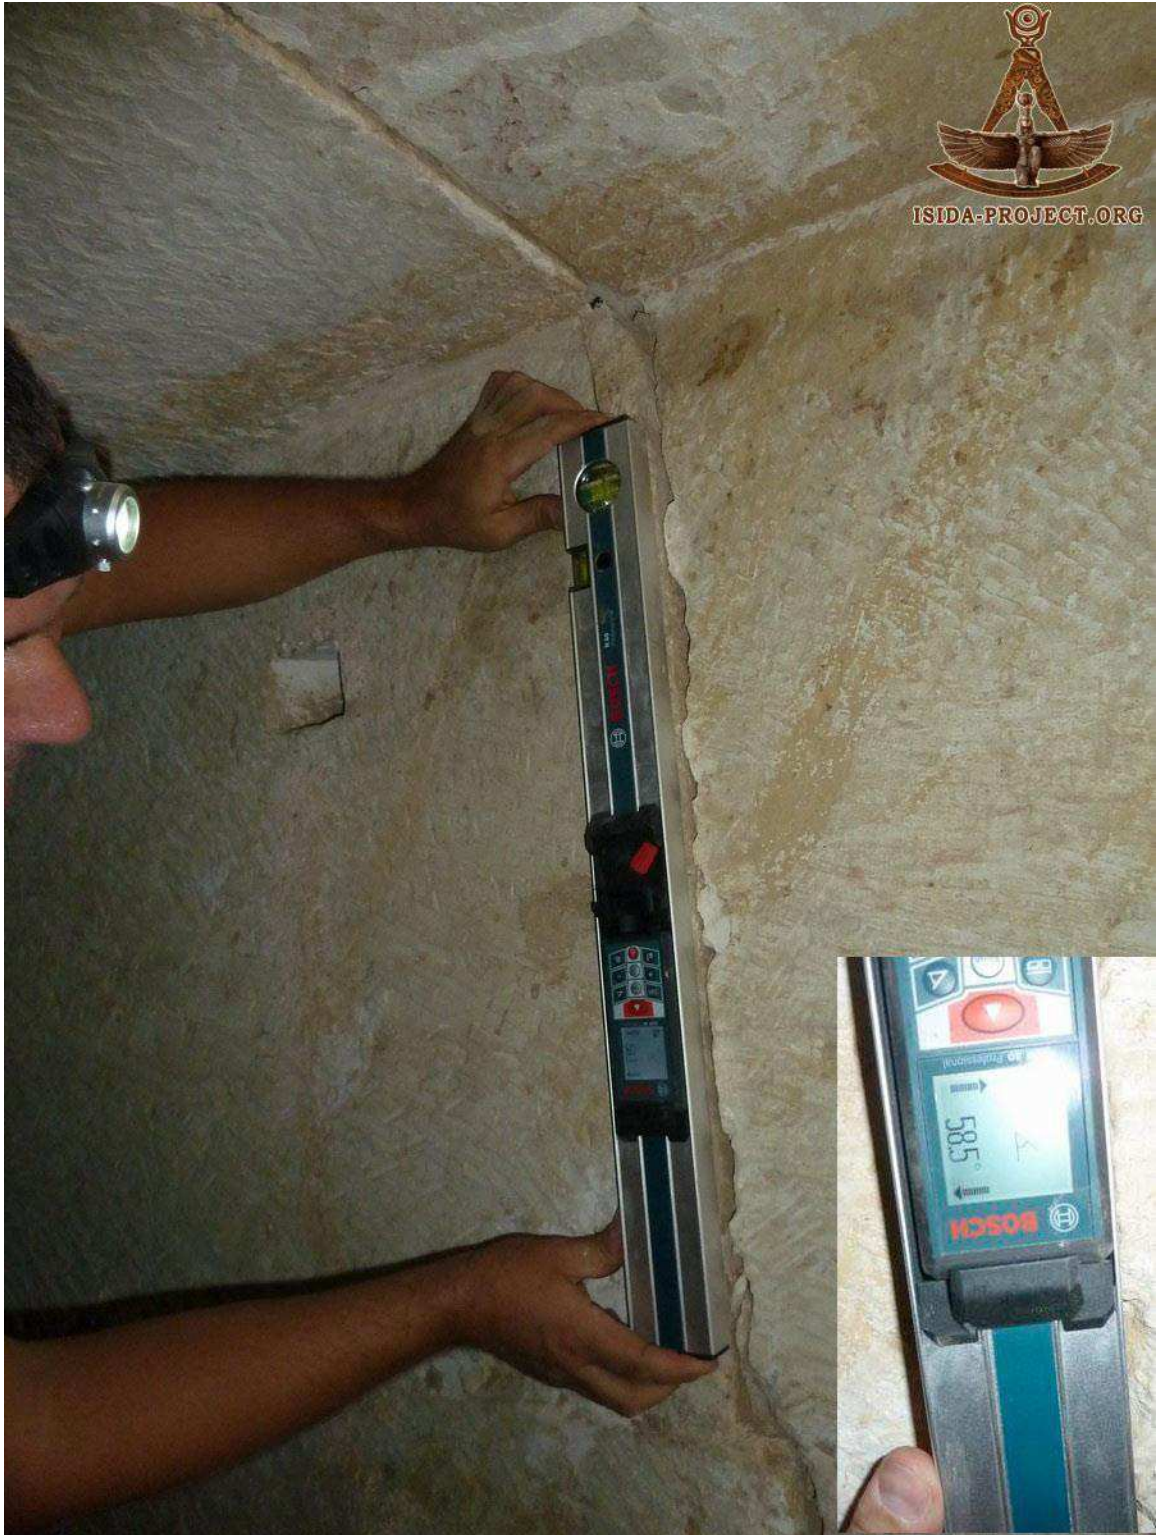
View of the continuous joint in the western passage measuring 58.5 degrees, South wall. Note also the square hole in the wall.

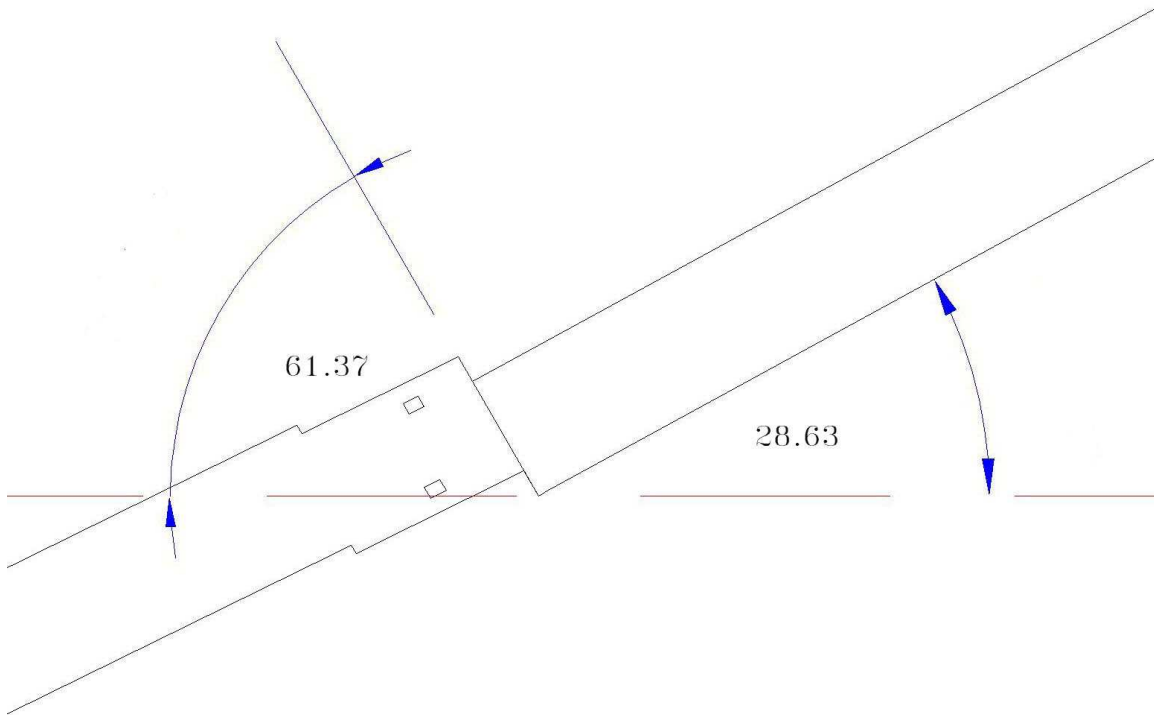
In the image above using Perring's angle for the upper part of the northern passage, which he gives as $28^{\circ}38'$ (drawing above is in decimal) we see that a perpendicular joint laid to the slope of the passage, agrees closely to what has been measured. It's a simple rule of geometry that as the slope of the passage increases, the corresponding perpendicular angle will decrease. Let us now have a look at the continuous joint angles in the western passage.

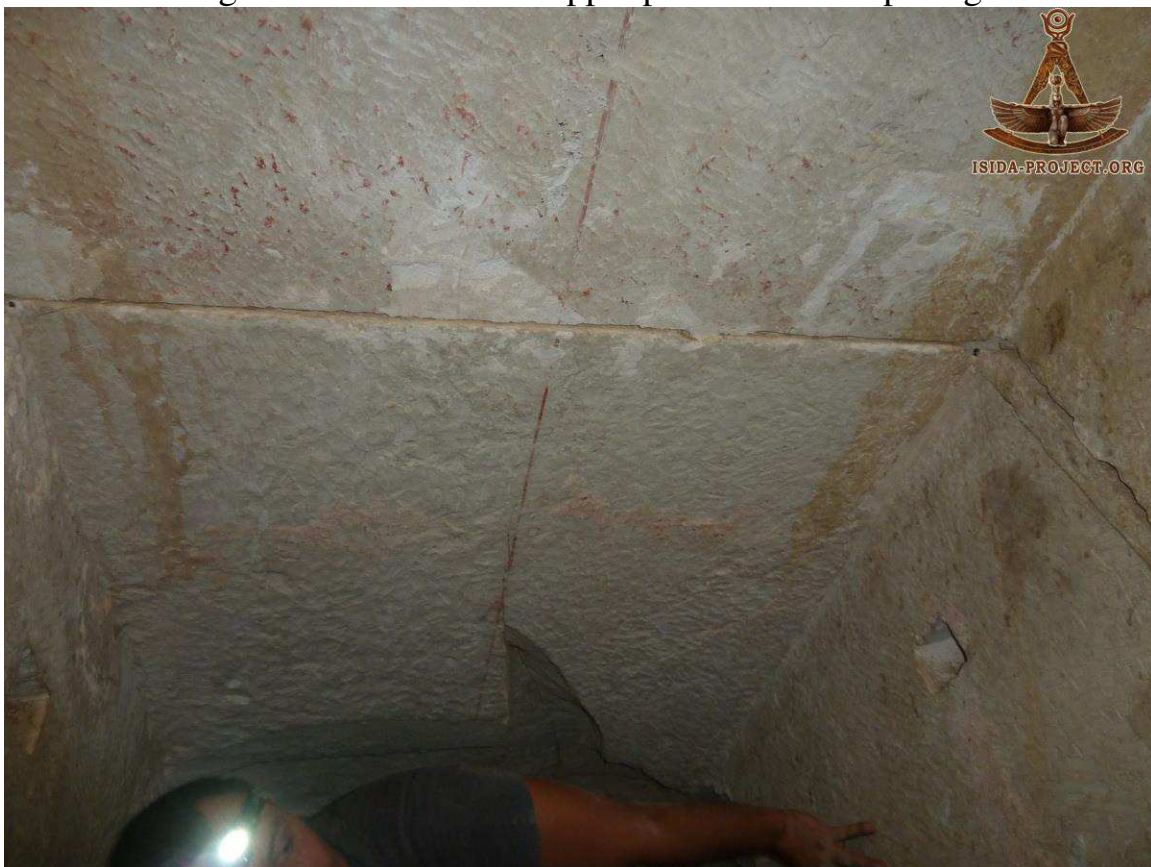
West passage continuous joint, here we see the ceiling joint meet the joint on the south wall. Also note the small square hole and red ochre line.

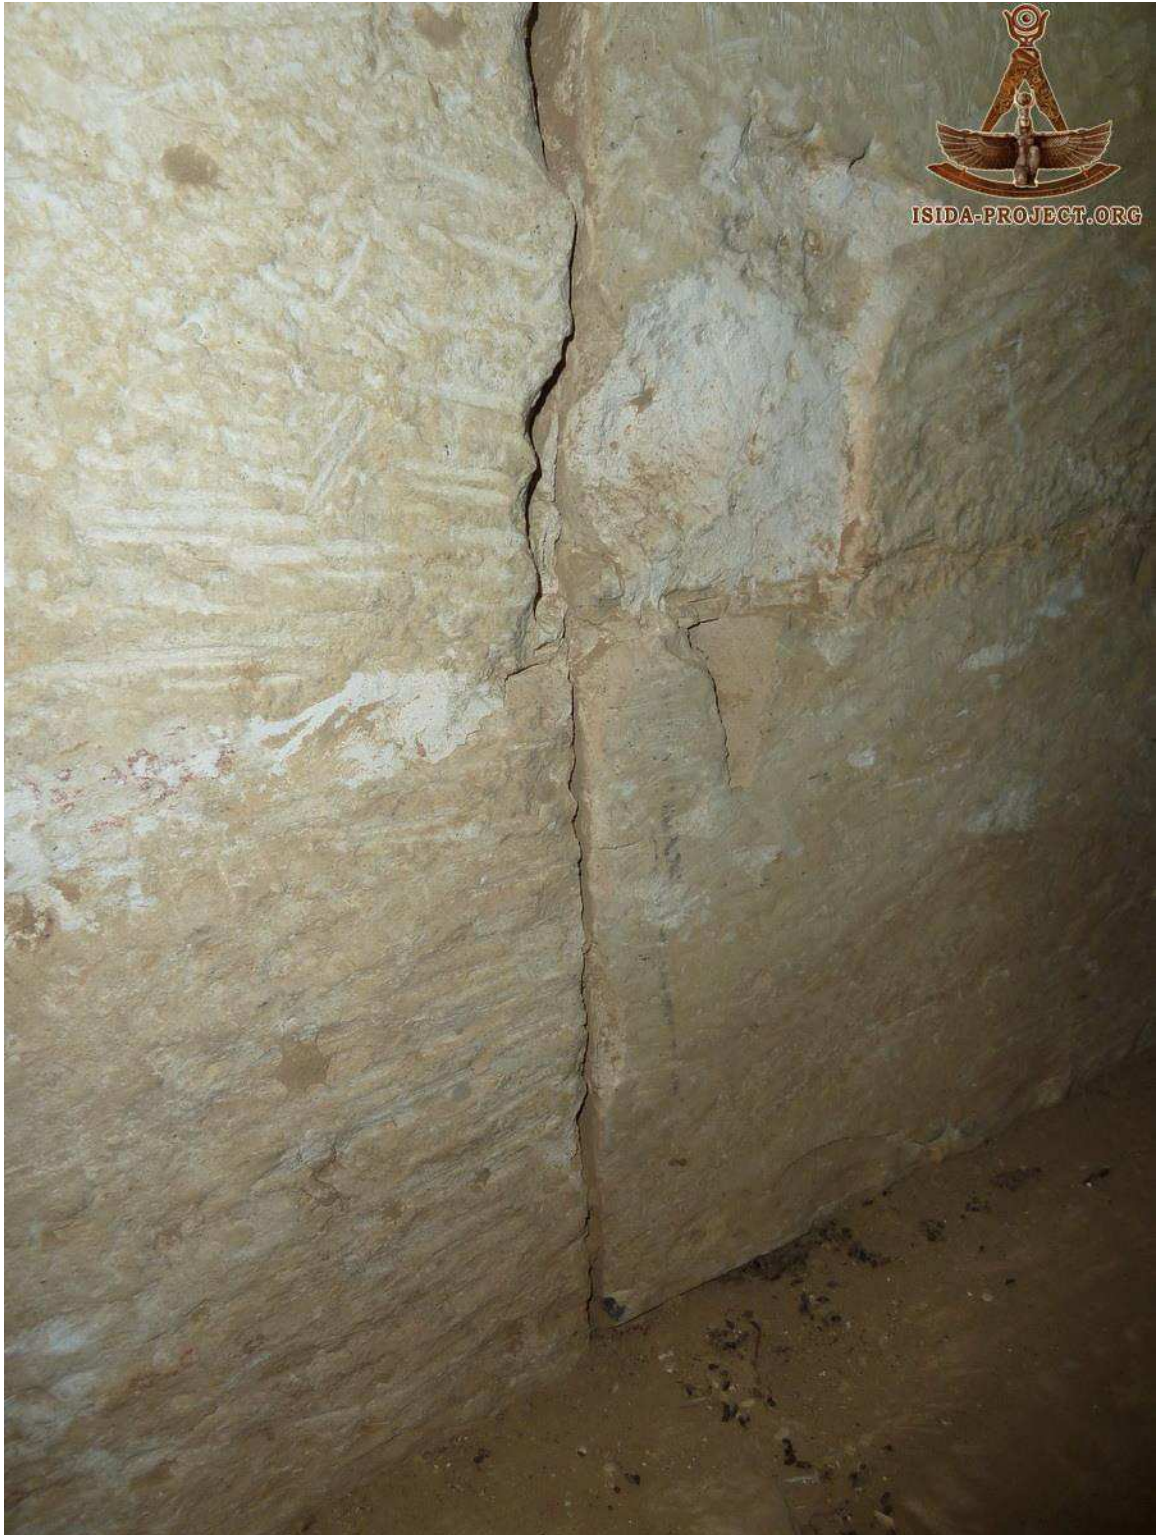
The continuous joint on north wall of west passage.

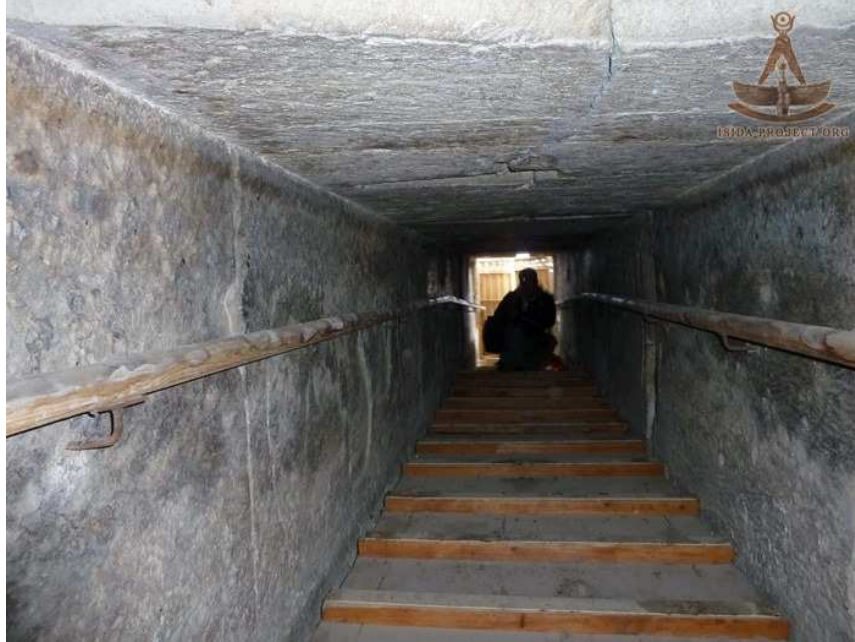
Looking up the north passage, Puchkov states the walls are made of a single course from the continuous joint.

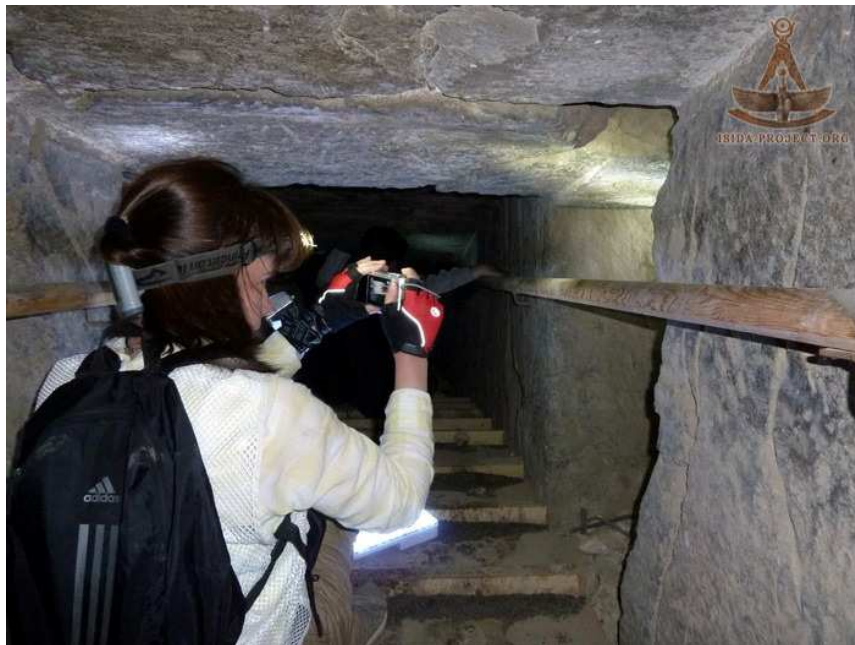
Looking down the northern passage at the continuous joint. The wall blocks immediately north of the joint have been excavated sometime in the pyramids history; the western wall block has been excavated up to 2m deep and .85m wide, the eastern wall block has been excavated to a depth of 1.1m and .75m wide.

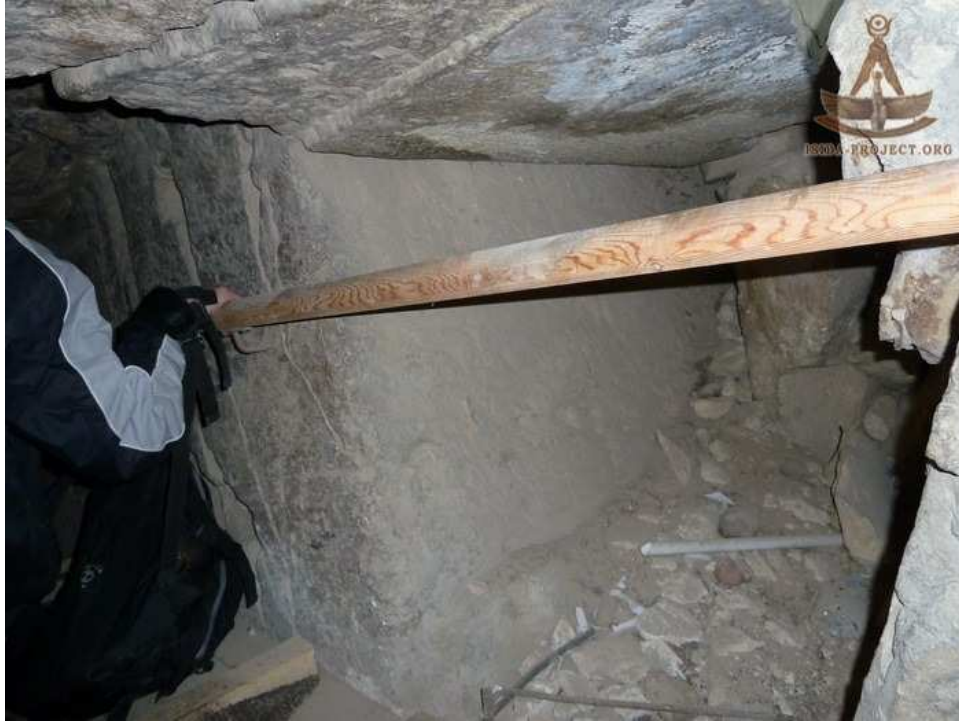
In this view we can see how the ceiling block has been dressed down and was described by Petrie. The exposed face of the block that is the continuous joint can be seen and was measured having an angle of 60.5 degrees.

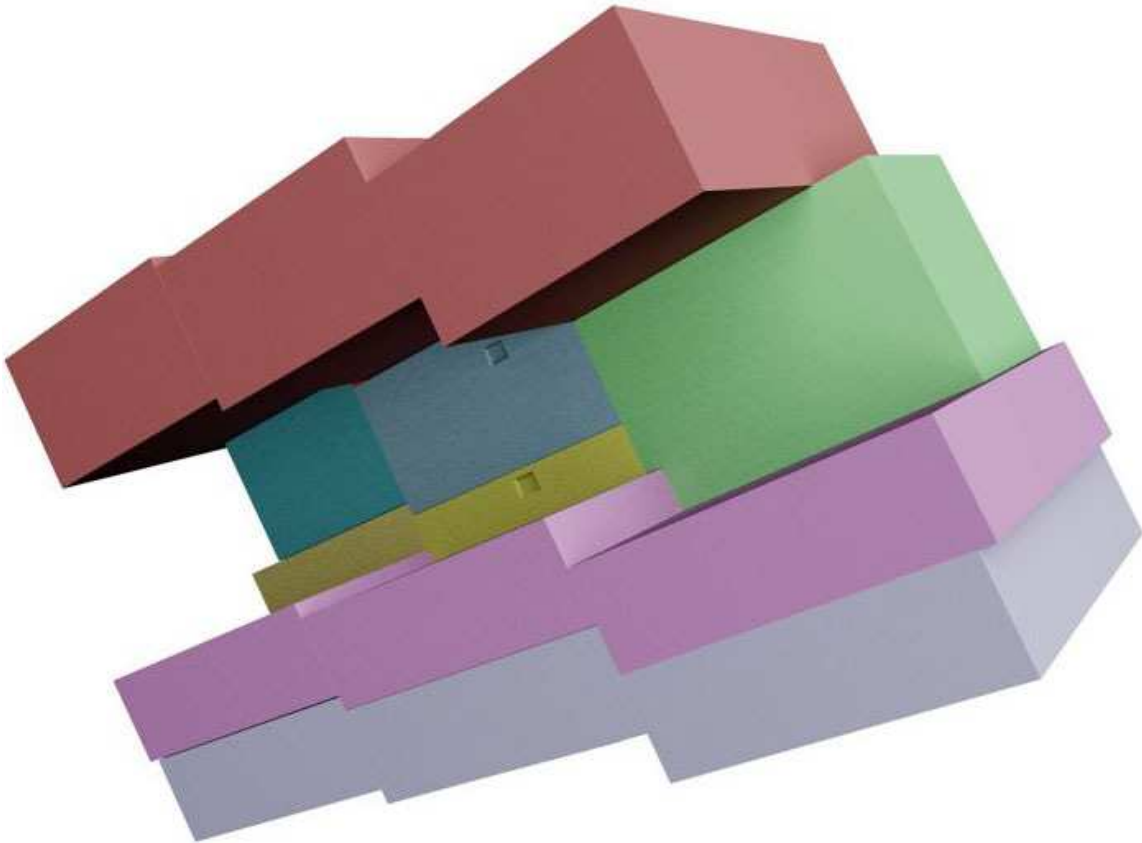
In this final image, the paving blocks have been fitted to complete the passage. This basic experiment matches well with the observable features in the corridor, both roof and walls show a continuous line, though the floor block is slightly north in this model, but then even M&R's drawing shows the floor block joint further north than the continuous line. The masons doing this work will have their own solutions and methods to the task at hand in this modification, but as a proof of concept, I feel it is a valid alternative to the accepted settlement theory.
