A Layman's guide to

The Meidum Pyramid

Keith Hamilton April 2017

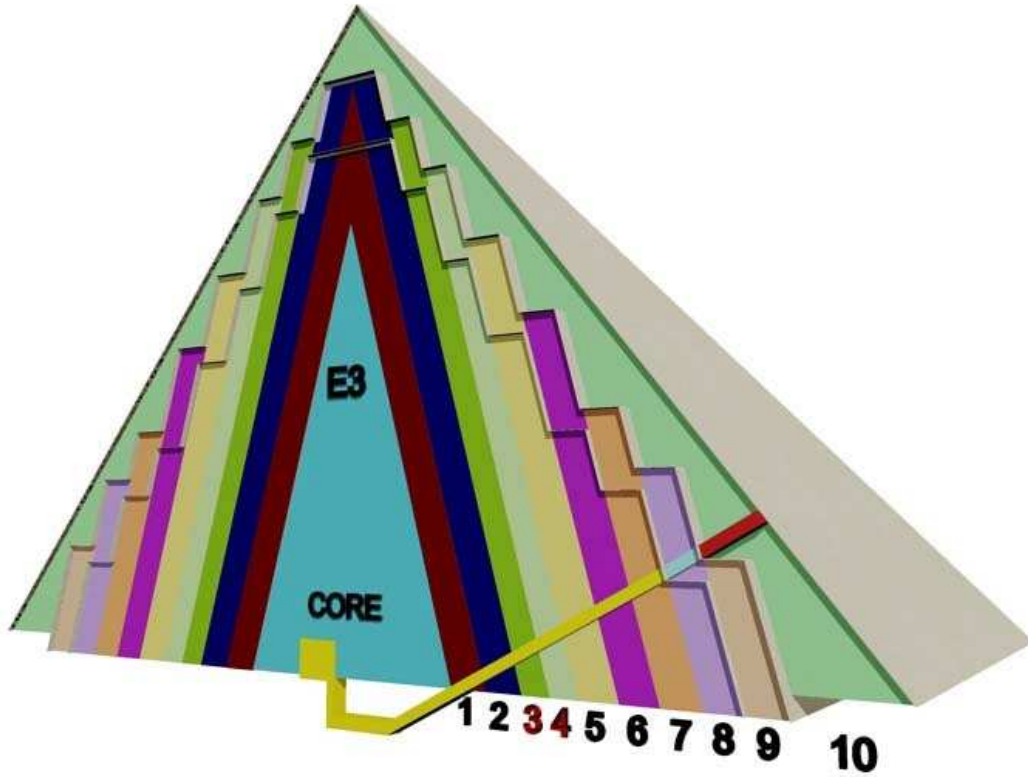
Phase E3, step pyramid converted to smooth pyramid 275 by 175 cubits.

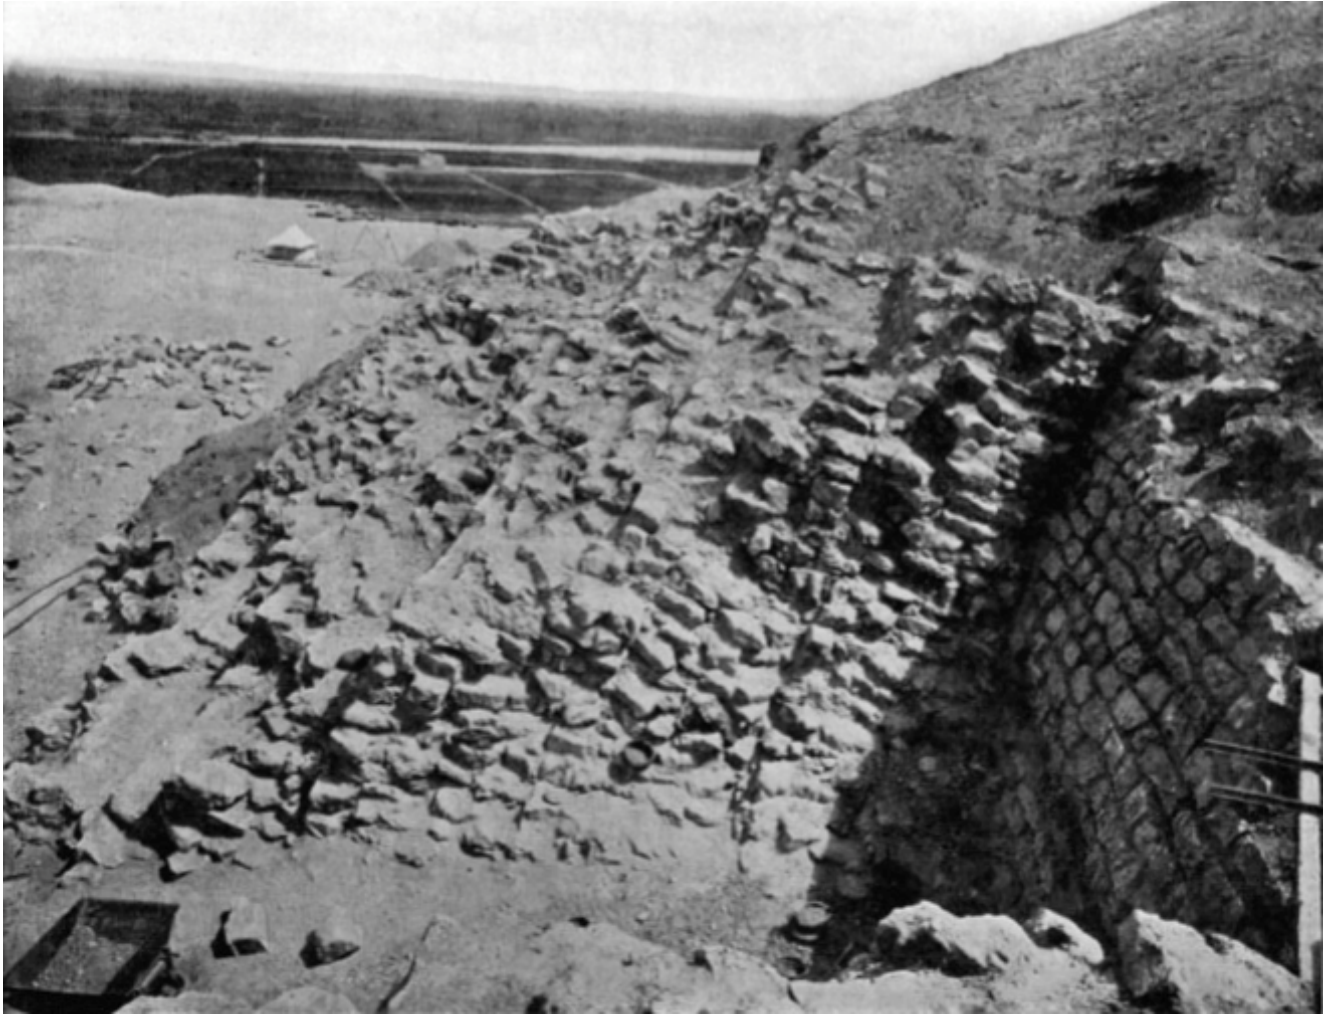
The 9 layers are generally referred to as accretion layers; these distinct layers of stone are not laid vertically but are inclined inwards, this construction method was common in the 3rd Dynasty. The image below of the so called layer pyramid at Zawiyet el-aryan gives a rough idea.

This construction method appears further refined at the Meidum pyramid, here the outer faces of the layers are finished with well squared and fitted blocks that cover a nucleus of more roughly shaped blocks. The layers are not totally independent from each other; Wainwright makes the following observation during the tunnel excavation;

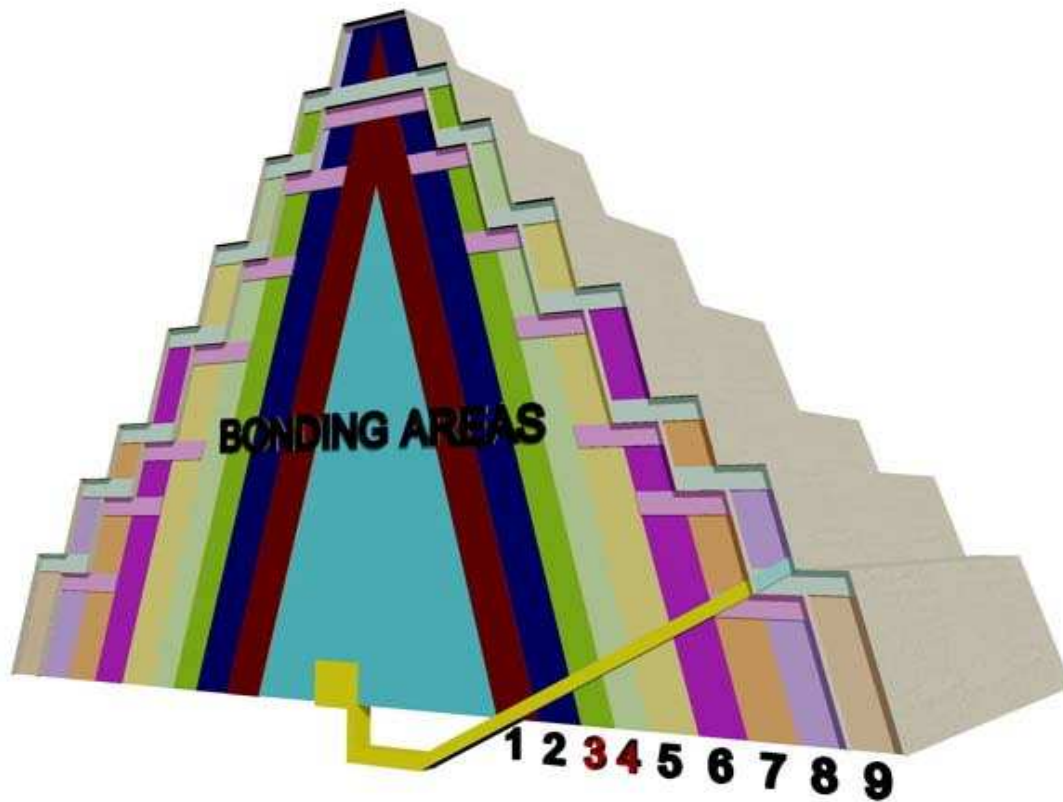
These possible bonding areas between adjacent layers are highlighted below.

It is thought that as the layers approached the area that was planned to be a step, a single platform was constructed over the two layers, bonding them together; the top of this platform would become the step. The inner most layer would then be extended upwards, on top of the platform guided by its next adjacent layer to the next step, were the process would be repeated.

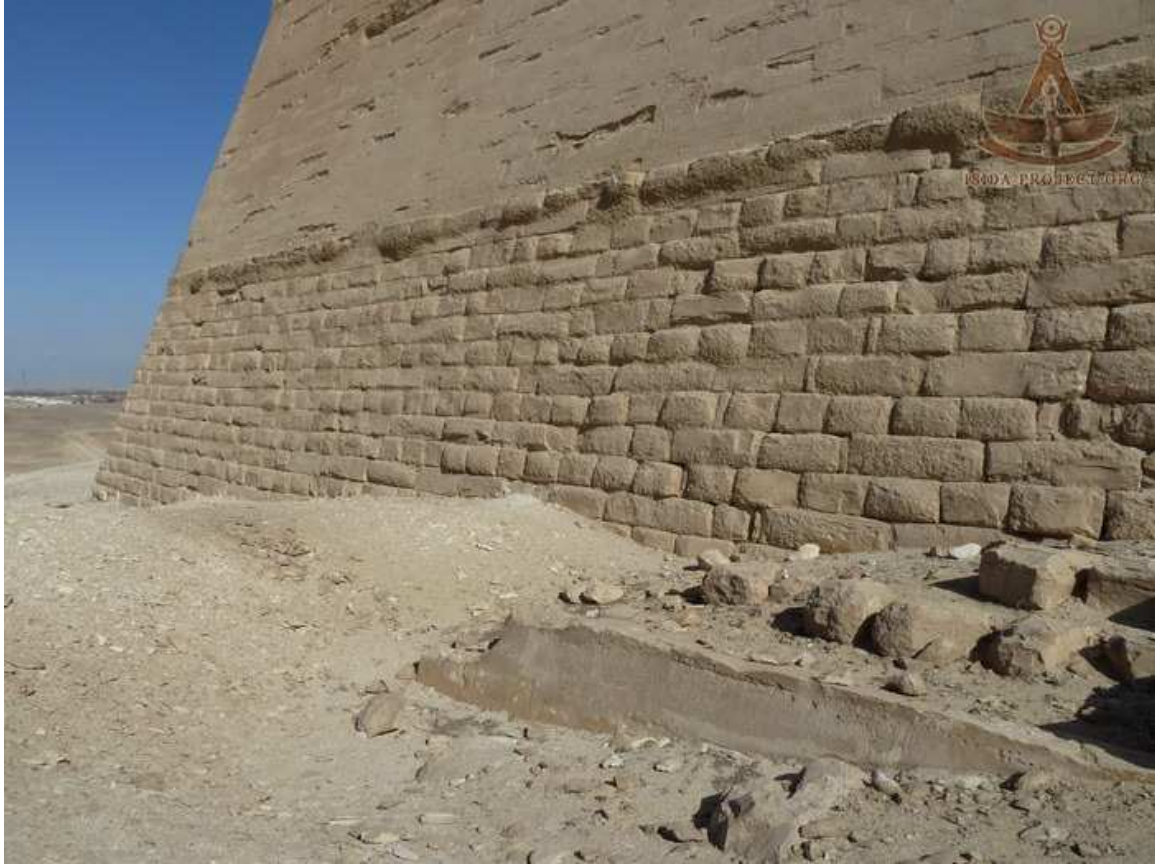
The picture above shows the large rough band and the smooth casing of E1 above it. The remnants of smooth casing in the foreground are also part of the lower step of E1. Visible at the top of the rough band, one can see the stone protruding below the smooth casing; this is thought to be part of the bonding platform.

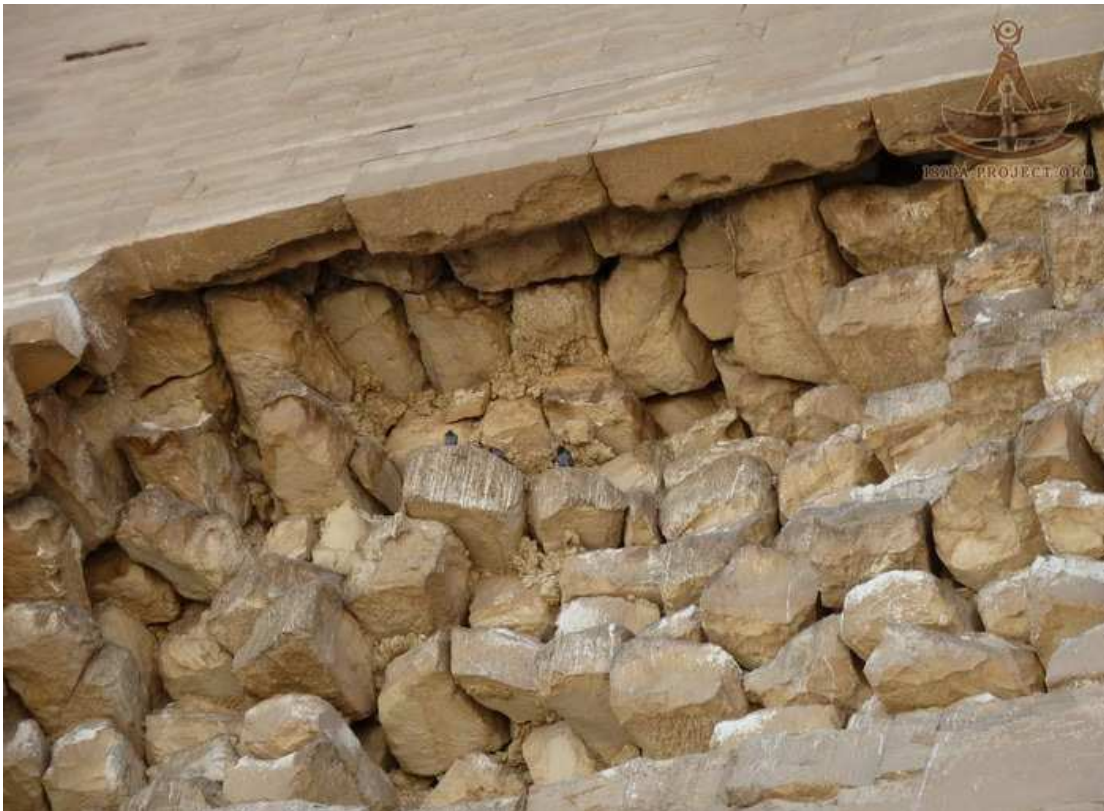
The image above shows the comparison between the quality of the finished casing stone and the rough filling. Apparently these large holes that are visible on the tower today are the work of locals to encourage bats and the collection of guano; a highly effective fertilizer popular with farmers. The thickness of the casing does not vary a lot, for example Petrie gives the average of the rough band at about 20.3 inches and in different parts of the smooth faces it is 23.6 to 17.8 inches. The large hole in the north face was mentioned by the English traveler W.G.Browne in 1793.

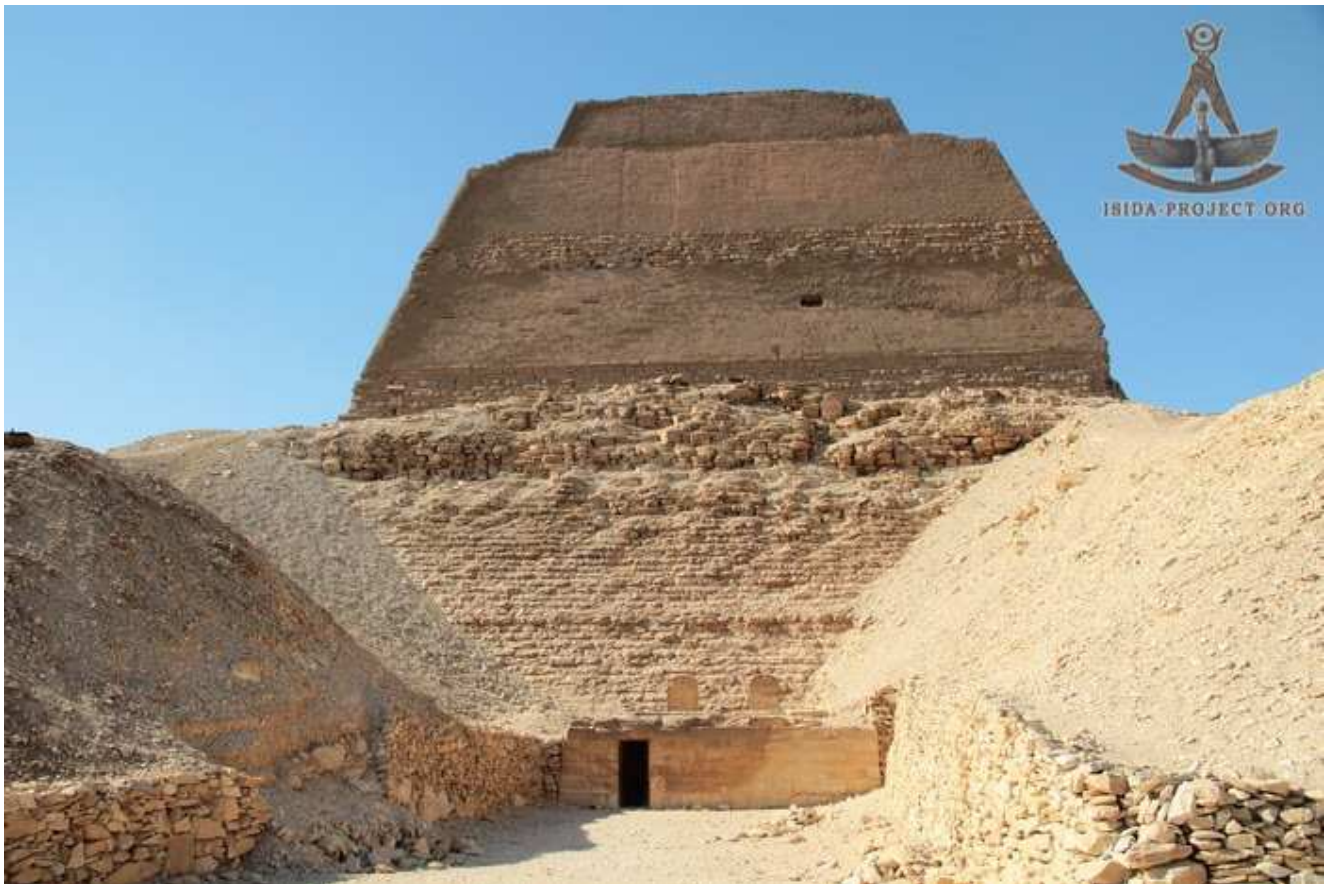
The Grooves are visible just above the upper rough band.

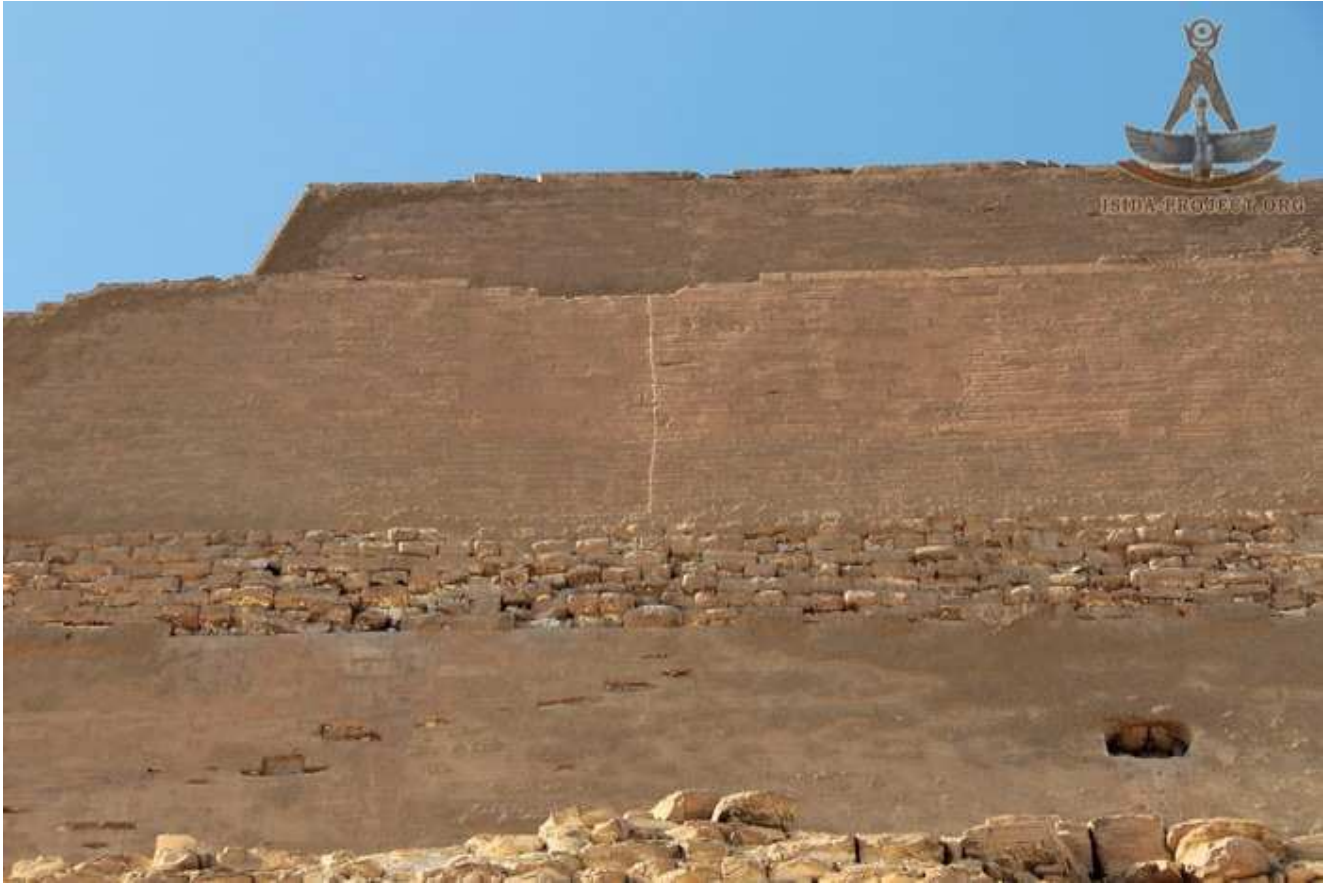
The Grooves are only visible on the two faces of E2 above the upper rough band; there is no groove visible on the face of E1 between the two bands. Petrie gives the width of the upper groove as 211 inches and the lower groove as 195 inches. The depth of the grooves is only 2 to 3 inches. Petrie states;

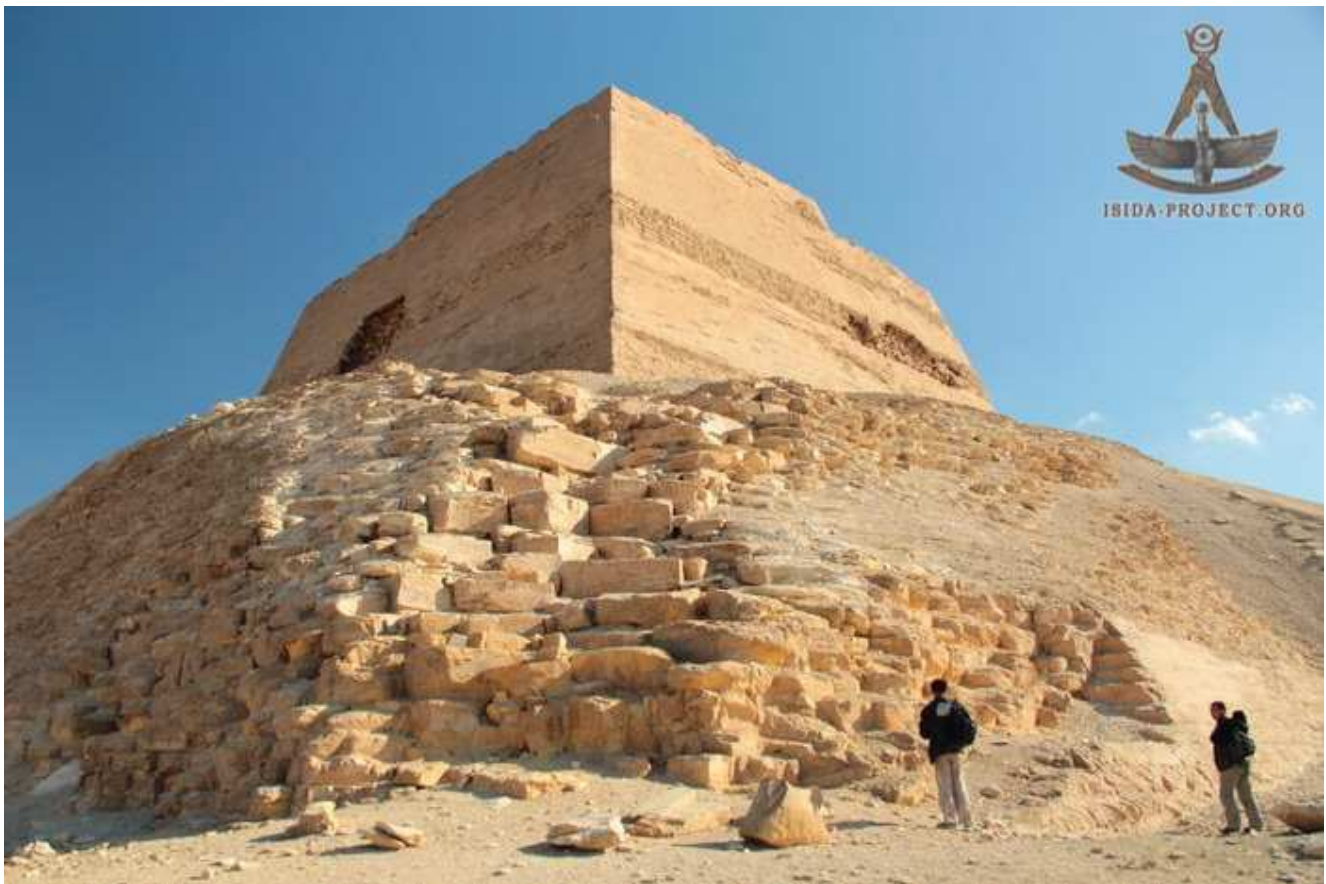
In the image above one can see in the foreground some of the remaining casing and backing stones of E3.

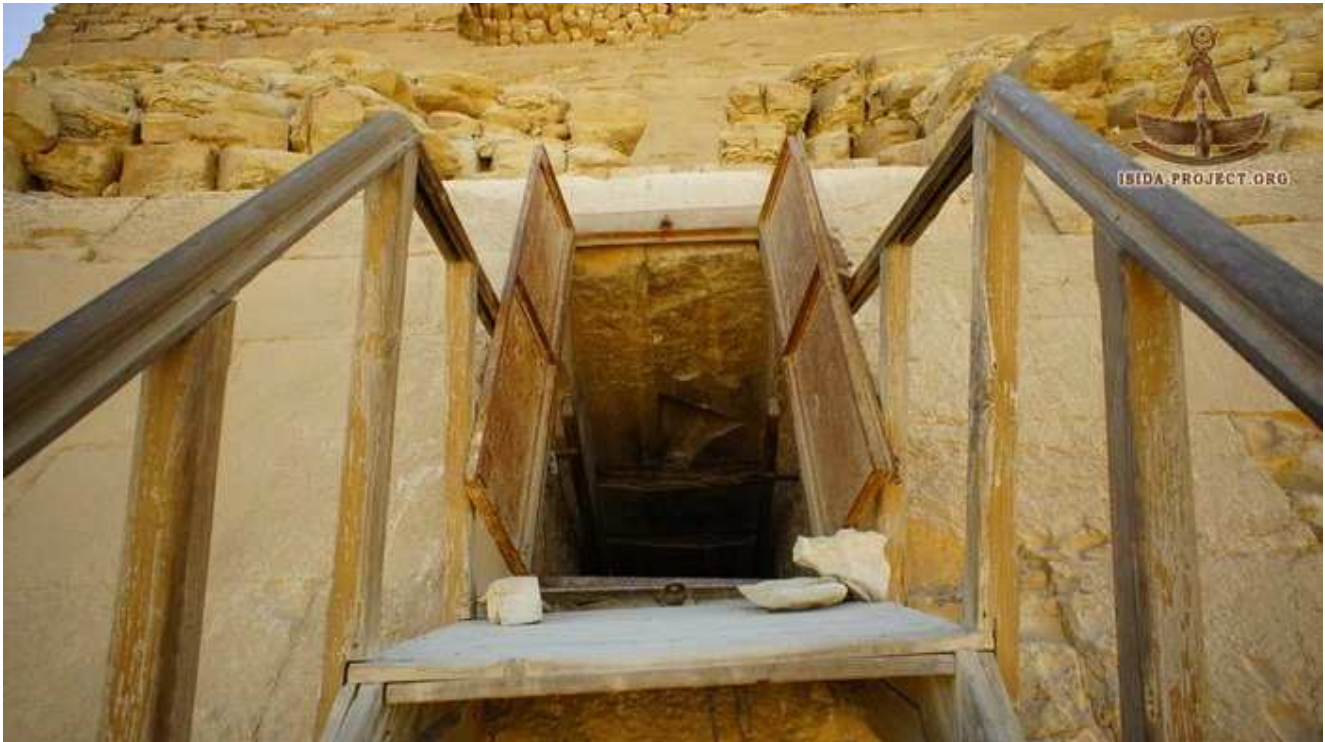
The entrance today is still in pretty good condition and surrounded by surviving casing stones of E3. The floor of the entrance passage Petrie gives as 720.7 inches above the pavement of E3, which is about 35 cubits or $1/5^{\text{th}}$ of the height of E3. In comparison to some other pyramids the perpendicular height of the passage is a quite comfortable 62.5 inches or 3 cubits; the width Petrie gives as 32.2 at top and 34.3 at base; M&R thought a possible 1 cubit 4 palms wide, which is a bit narrower than some other pyramids.

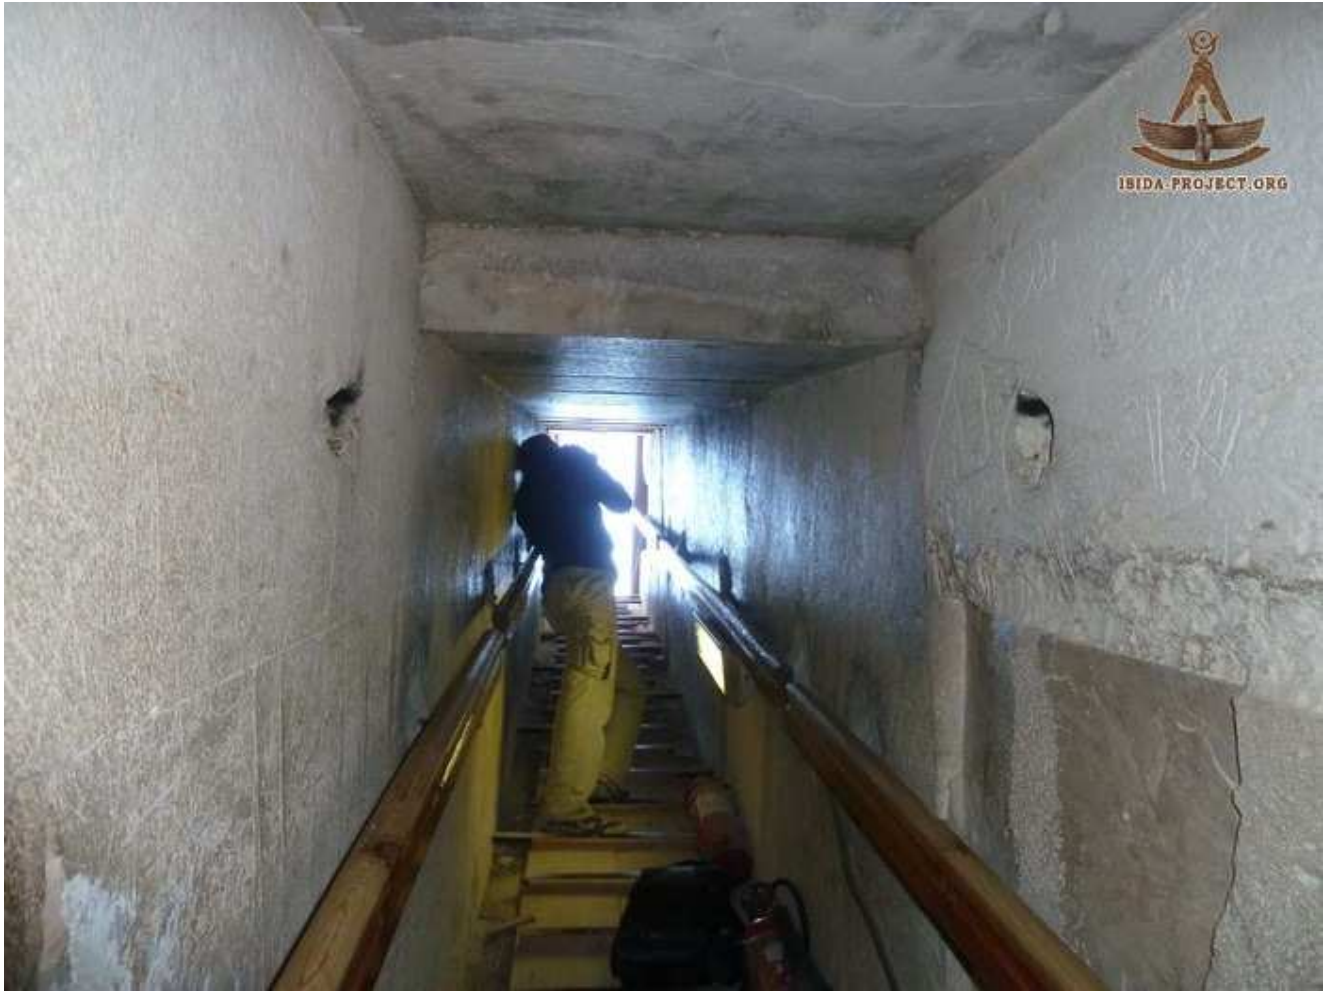
In the image above looking up toward the entrance we can see the relatively good preservation of the upper passage and the upper D shaped holes. Petrie describes the joint thicknesses as very fine and under $1/100^{\text{th}}$ of an inch. The height of the cutout of E2 can clearly be seen against the last roofing block of E3. The walls of the corridor rest on the floor stones. Apparently inscriptions were found in the upper passage from 19th dynasty scribes.

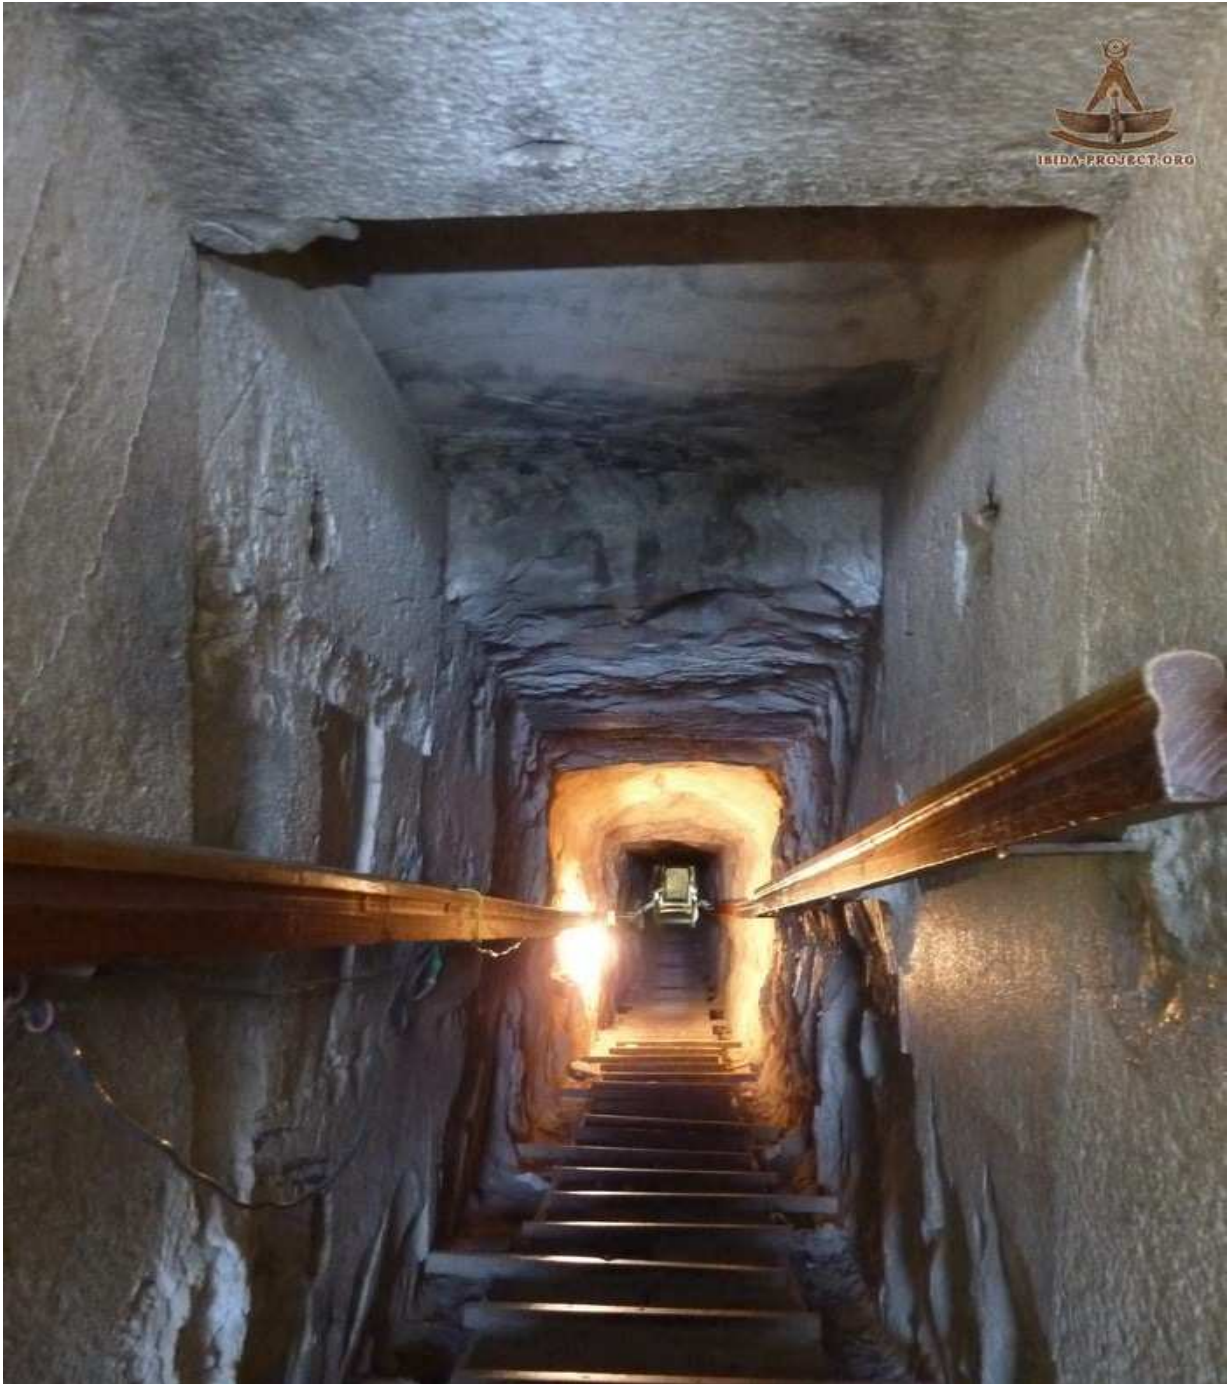
Looking down the passage the damaged southern edge of the cutout can be seen along with the start of the cavernous damage that greatly afflicts the remainder of the passage.

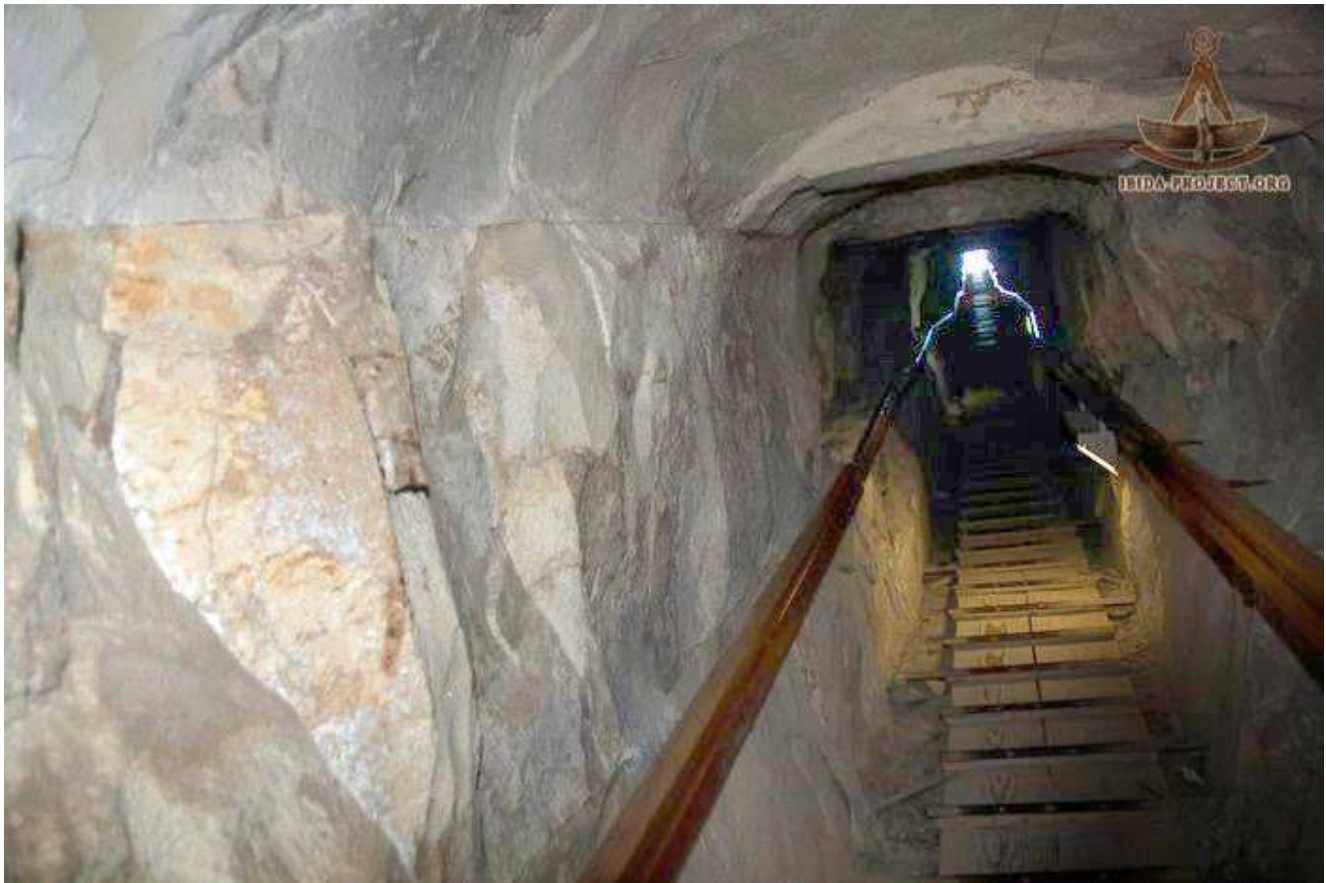
The extensive damage to the passage means that the joint lines are often the only clue to the form of the passage. Examination of the joints shows that the passage wall is composed of two courses from the original E1 entrance all the way to the passage end. M&R thought this proof against Borchardt's view that a structure of two or three steps that he termed E0 might exist. As a consequence it would also affect Petrie's idea of a primal mastaba.

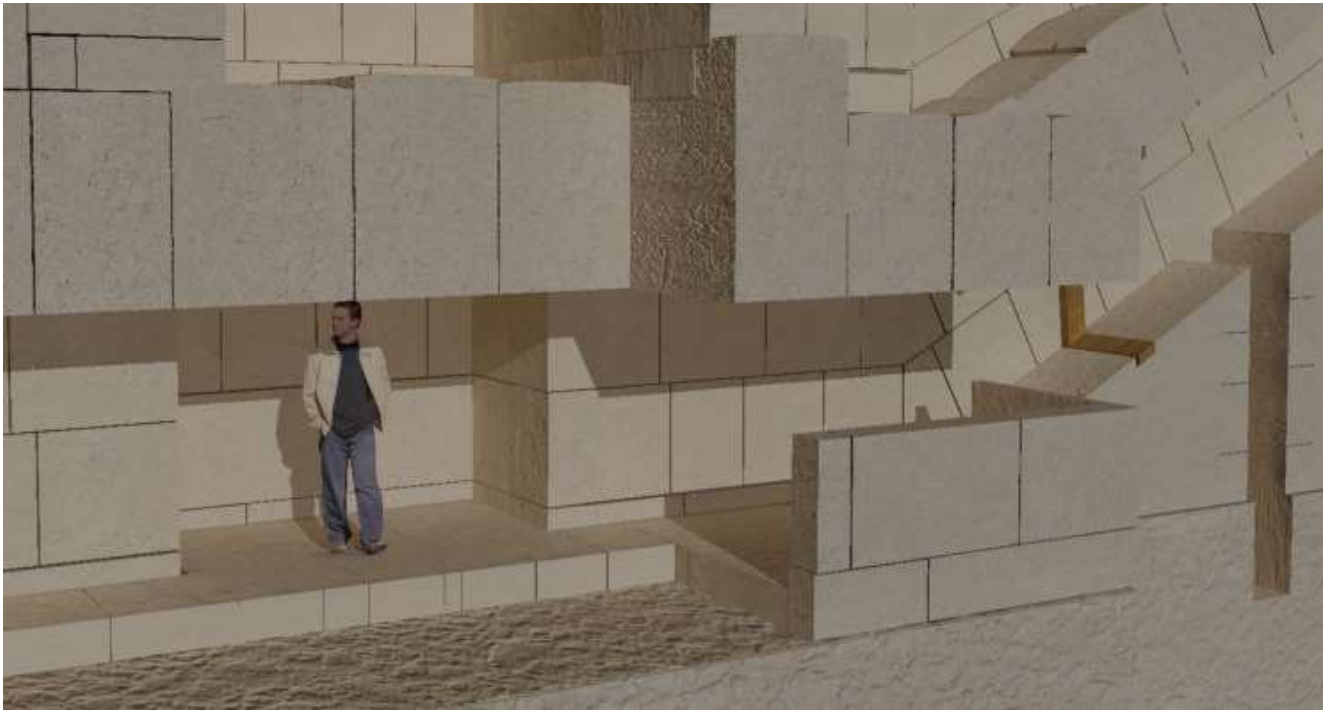
The lower chambers, as seen in the section above, are quite small and of the same size, being 5 cubits long by 2.5 cubits wide, excluding passage width. The descending passage opens immediately into the east chamber via the 15cm step. The flooring stones of the horizontal passage and side chambers all lie on the trench floor. There are 3 masonry courses to the chambers, with a smaller course at the bottom. The roofing blocks are quite substantial as they have to span approximately 2.2 metres of chamber and passage.

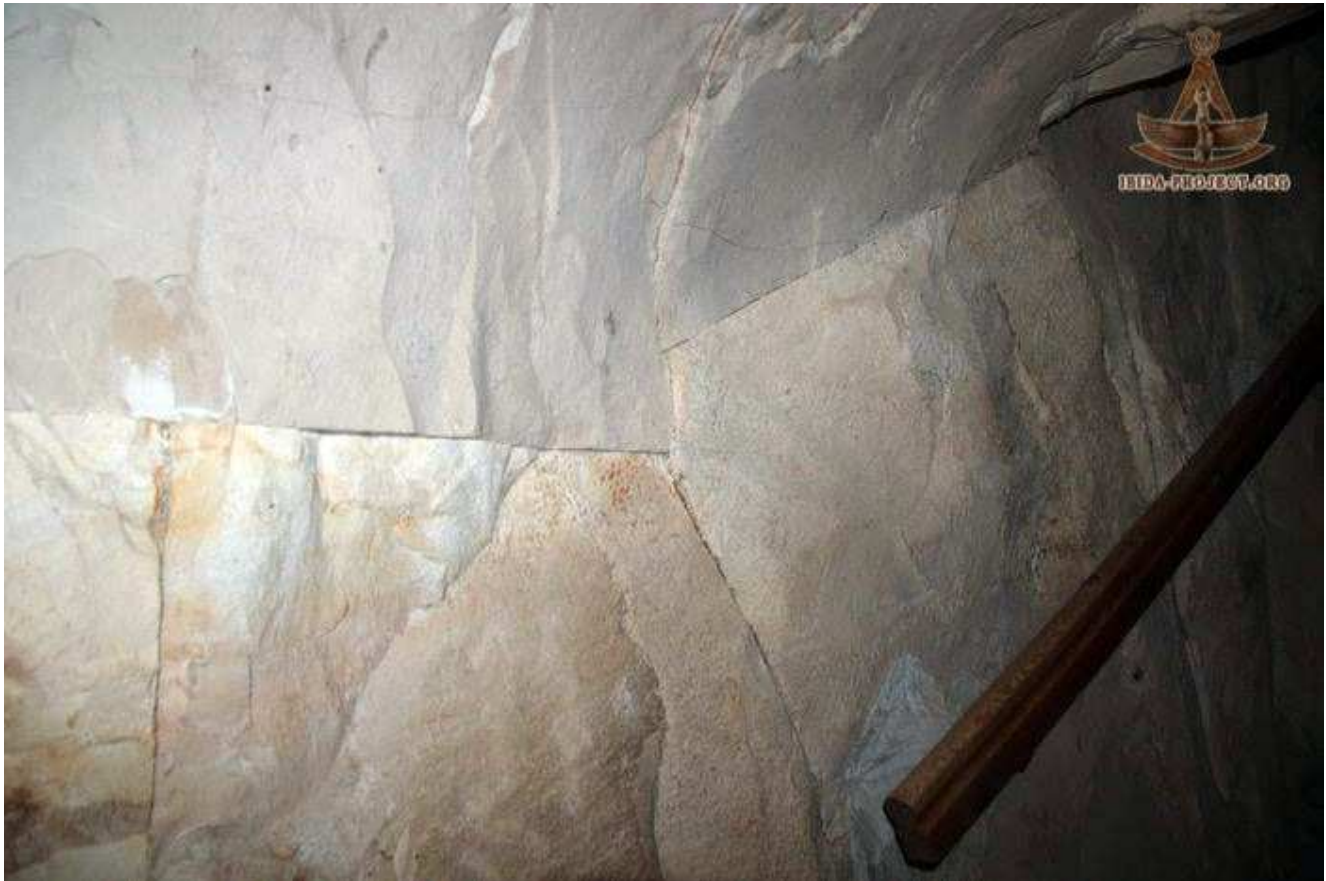
In the image above we can see the damaged junction between the descending passage and the horizontal passage. The masonry joints can be seen, including the 12cm high step that may have protected the end of a hinged door. Though the chambers and passage are equally damaged, M&R point out the good preservation of the floor.

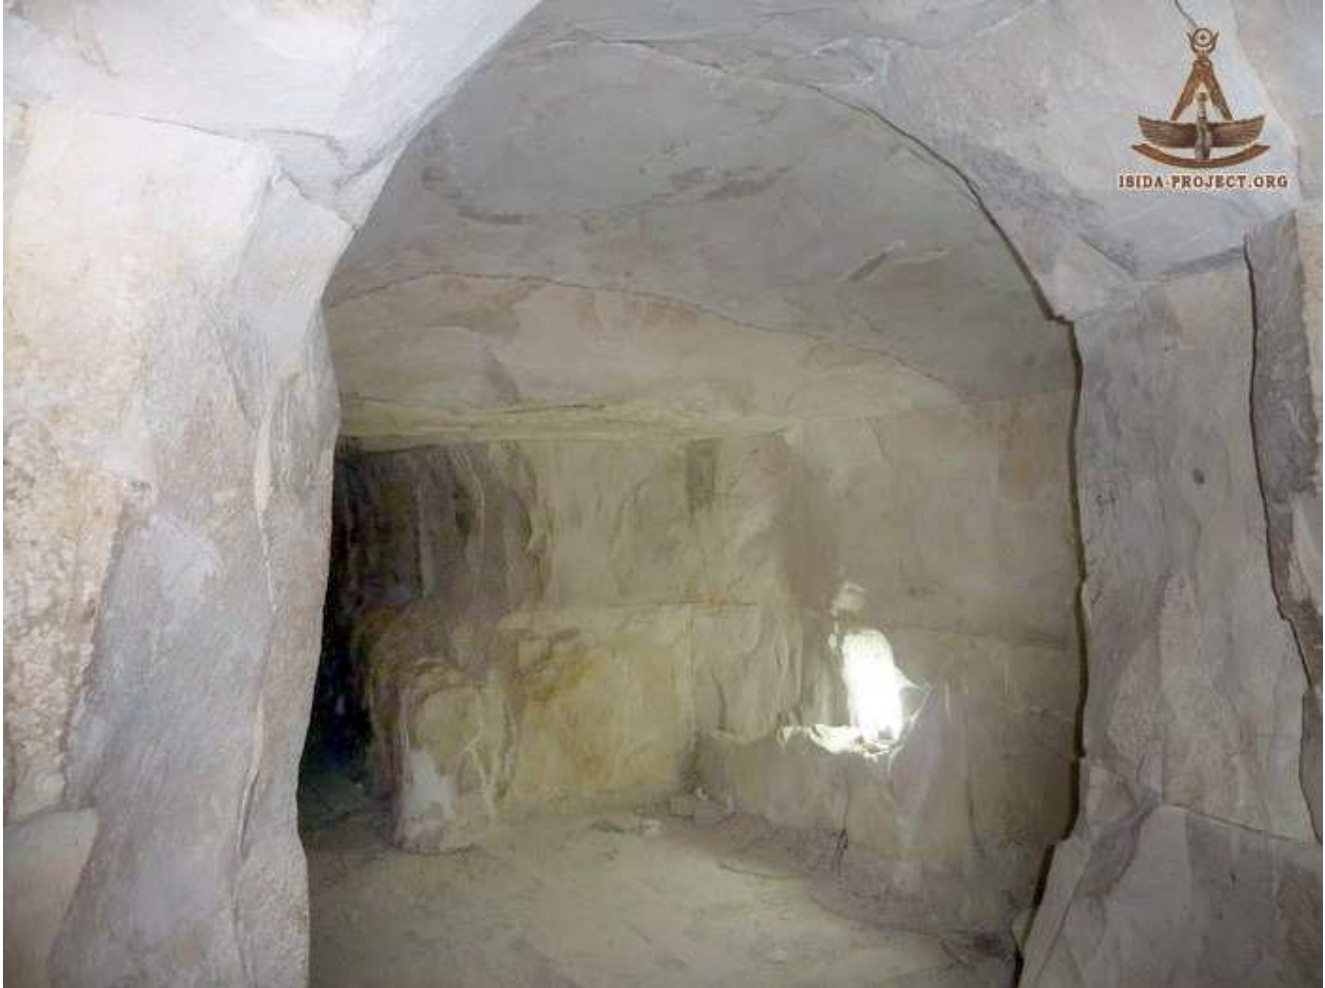
The image above gives a clear indication of the damage to the lower chambers, one would be forgiven for thinking that the chambers were carved out of the natural rock and not made of masonry.

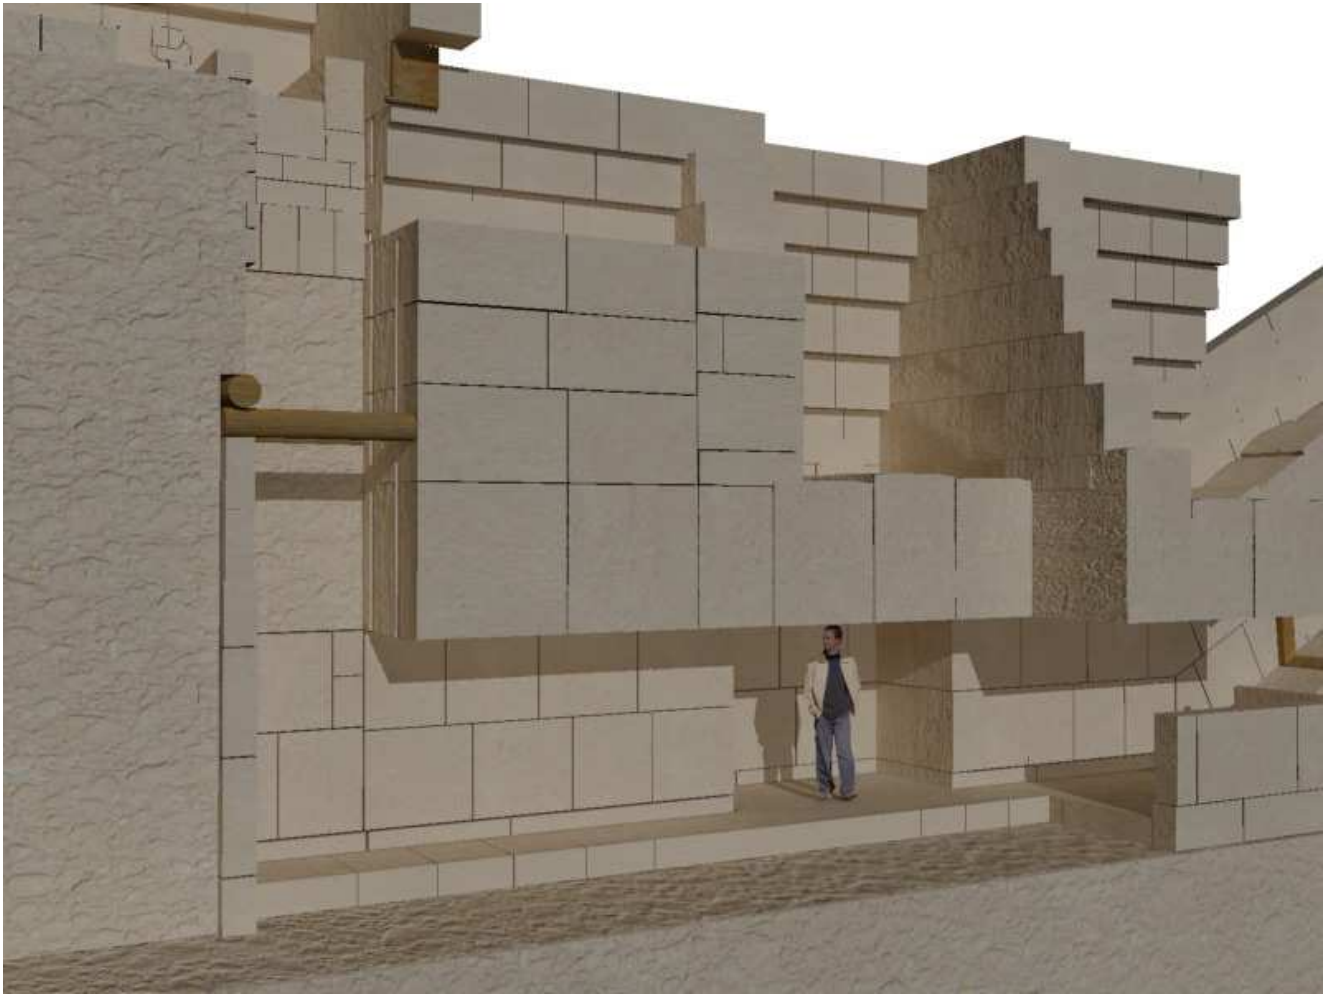
The horizontal corridor leaves the westernmost chamber and carries on south to open onto the vertical shaft. The height of the shaft from corridor pavement to main chamber pavement is about 6.25 metres. Today the corridor pavement in the vicinity of the shaft is missing and the rock floor of the trench has been cut deeper to a depth of 80cm from top of pavement level. Also the lower block on the north wall of the shaft appears to have its lower edge cut away.

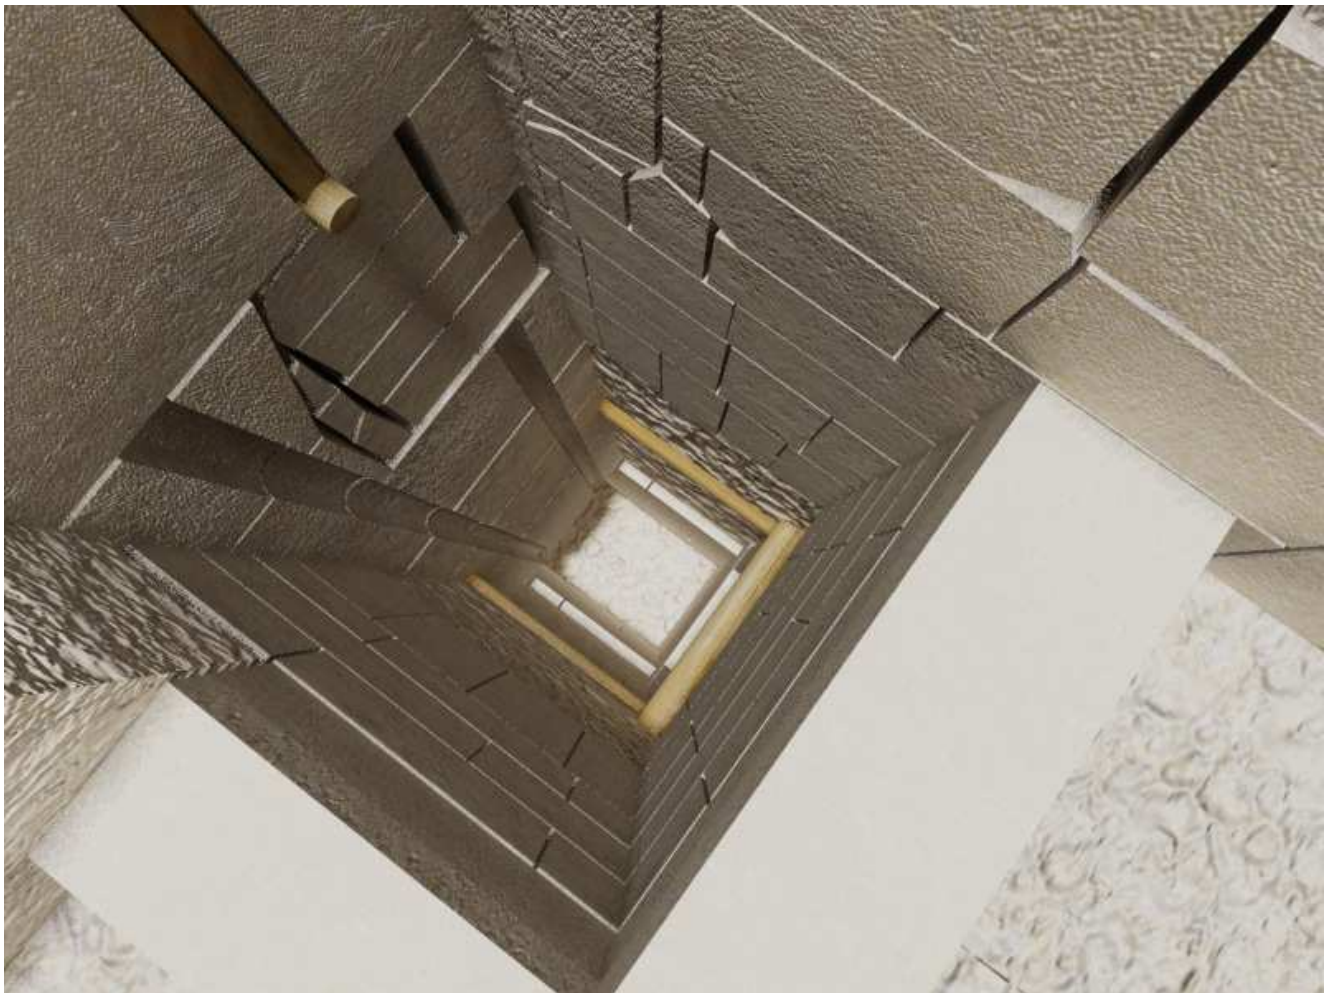
Looking down the shaft we can see the eastern groove interrupted by the blocks that cover the corbelled space and, above the blocks, the tenoned beam and wooden board. This beam is not centered on the shaft but about 30cm from the east wall.

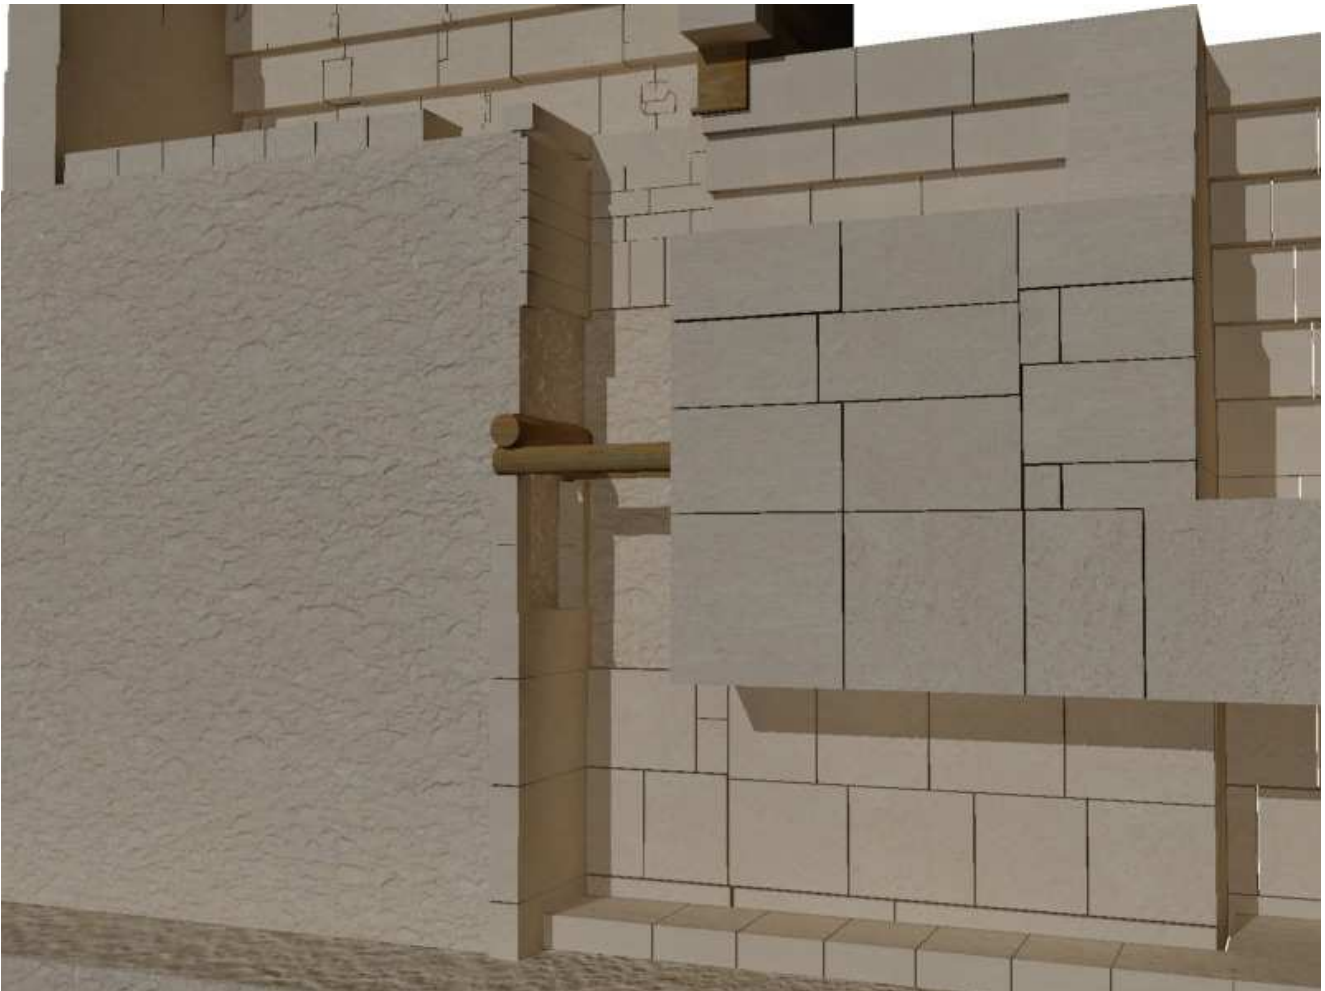
Indications are that, for the most part, the vertical shaft was tiled, although I believe the space below the wooden beam in the south wall may have been left. In the south wall four courses of masonry have been laid of unknown depth, and on top of these are what appear to be two stone supports that support the southern ends of the two beams that are recessed in the east and west walls. The northern ends of these beams are inserted into the masonry of the north wall. These beams are about 20cm in diameter. It has been suggested that the beams were to help support the rock in the shaft.
