A Layman's guide to

The Meidum Pyramid

Keith Hamilton April 2017

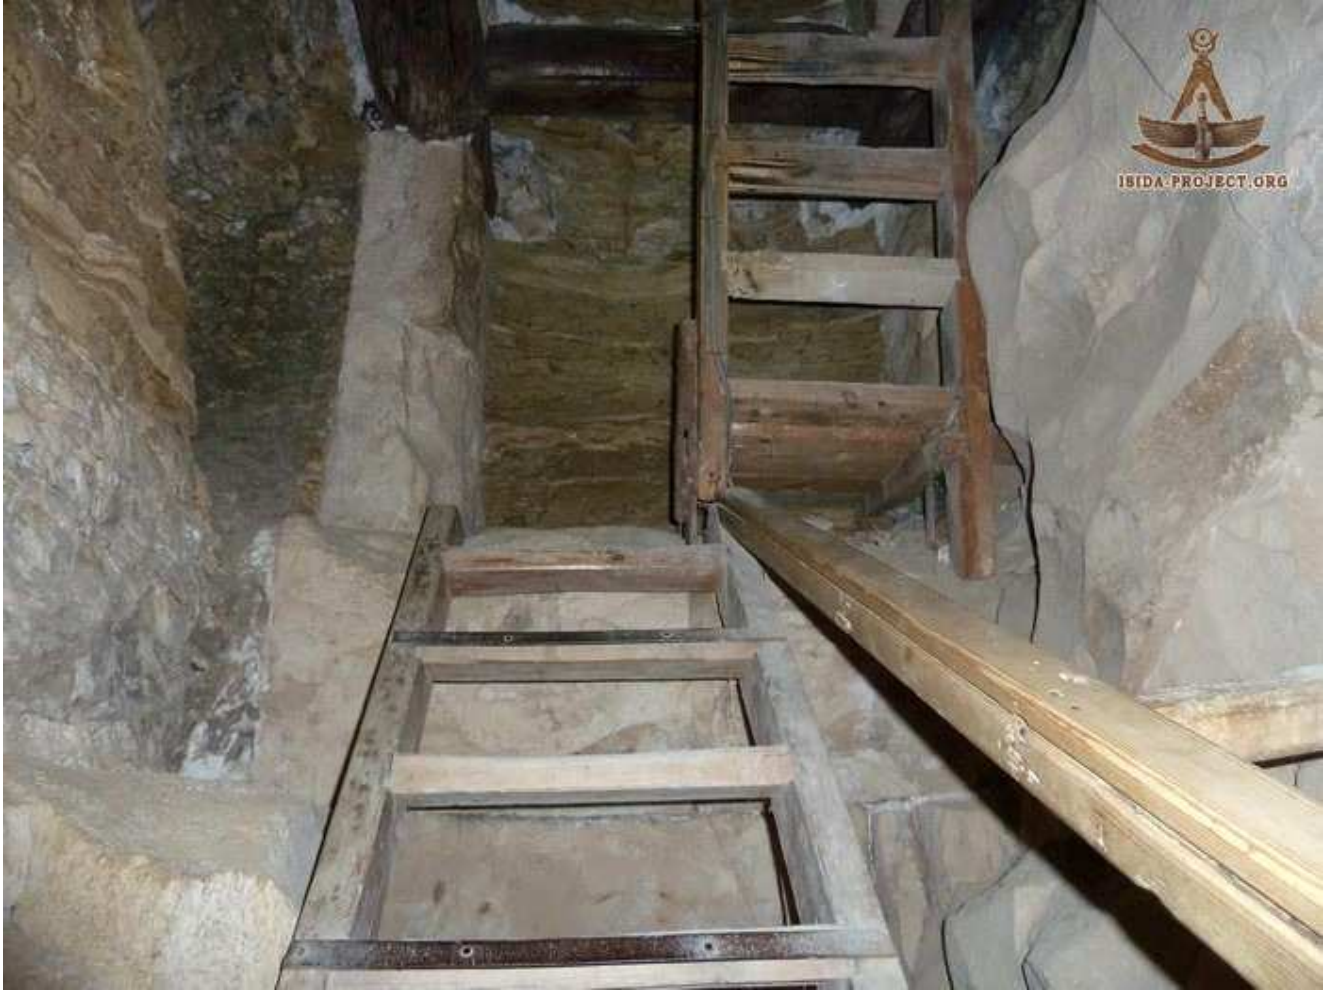
Looking south up the shaft we can see the stone support supporting the beam. The space between the supports and under the beam is the natural rock and probably the most southern edge of the trench.

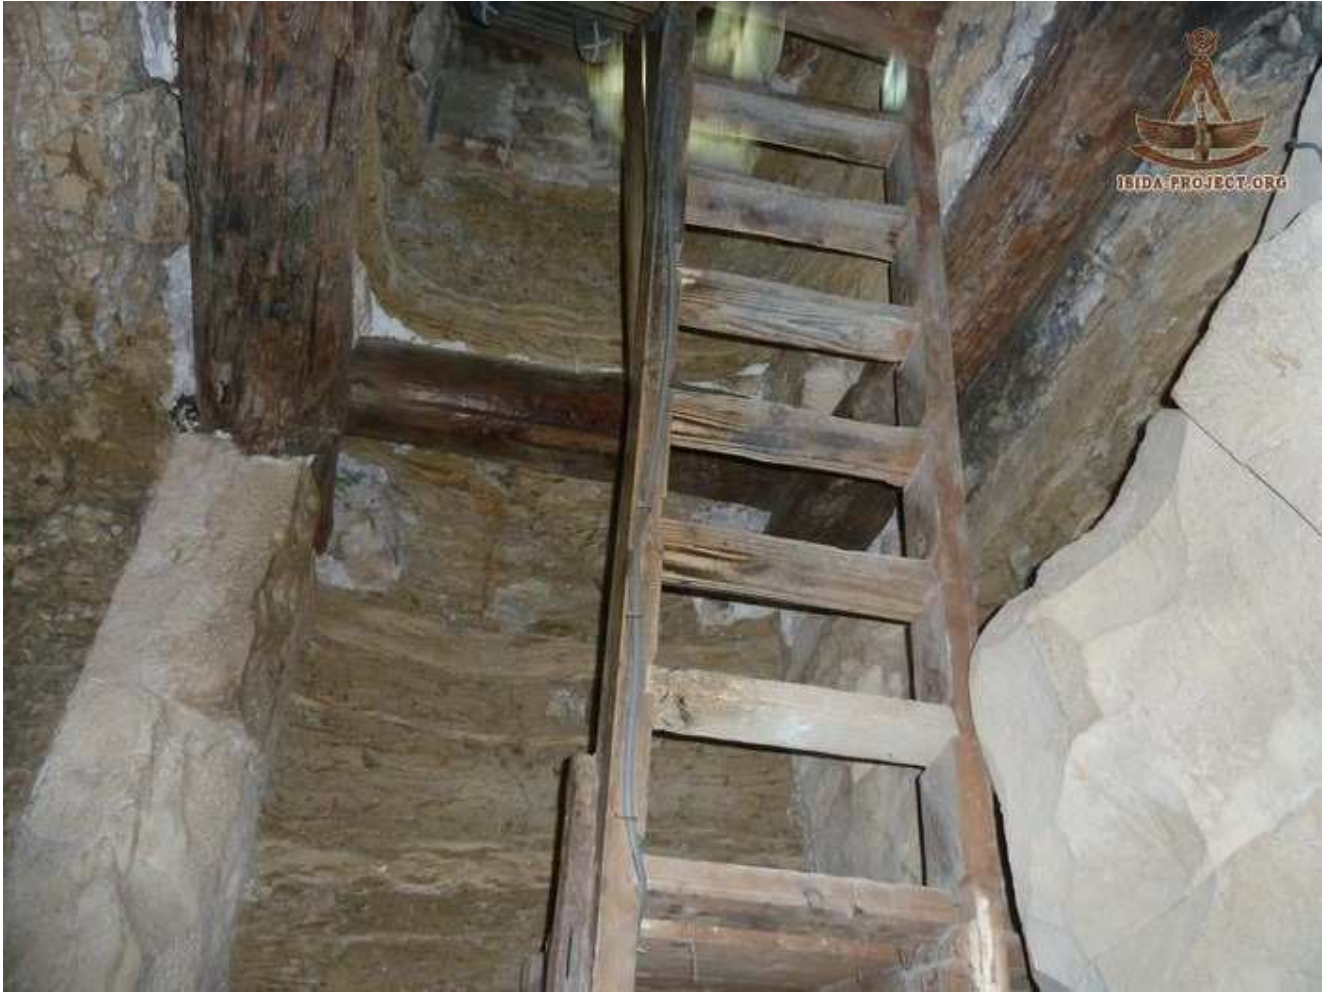
Looking further up, one can see near the top of the picture some of the surviving tiles adhering to the south wall; part of a thin slab of stone can also be seen on the west wall.

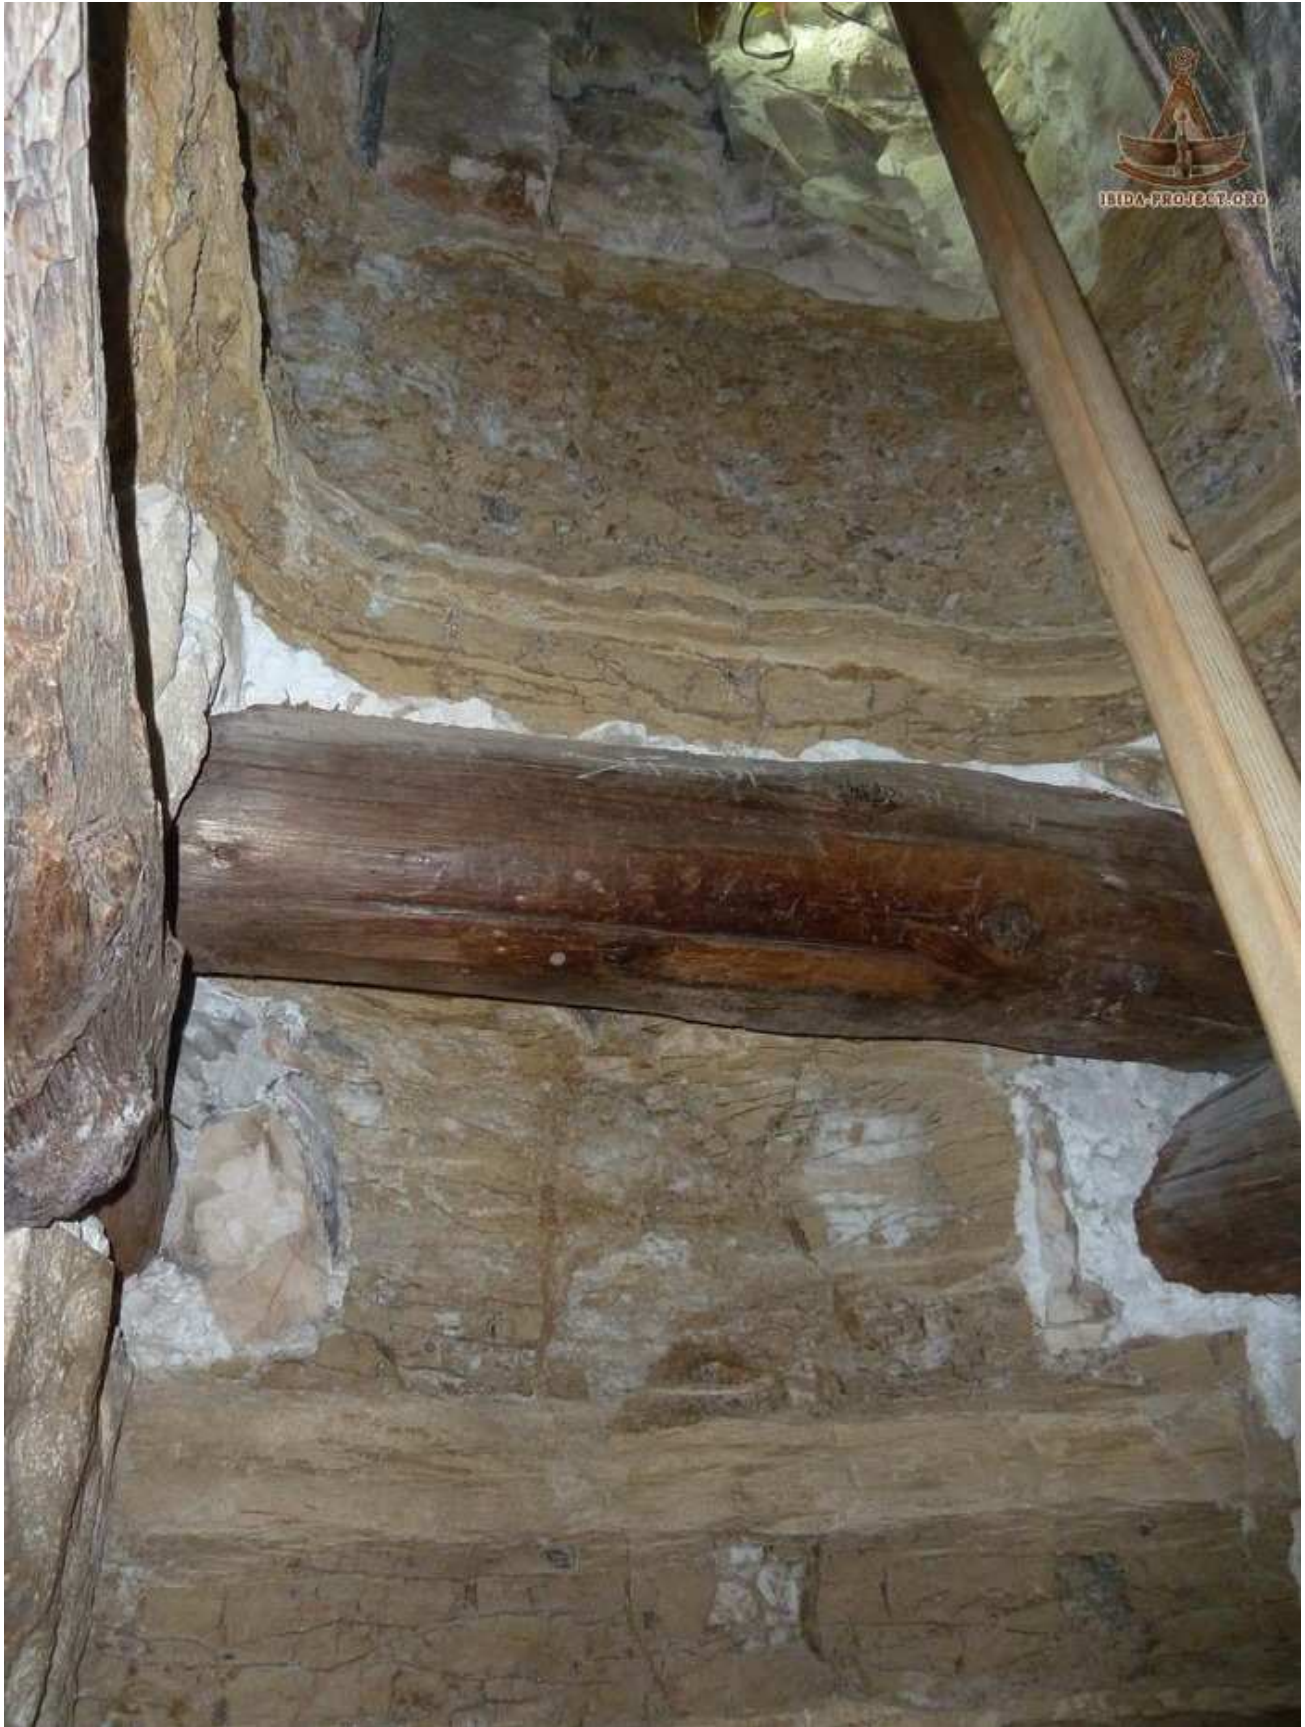
The close up image shows the tiles in more detail, and remnants just visible above the left beam. The reason I feel that tiles might not have been fitted in the space between the supports and below the south wall beam, is to do with the practicalities of inserting the beams. Like the D holes in the descending passage I suspect the holes in the rock were made bigger than the beams, to enable the beams to be slid in at an angle and then withdrawn to fit into the holes in the north wall. The excess space left in the rock holes could then be filled with masonry and mortar to tightly secure the beam. The picture shows bits of masonry below the south beam in the corners where the beams would be inserted; are these remnants of tiling or masonry inserted to make good a hole? Of course tiling could have been done after the beams were fitted.

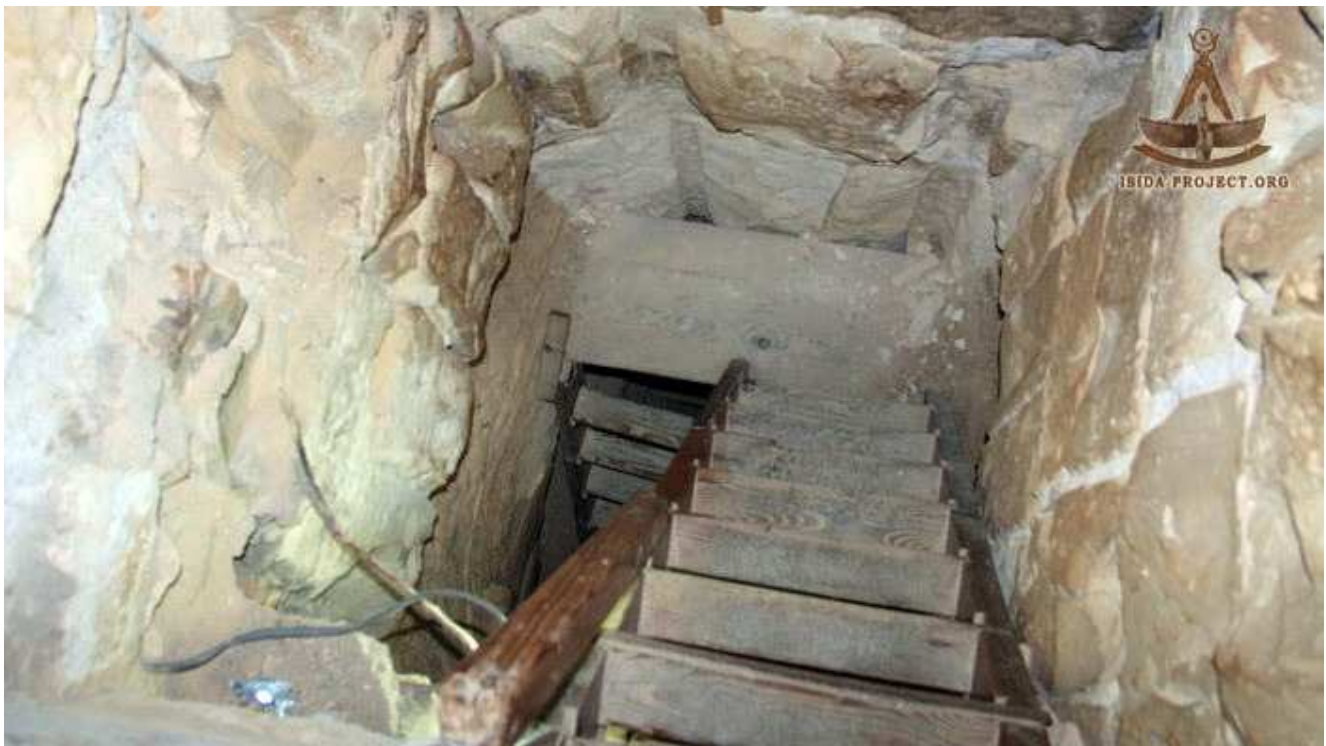
Looking down the vertical shaft and the grooves on the northern wall.

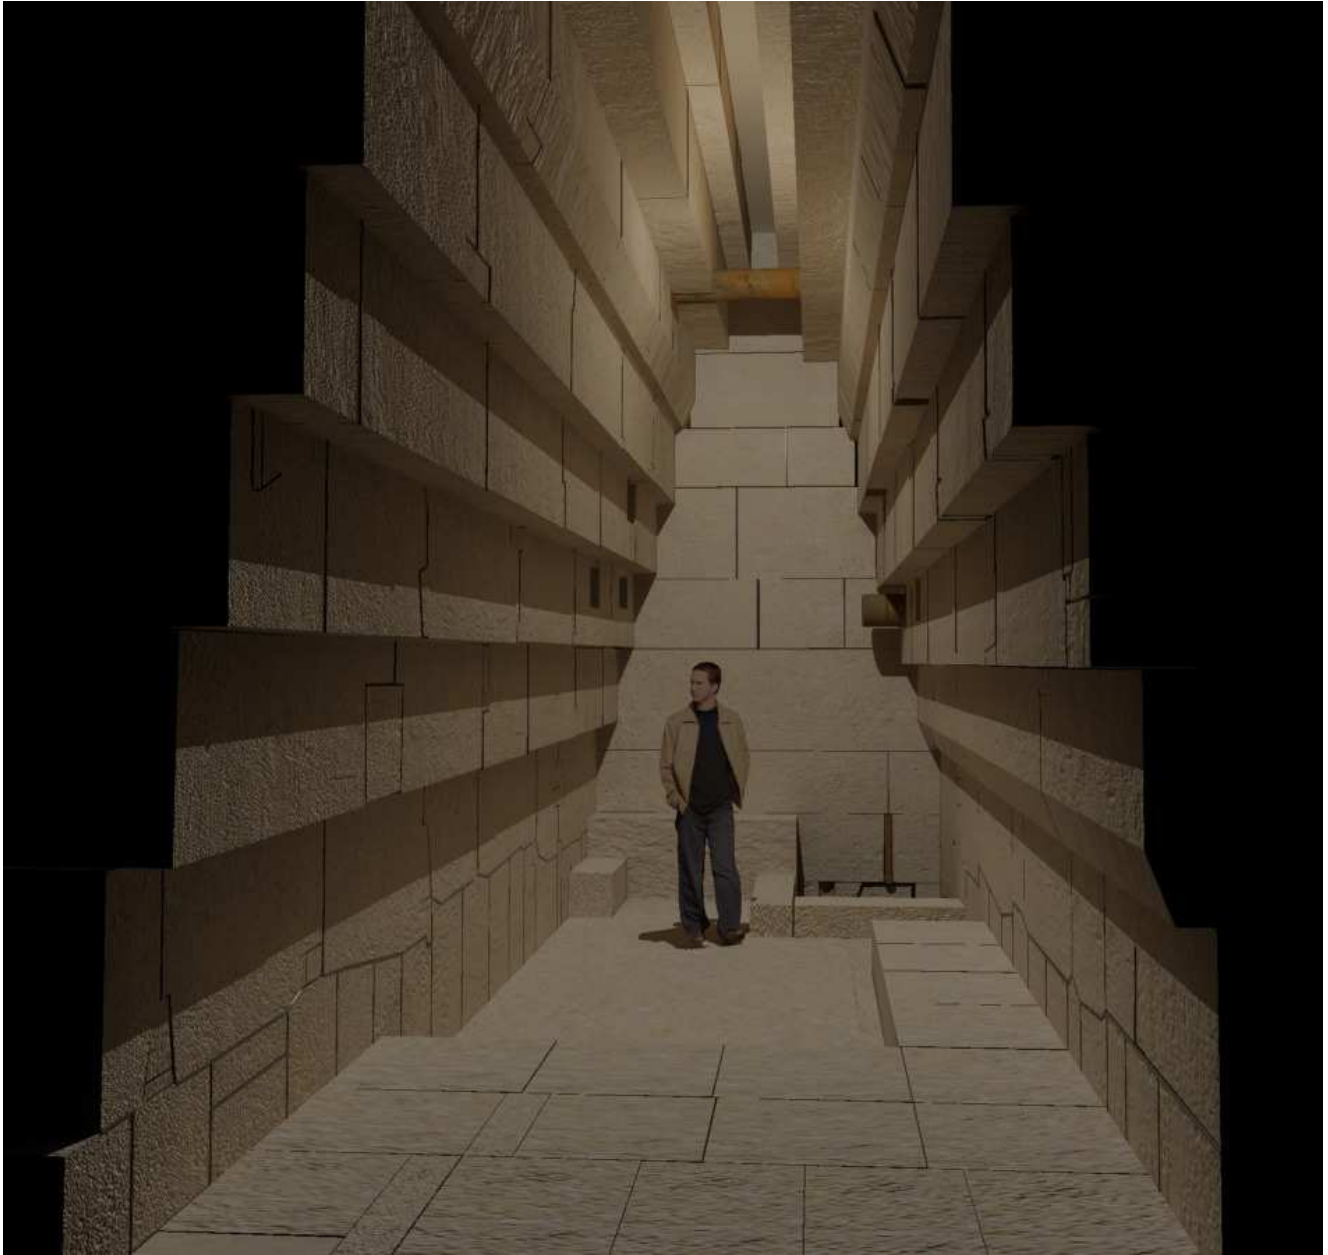
This impression, looking north, shows the vertical shaft entering the main chamber in the northeast corner. The pavement is mostly missing in the northern half of the chamber. The north and south walls are vertical.

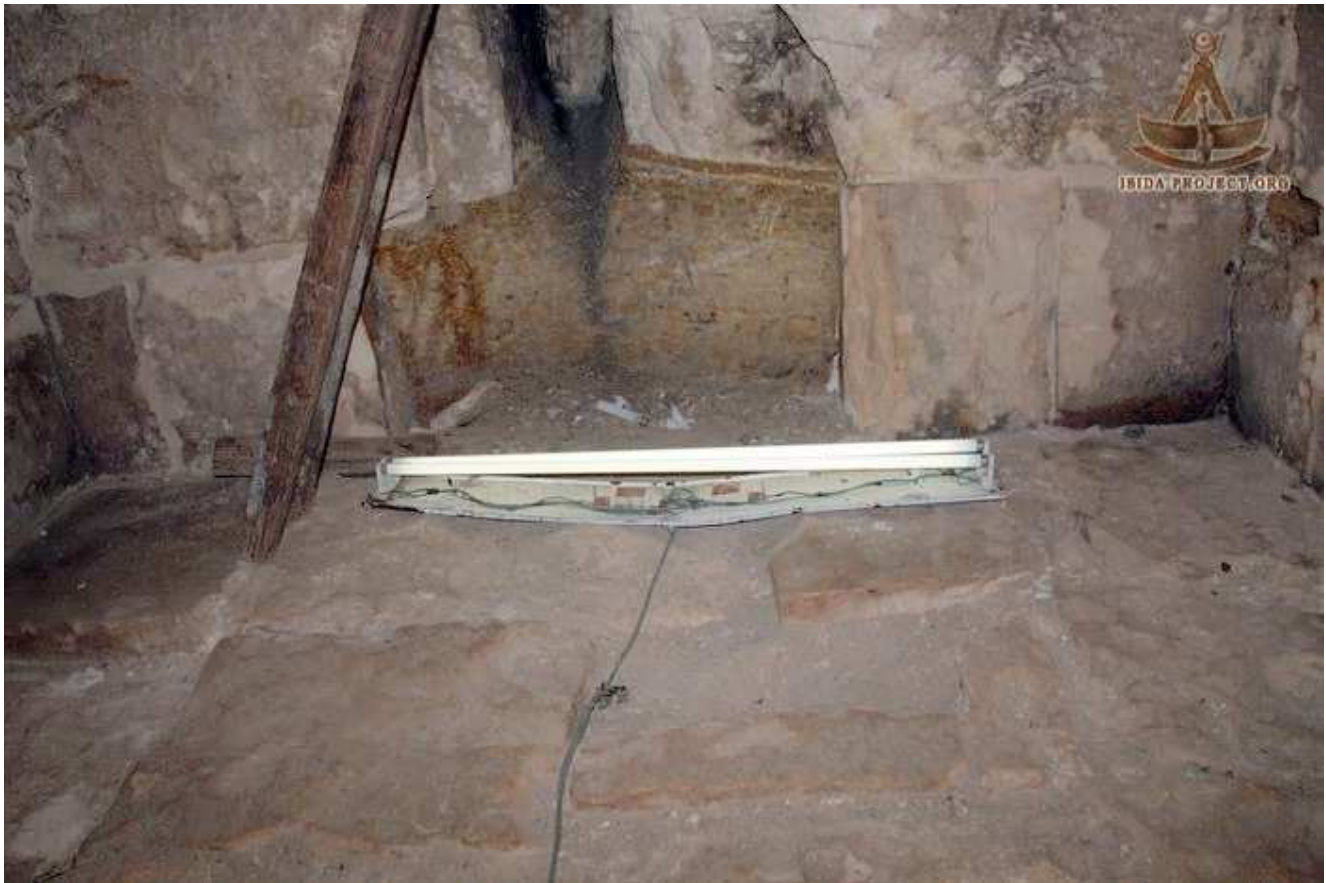
In the image above, a breach in the southern wall shows the lower patches of stone and, where they have been removed, the natural rock can be clearly seen.

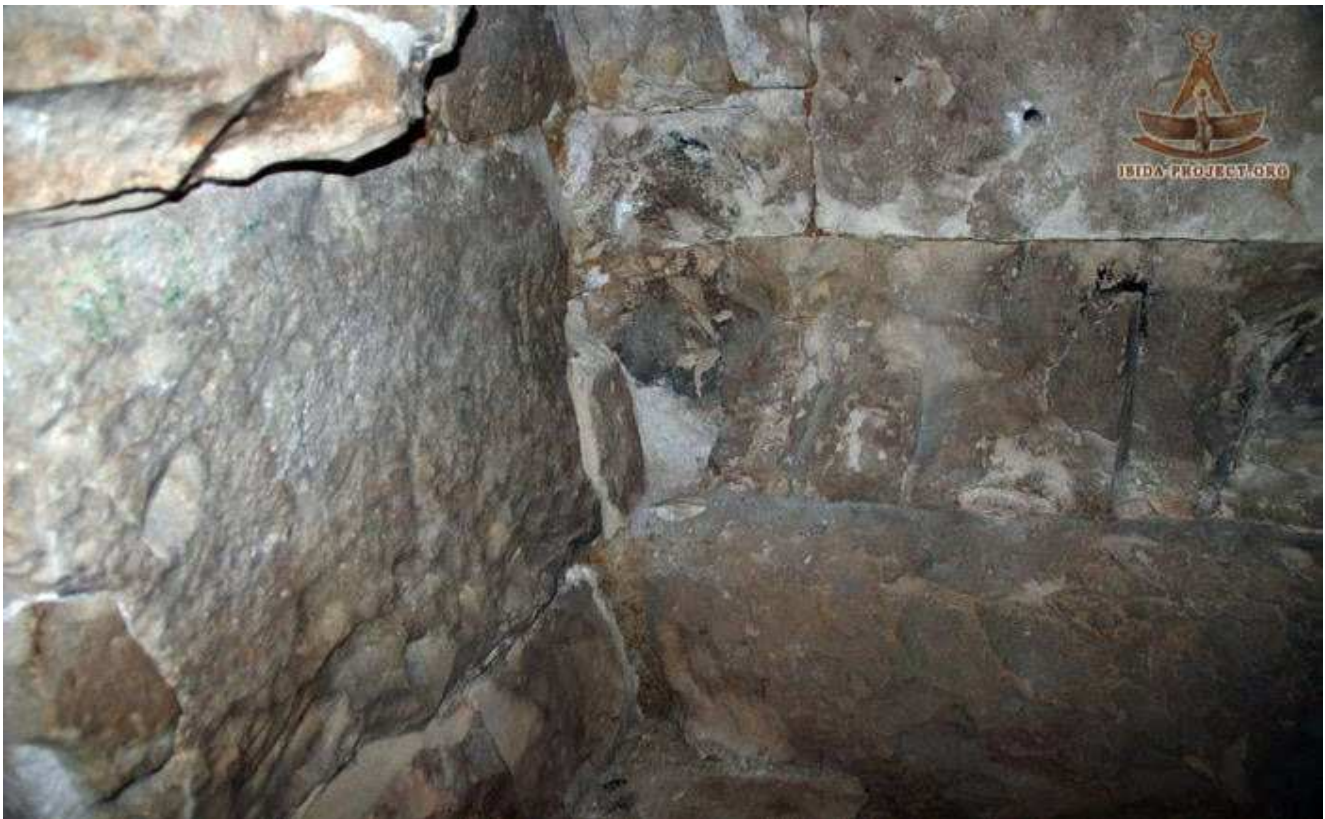
The Bank is just visible in the right foreground of the above image.

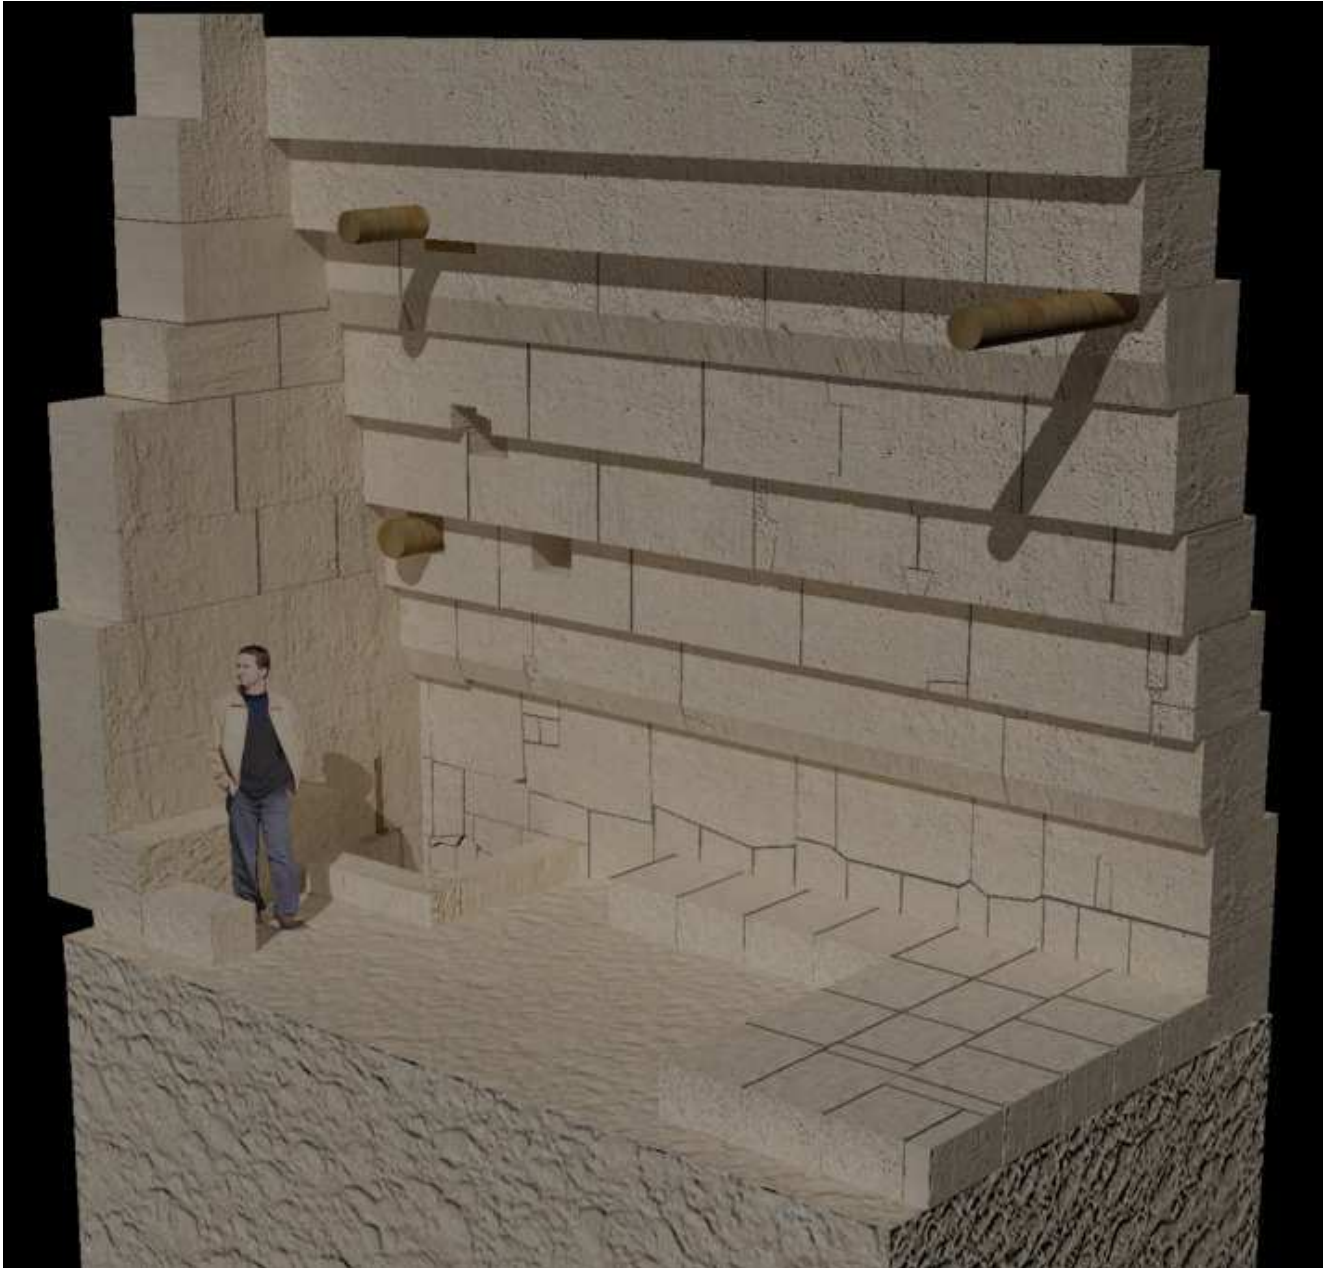
The image above looking towards the east wall shows the relative positions of the features described.

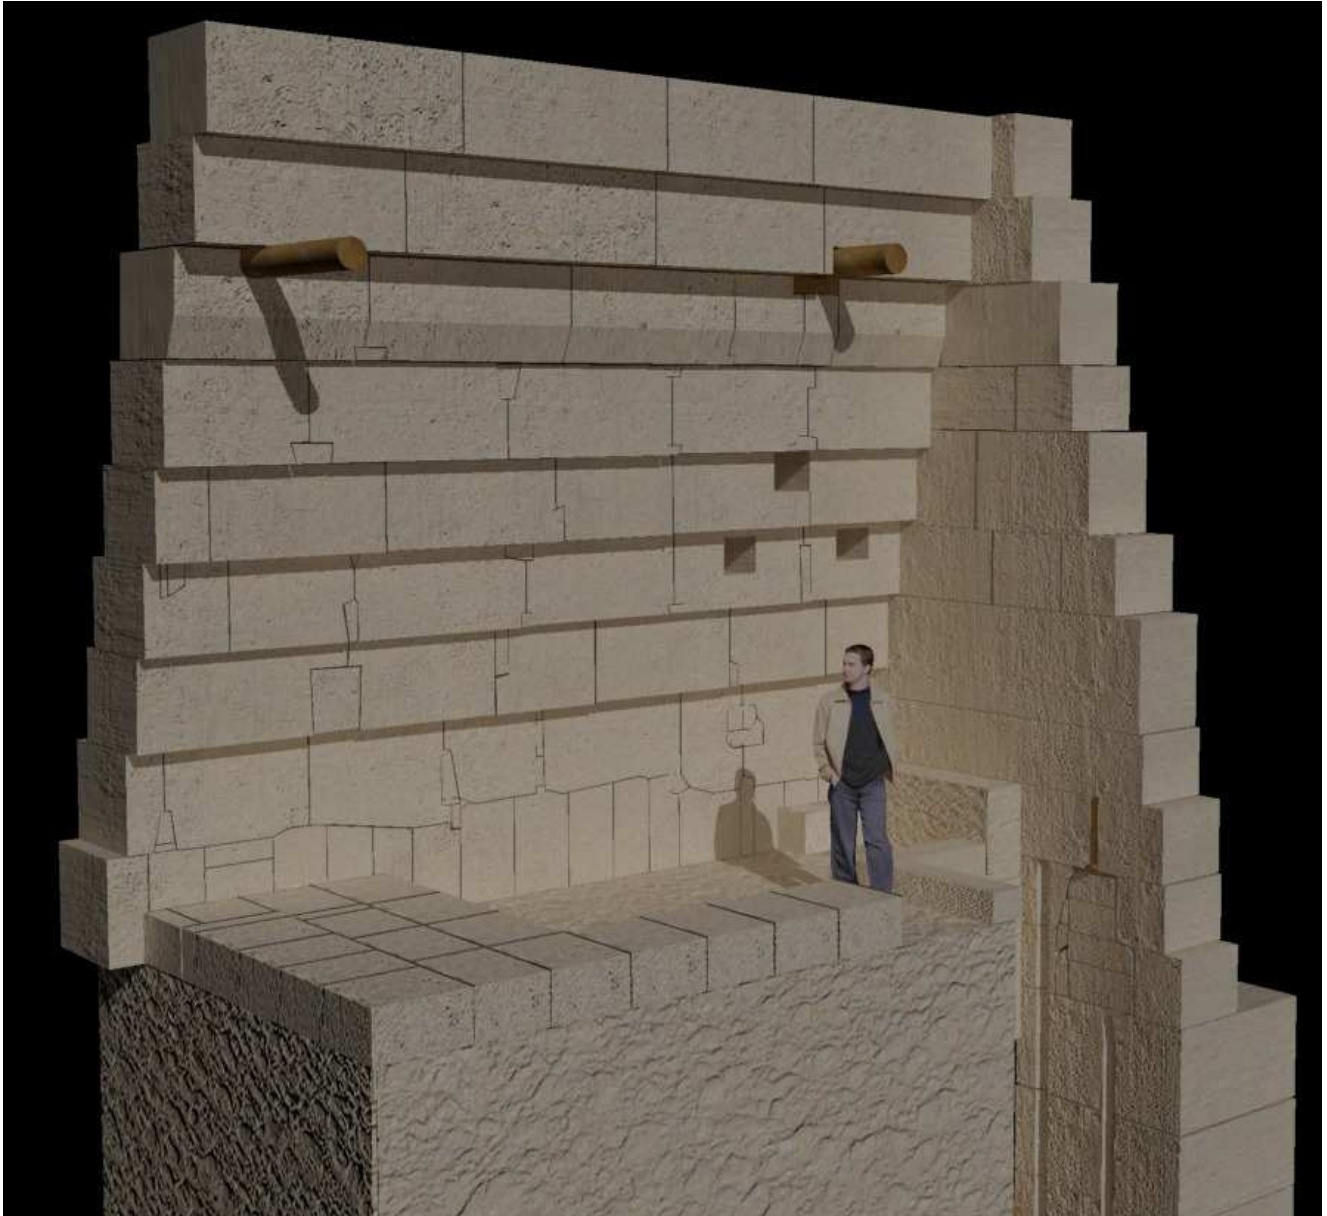
View looking towards west wall.

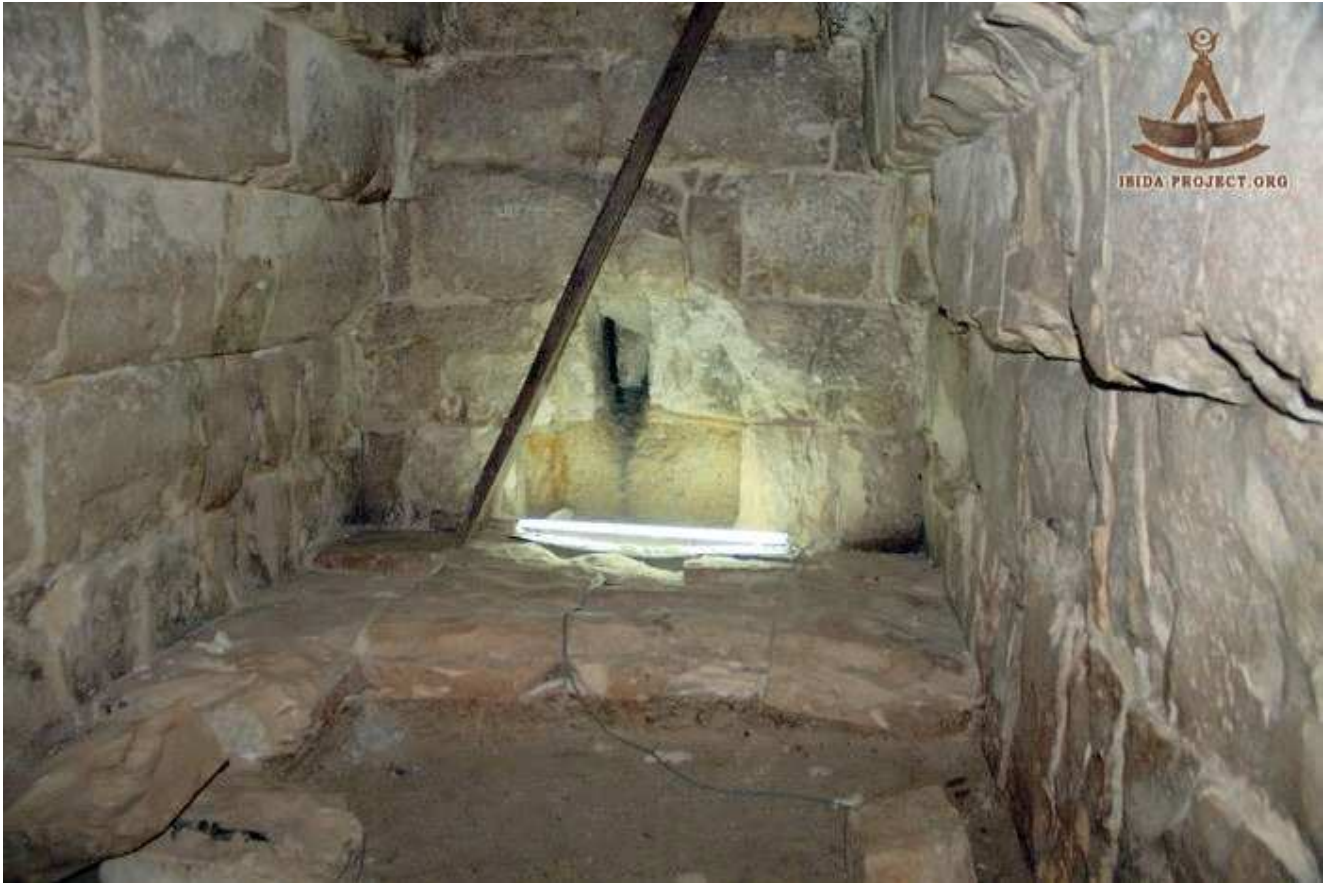
Looking south, we can see the surviving pavement stones laid on the rock; also in view is the excavation in the south wall and the chamfered edge on the first overhang on the east wall. There is hardly a block in the chamber not damaged in some form or other.

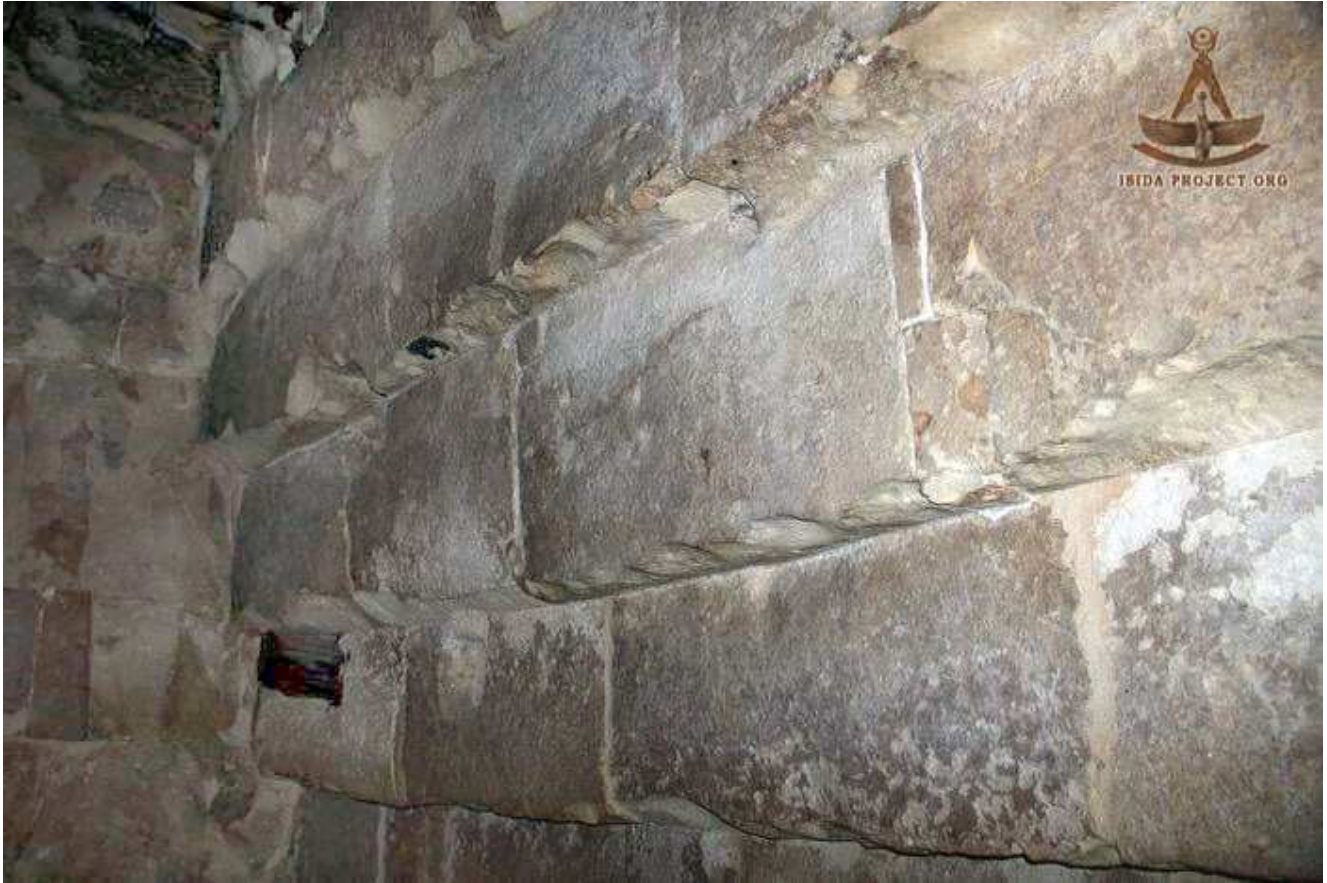
Looking along the east wall, we can see a piece of beam in one of the square holes; the other two square holes are just visible above and to the right of it. Also visible are some patches of stone near the joint lines that are quite widespread in the chamber.

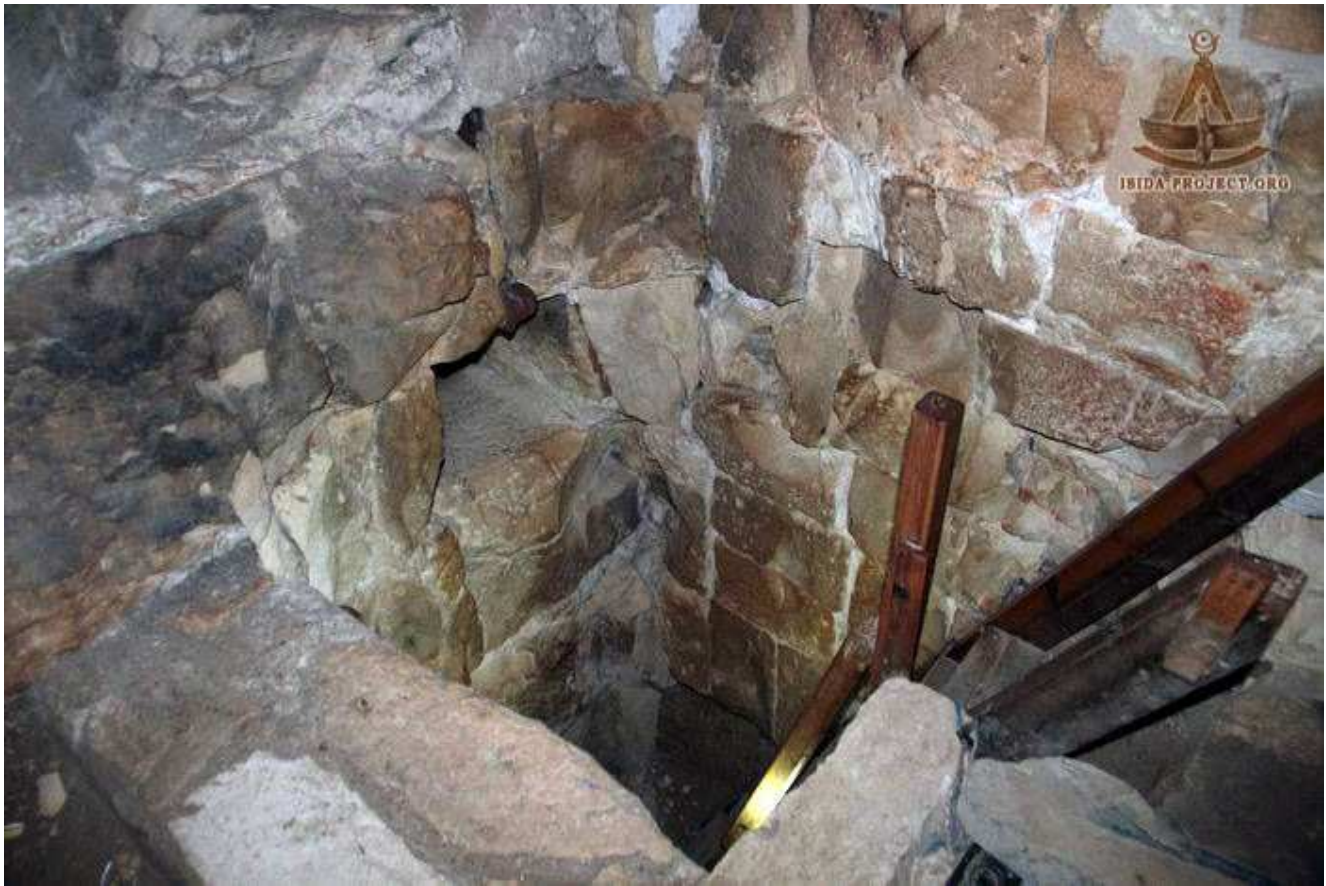
Looking down the shaft we can see some of the wooden board and beam in the north wall, below that a hole that is part of the corbelled space that originally would have been closed with a stone block. To the right of these features, there appears to be a depression and some damage to the east wall which may have a bearing on what I want to discuss next and that is the sealing of the chamber.

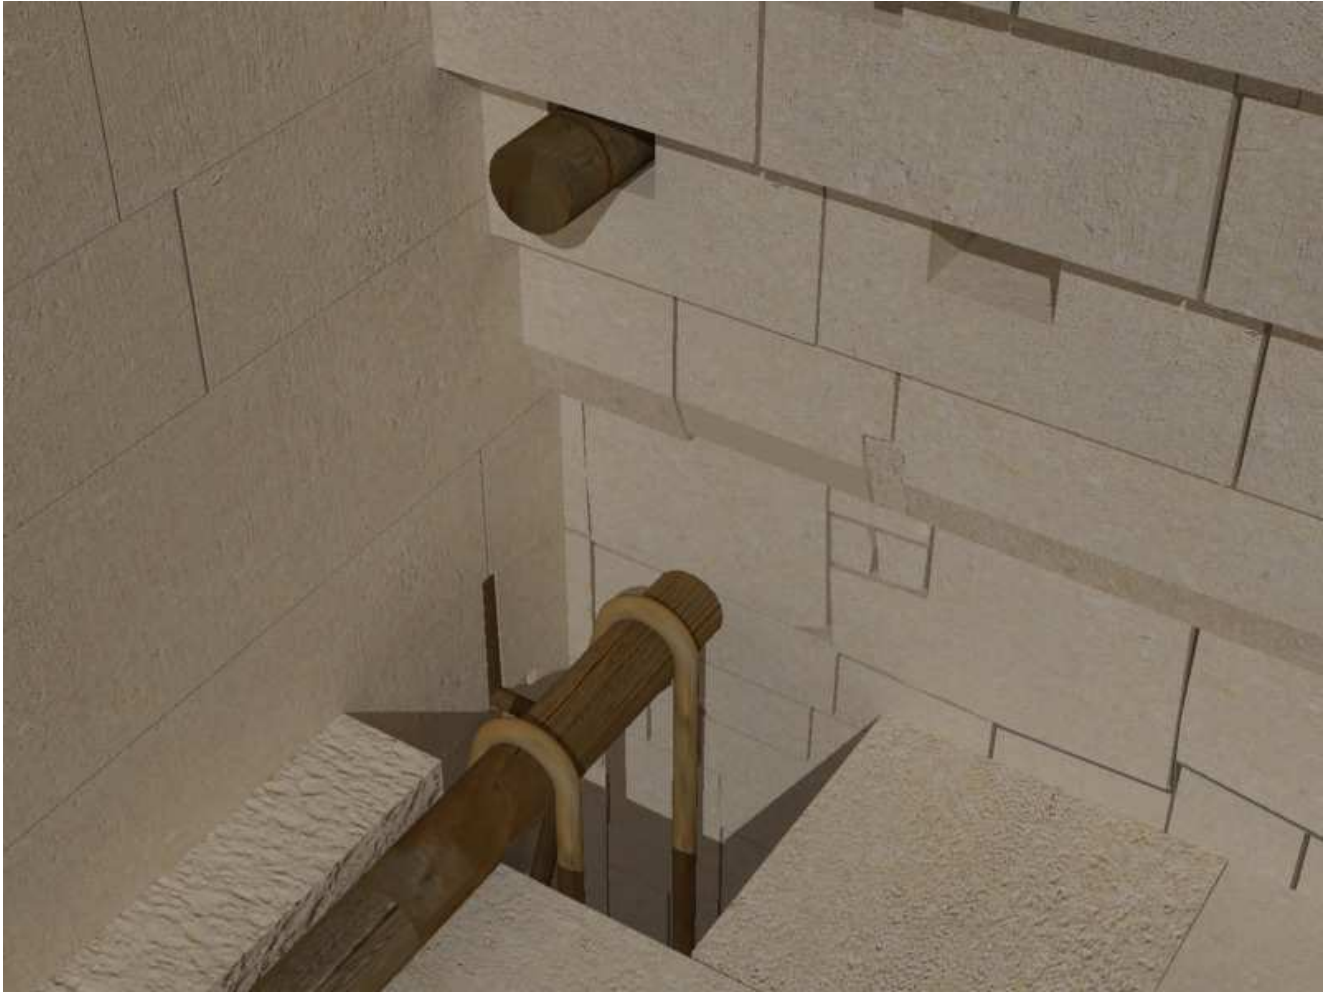
Once the decision to seal the chamber was made the following sequence of events may have been done. First, the corbelled space in the north wall of the shaft would be walled up; the trapezium cut mentioned by Dormion on the west wall of the space was probably made to aid in inserting the four blocks and then patched up with the small pieces of stone. Next, the 10cm beam would be inserted along with the 5cm wide wooden board. The four blocks and board would sandwich and hold fast the beam, this beam would probably only protrude into the shaft a short distance and its function would be to provide a backstop to prevent any intruders from attempting to push the portcullis block up the shaft. The board, beam and blocks in the space are 40cm deep.

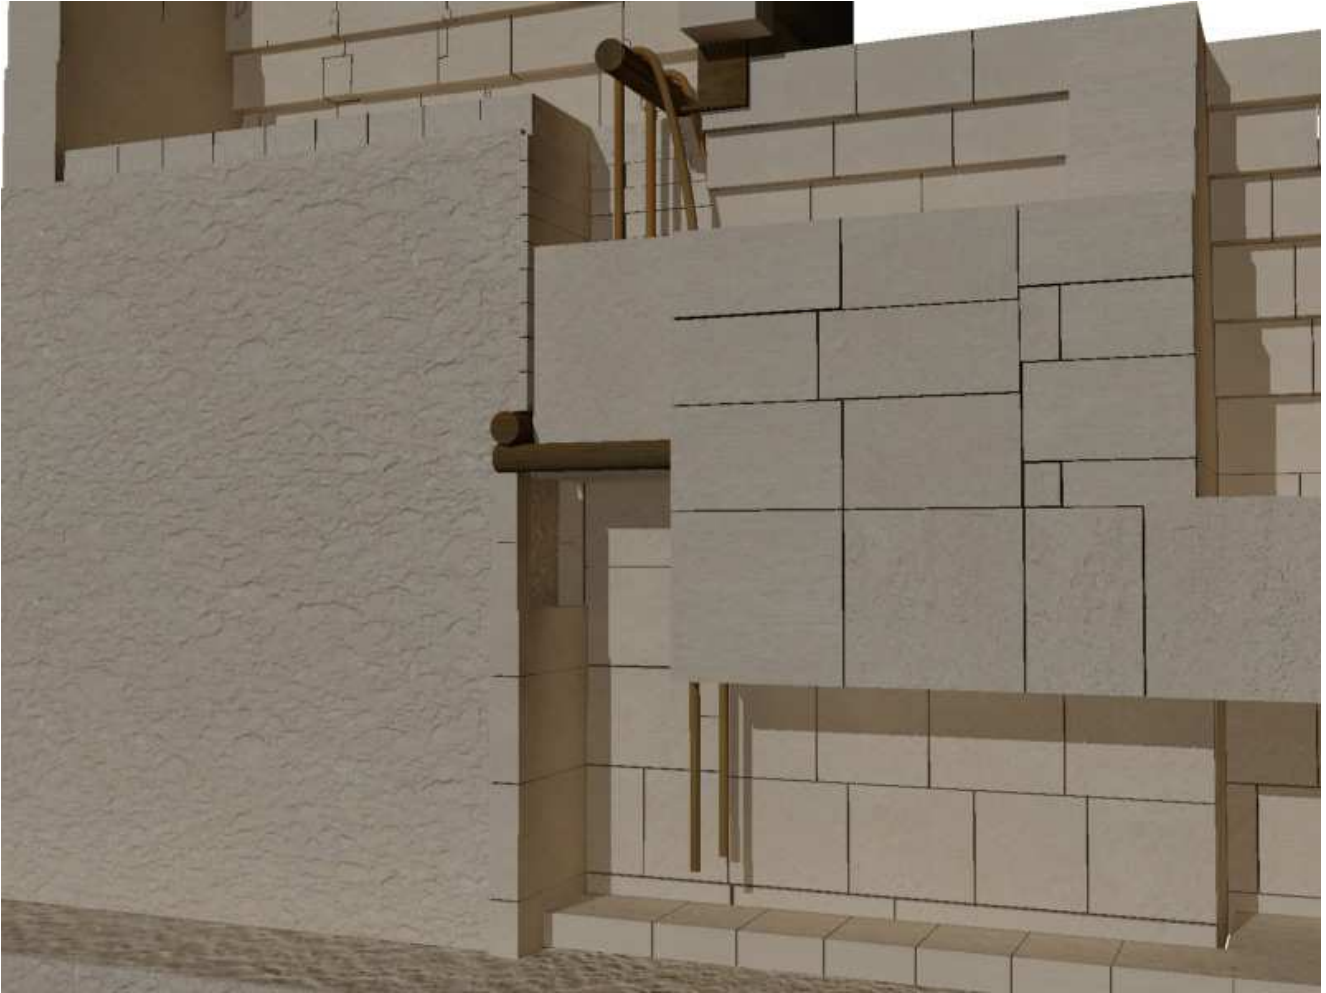
In the reconstruction above I have used a portcullis block whose height is equal to the corridor below as an example, but it may have been smaller in height.

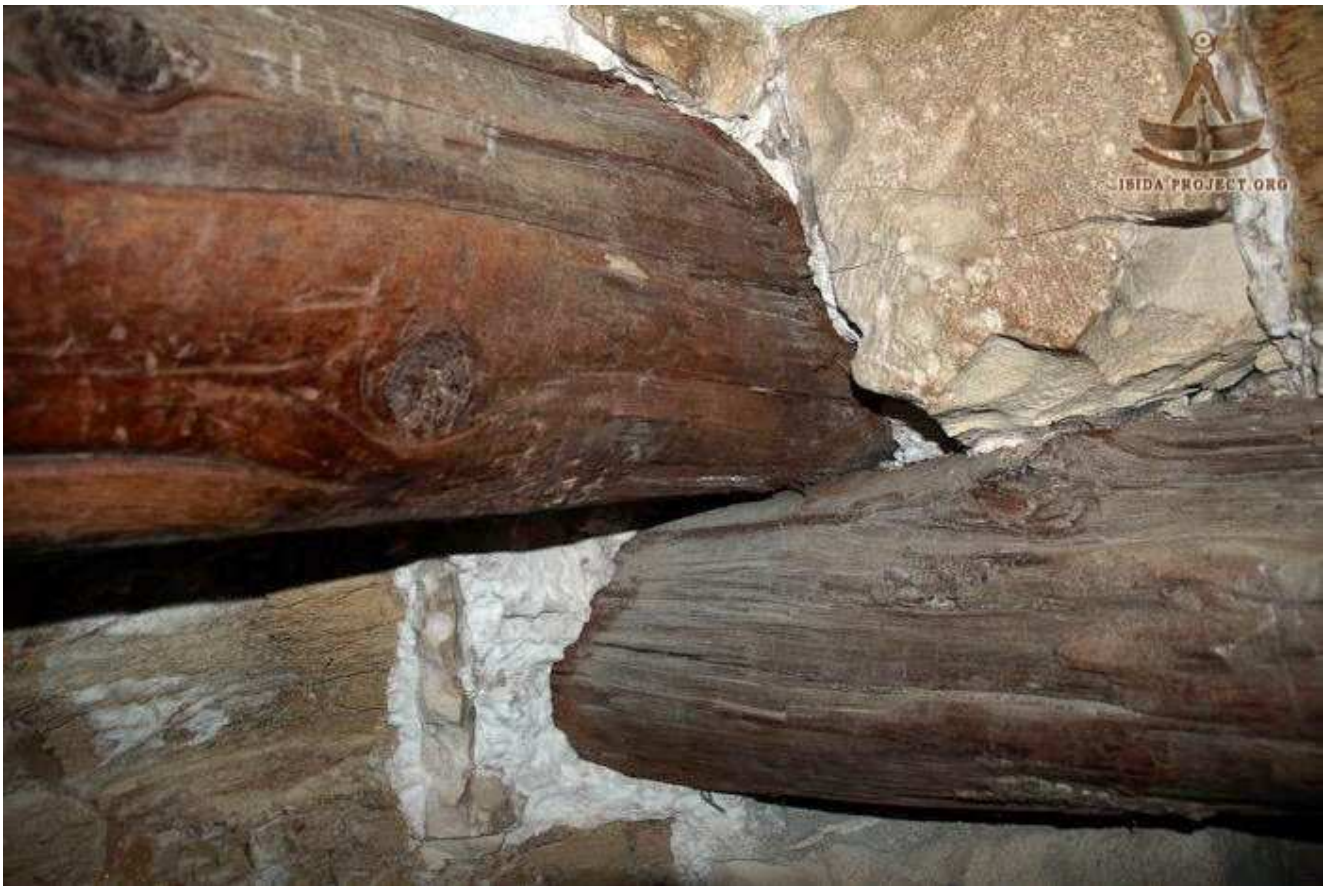
A close up view, where West and South wall beams meet

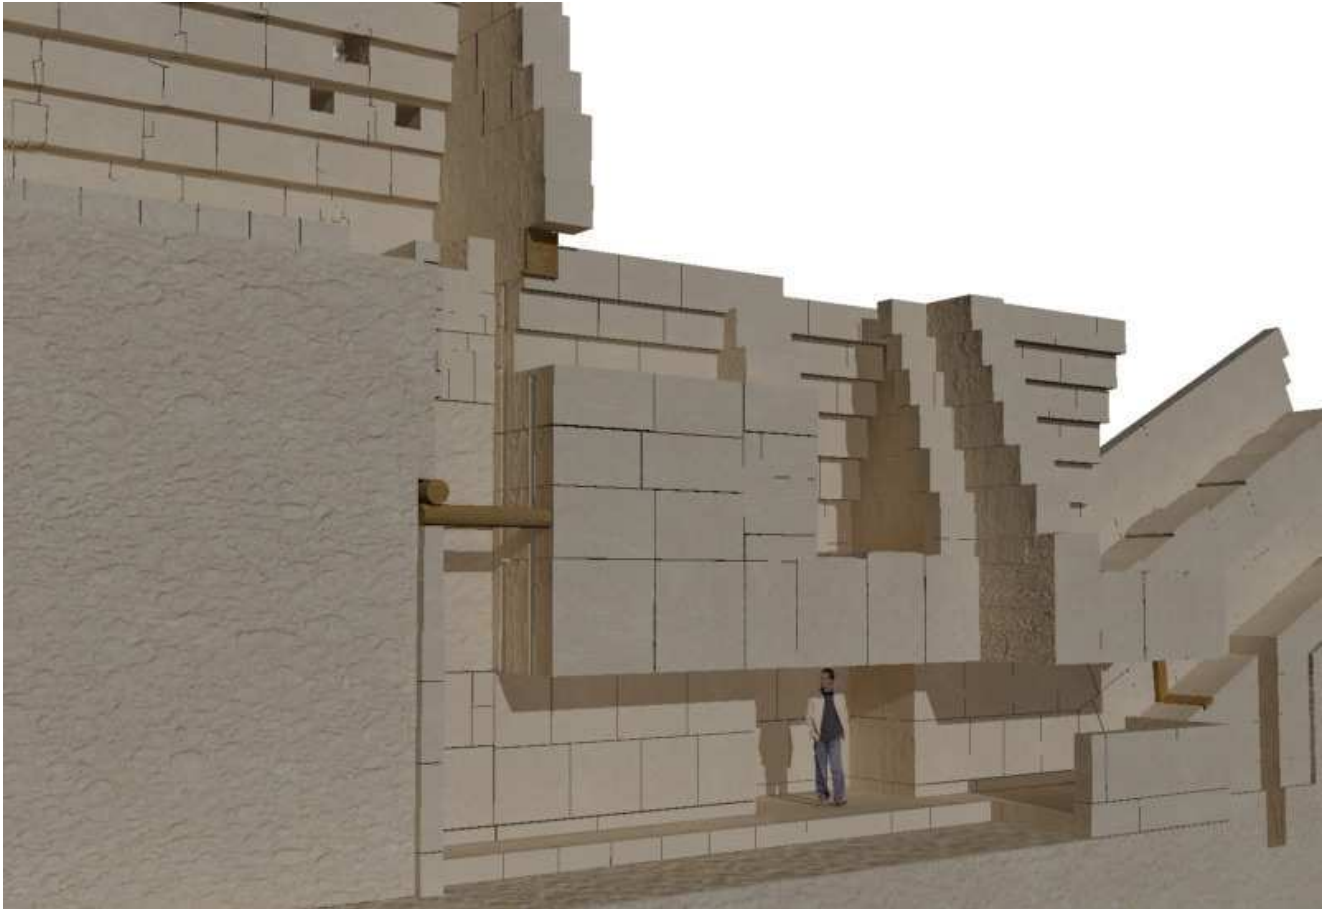
In the image above the relieving chambers/spaces can be seen above the two lower chambers, the lower end of the descending passage; and the corridor leading to the shaft. Dormion and Verd'hurt discovered these unknown spaces between 1998-2000. They were concerned about the large span that the roof beams of the lower chamber had to cover and wondered if a weight relieving system was present above.

The relieving spaces above the lower chambers are made of seven courses of which 5 are corbelled. The floor of the spaces is the upper face of the beams that span the chamber below, which vary in height. Dormion commented on how he thought the horizontal ceilings of these spaces appeared to correspond to the level of the natural rock. On the condition of these spaces Dormion says:
