A Layman's guide to

The Meidum Pyramid

Keith Hamilton April 2017

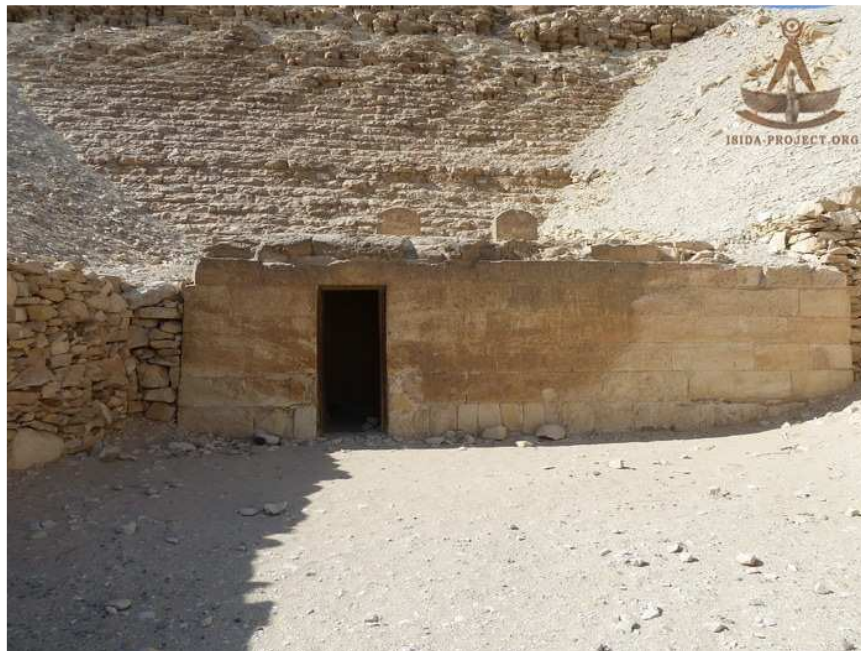
In the image above, the lowest course of the temple is clearly different to the others and not unlike what we see in the main chamber in the pyramid, are these thick tiles? Was the top of this course intended to coincide with the finished floor level of passage and chamber? If so this would reduce doorway height to 60.6 inches (1.54m) though once through the door, the lintel course would increase headroom to 1.88m.

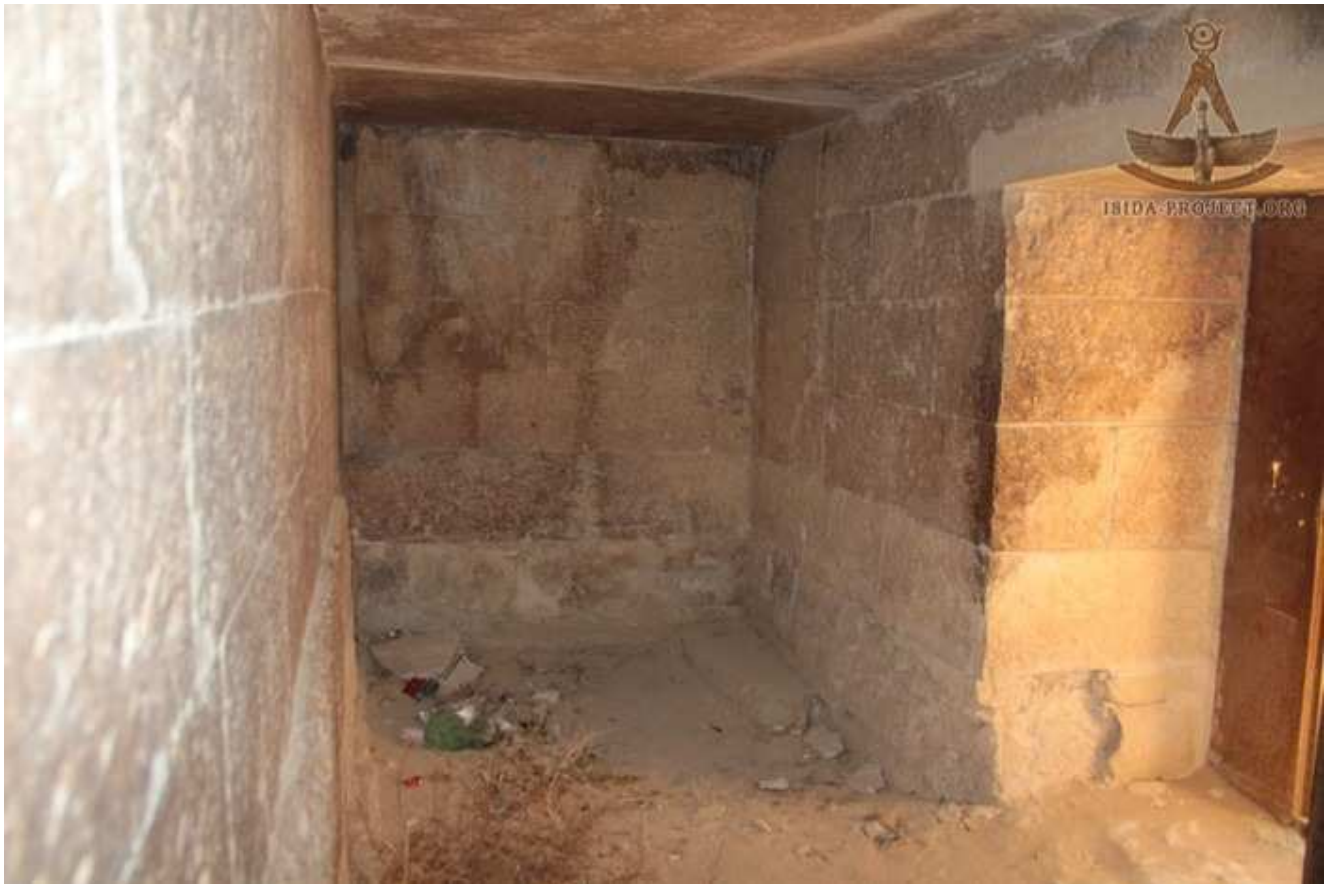
In the image above in the chamber by the courtyard entrance, you can see what appears to be an undressed lower course and possibly a broken tile by the door. Generally the temple is described as being made from tura limestone; but is this lower course local stone simply tiled? Was the thinking not to waste better quality stone on this course as it would not be seen by any subsequent floor blocks?

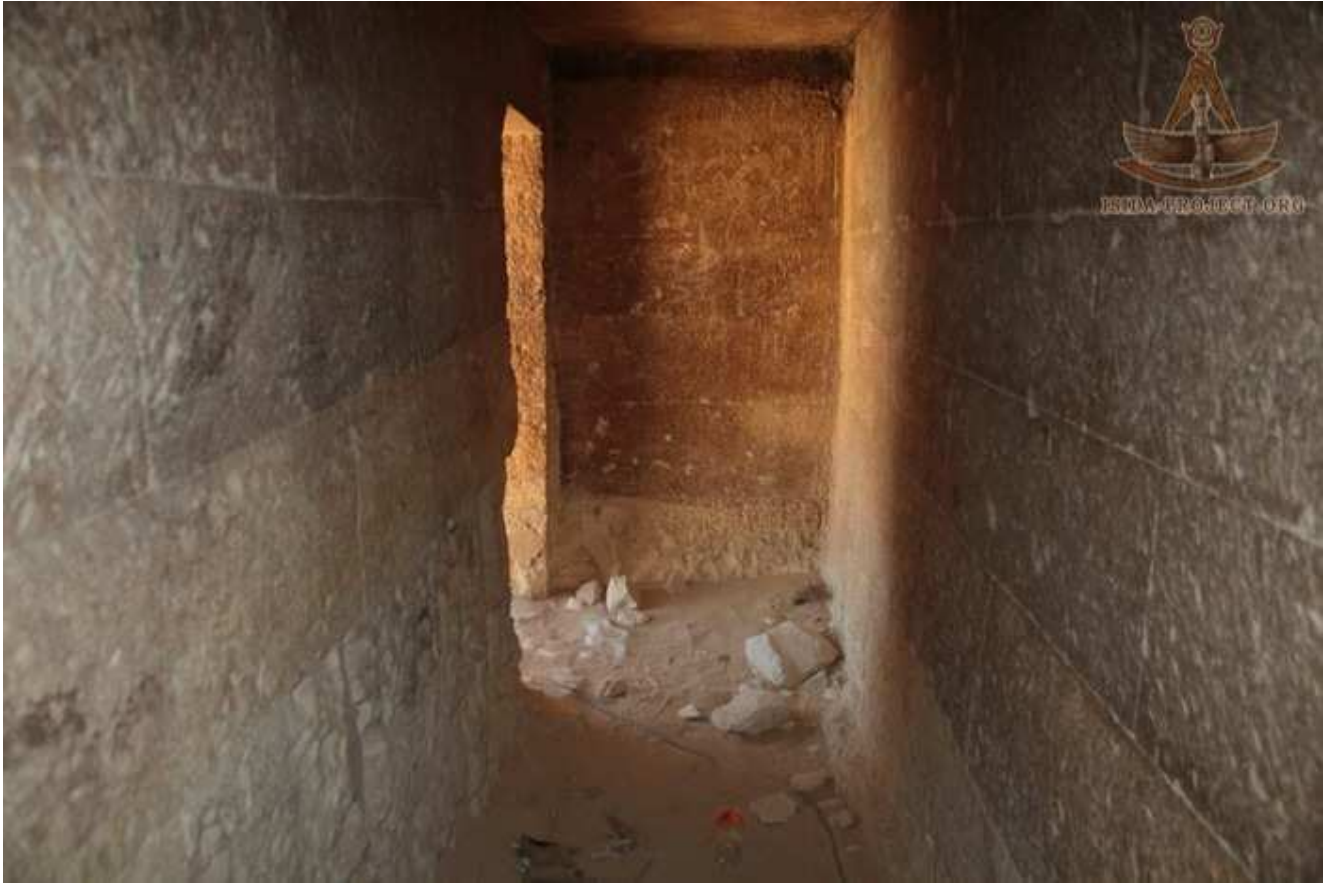
View along entrance passage

In the foreground is part of a ledge which is the second course, sitting proud of the course above, was this course still to be dressed?

Also in view is the footing that extends beyond the walls, that Petrie measured as 17 inches high in the south west corner of this chamber; this footing could also be used to support paving slabs. It's hard to imagine paving not being fitted and the floor being left in this rough unfinished state. One tends to think a temple to be a clean sacred place, were cleansed and purified priests went about their rituals; walking along a dirty floor doesn't seem to fit the picture.

Apparently in this passage Petrie found an intrusive burial from the 18th dynasty and the entrance door was carefully blocked with pieces of stone to protect it.

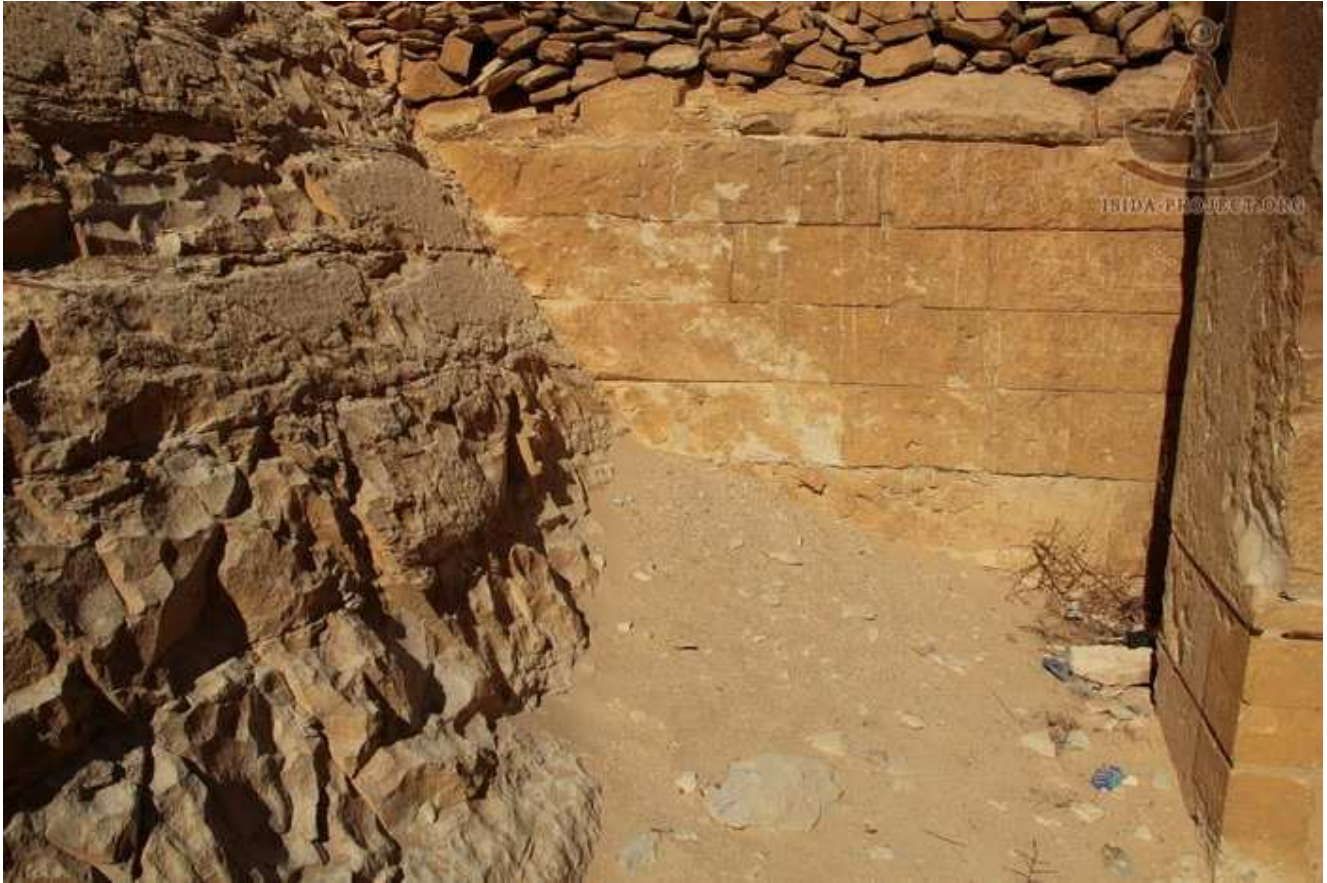
In the image above we see the north wall of the temple rest up against the casing of E3. The damage apparent on the casing is quite distinct to that of the temple wall, which seems strange.
