The Black Pyramid of Amenemhet III at Dahshur

A Layman's guide

Keith Hamilton

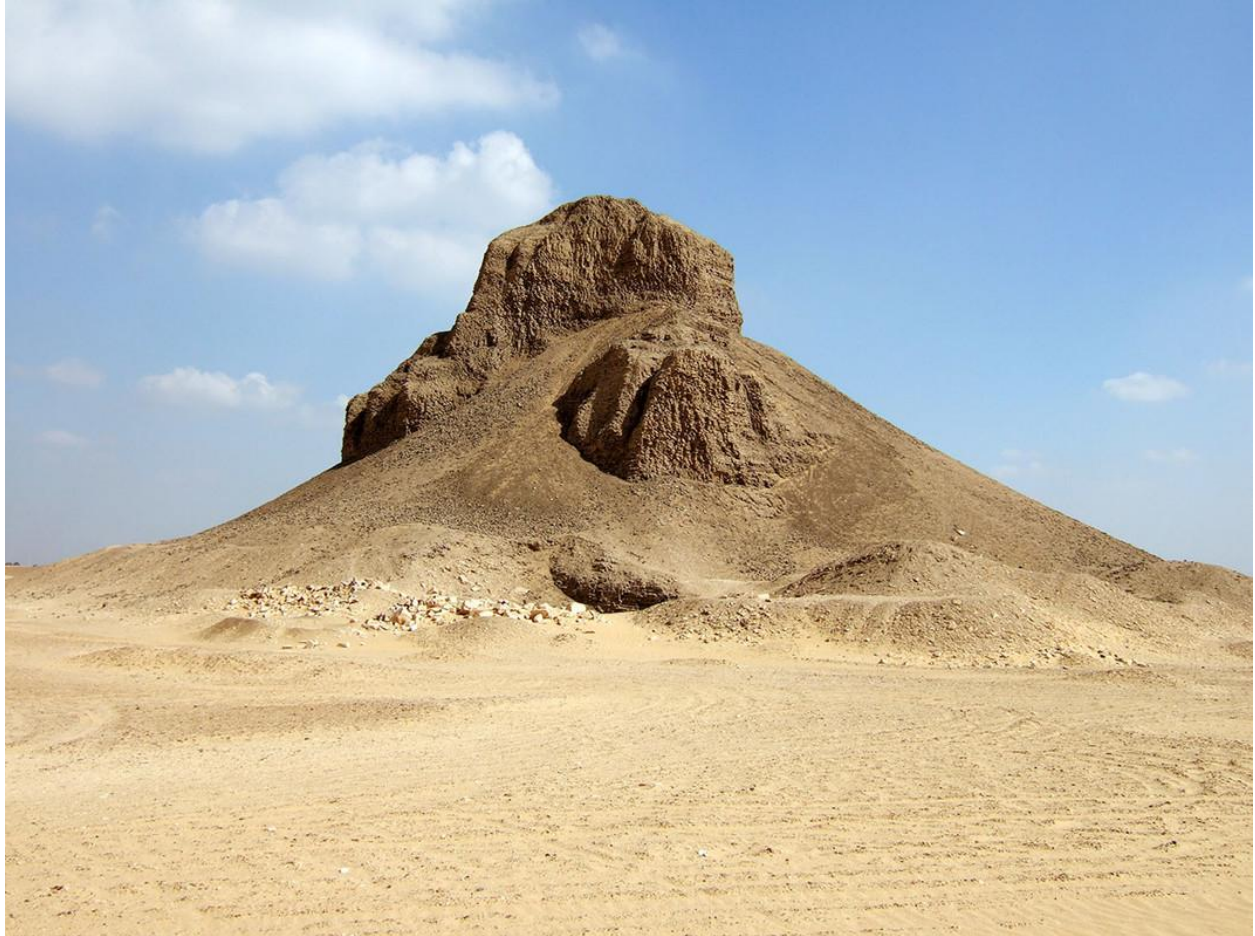
The above ruinous mound of mud brick is all that remains of the pyramid superstructure built by Amenemhet III of the 12th dynasty. Perring who visited the structure in 1839 stated; *“It is called by the Arabs, "Haram é Sodah," the Black Pyramid, and is now much destroyed, as it has afforded materials for the houses and tombs of the neighbouring village of Mensheeh.”*¹

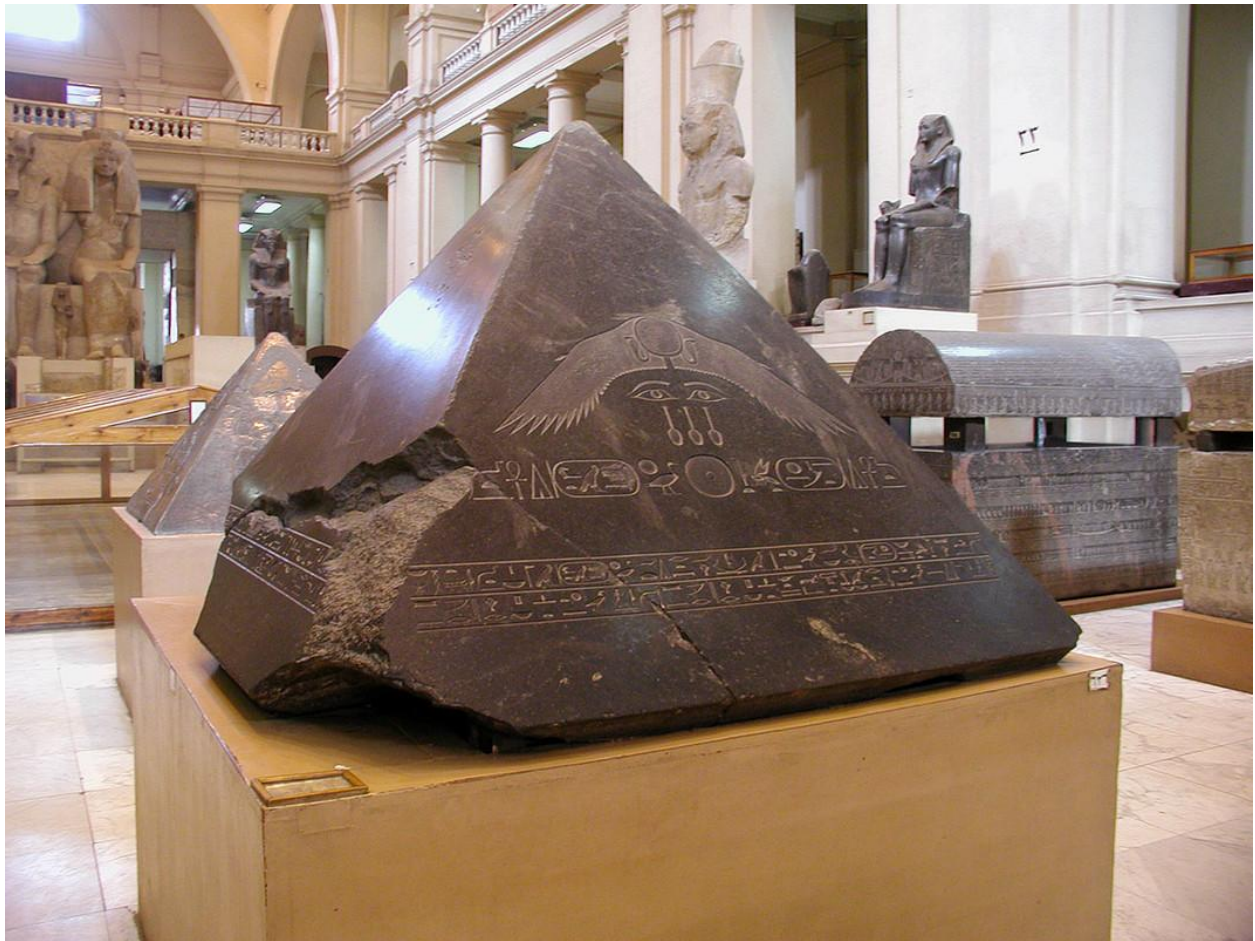
Some 5 years after De Morgan's work in October 1900 the above pyramidion was found in the vicinity of the pyramid temple, and in excellent condition. Arnold gives the calculable angle as $54^{\circ} 30'$. Arnold would comment on the condition of the pyramidion; *"The good state of preservation of the surface gives rise to astonishment when one considers that the top of the pyramid has demonstrably been exposed to wind and weather up to the Amarna period, i.e. almost 500 years. The erasure of the Amun name in the royal cartouches shows, however, that the pyramidion in the Amarna period was not yet a discarded block in the temple rubble, but was still standing as a monument. For it can hardly be assumed that the persecutors of the Amun name also tampered with shattered monuments that were to be regarded as destroyed anyway. On the other hand, the question arises as to how Akhenaten's emissaries could know that the pyramidion, when it was still in its place 75m above the pyramidal foot contained the Amun name, and how*

The good condition of the pyramidion concerned O. Firchow, who suggested that it may not have been fitted and that the pyramid was unfinished.²¹ Arnold would counter that the completeness of the rest of the pyramid complex, rather suggested that it was finished. The condition of the pyramidion is a concern to me; might we not expect more damage to it if it was dislodged and tumbled some 75m? If fitted it had a 1 in 4 chance of being found in the temple area; but the possibility cannot be discounted that the pyramidion always resided inside the temple; protected and easily found by Akhenaten's men who had easy access to erase the Amun element out of the cartouches. If we accept De Morgan's view that the pyramid resembled the Bent pyramid, then it is likely that any pyramidion that capped this upper section would display a shallower angle.

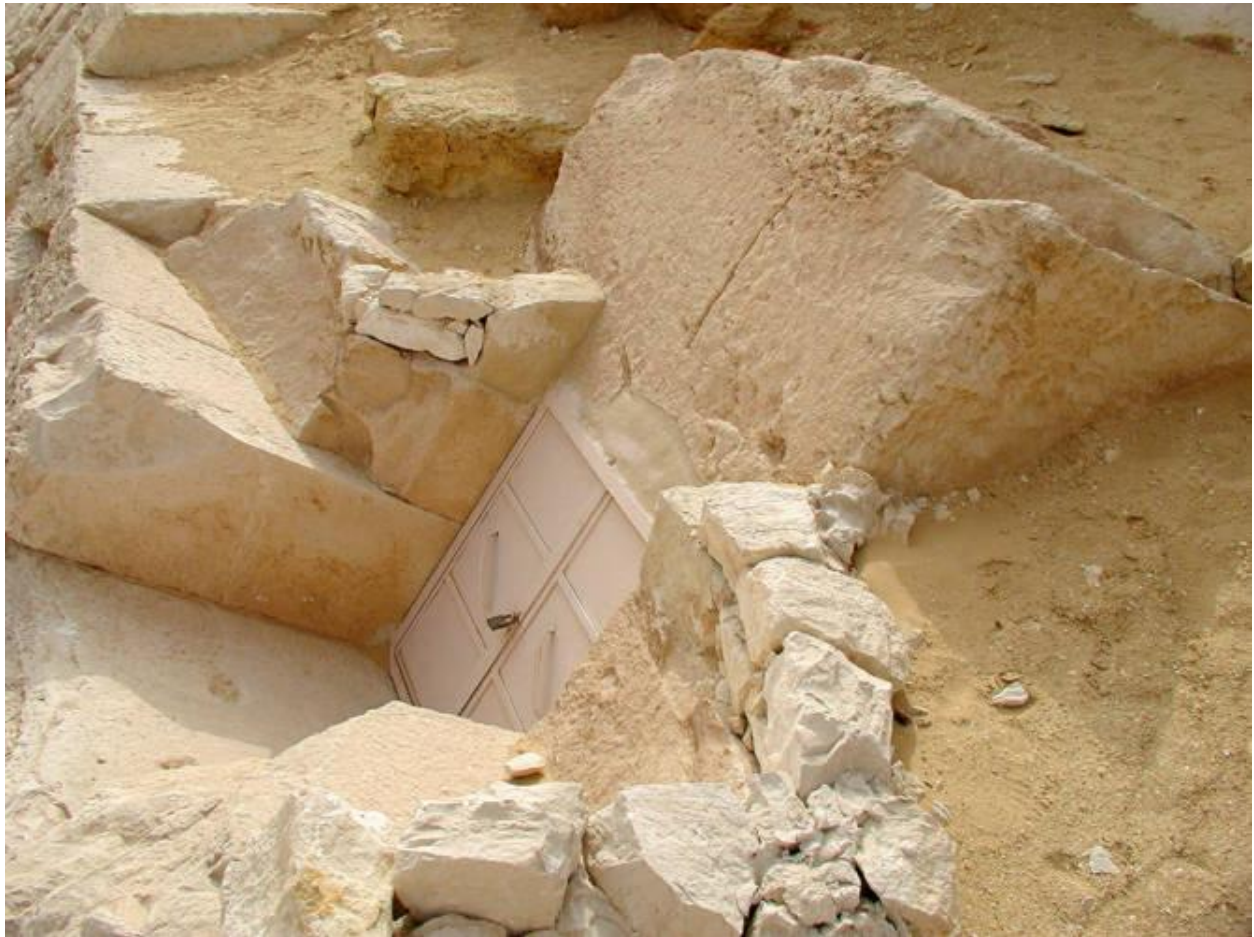
The above image of the entrance to the subsidiary highlights surviving casing; recently Colin Reader used a clinometer on the east and north face : ten locations were measured, the results were one instance of 45, one instance of 47, and 8 instances of 48 degrees. As a check he used the clinometer on the surviving casing stones of the Red by its temple and obtained 43-44 degrees. On a second trip, using a different instrument he obtained the same results. I am grateful to Reader for sharing these results; and it would be beneficial that further research is carried out to determine these casing angles; but it highlights the confusion to be found in a lot of literature. The northern Brick pyramid has also been subject to different angles

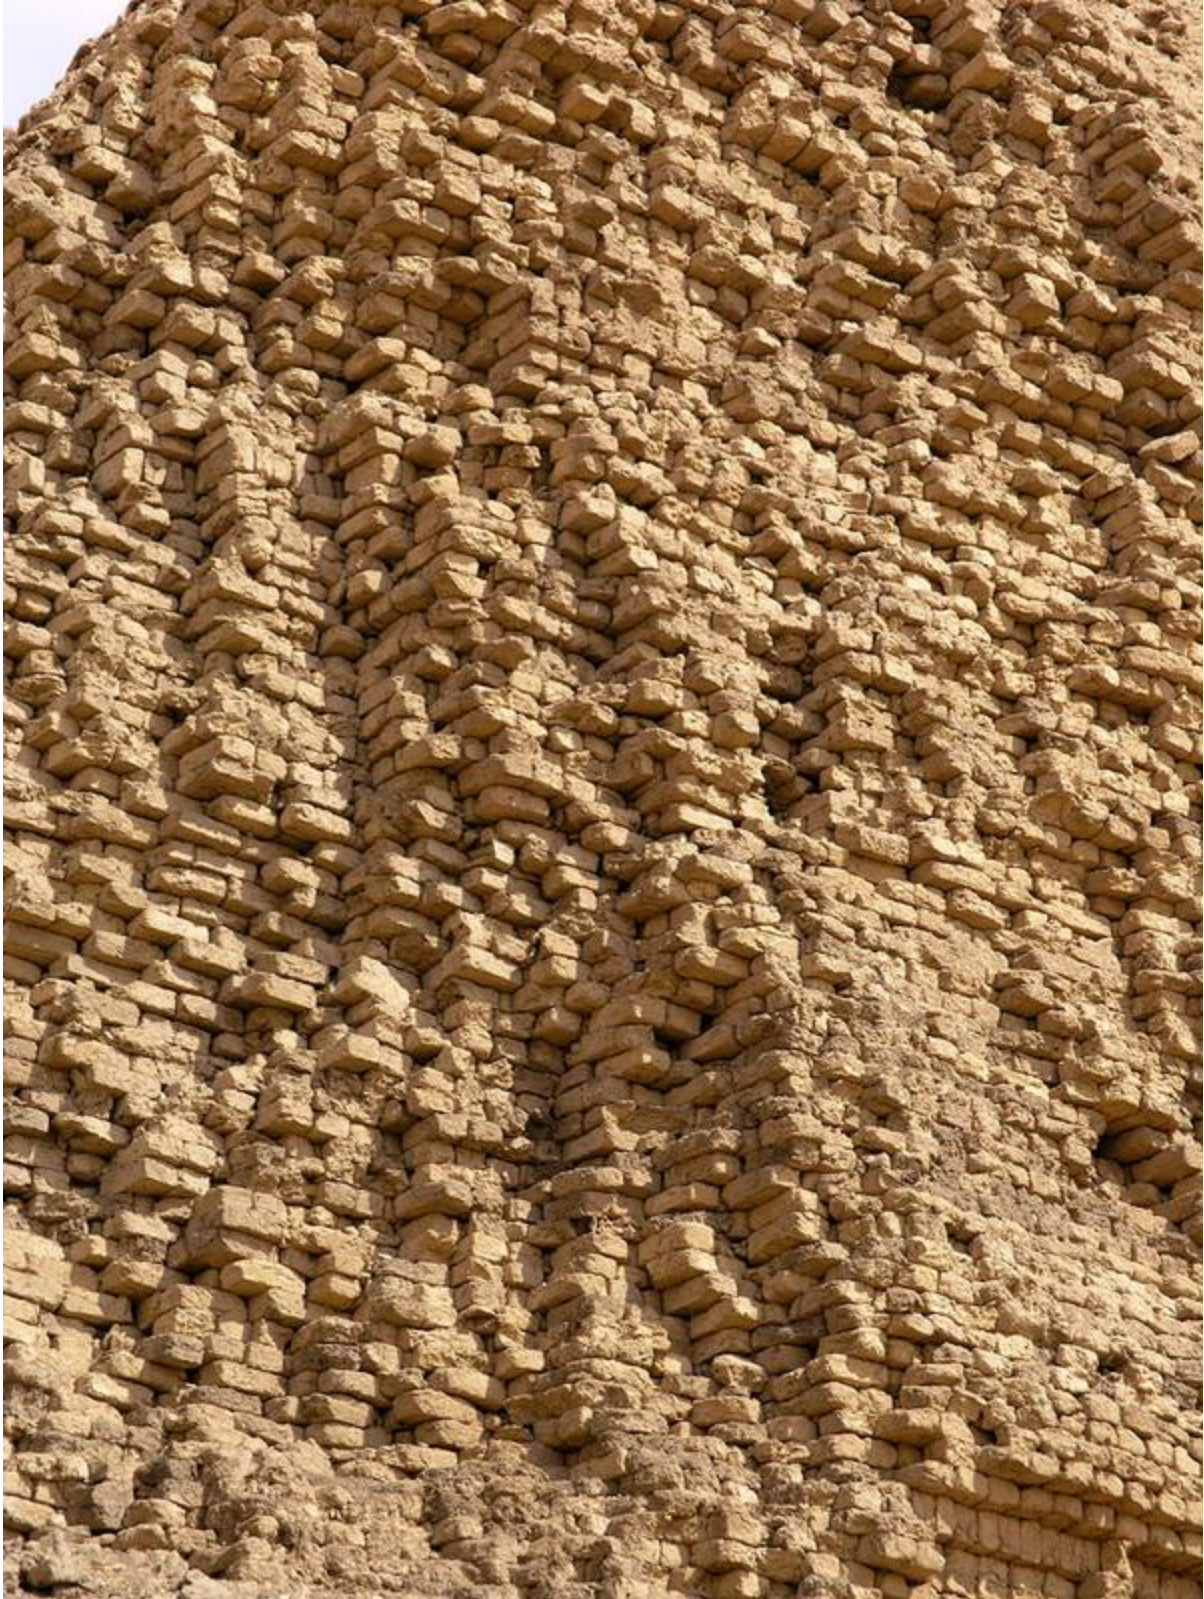
Some of the Marks were noted by Perring (shown above); he would also comment that; *‘It is built in the same manner, but not so carefully, as the other brick pyramid.’*²⁷ Arnold states that the bricks are laid without mortar; instead, they reside on thin layers of sand. A better preserved section of the core by the west entrance, indicated a 3-4m brick step behind the limestone casing.²⁸ As like so many Middle Kingdom pyramids, the bricks tended to have their narrow ends facing the outside; the image overleaf gives an idea.

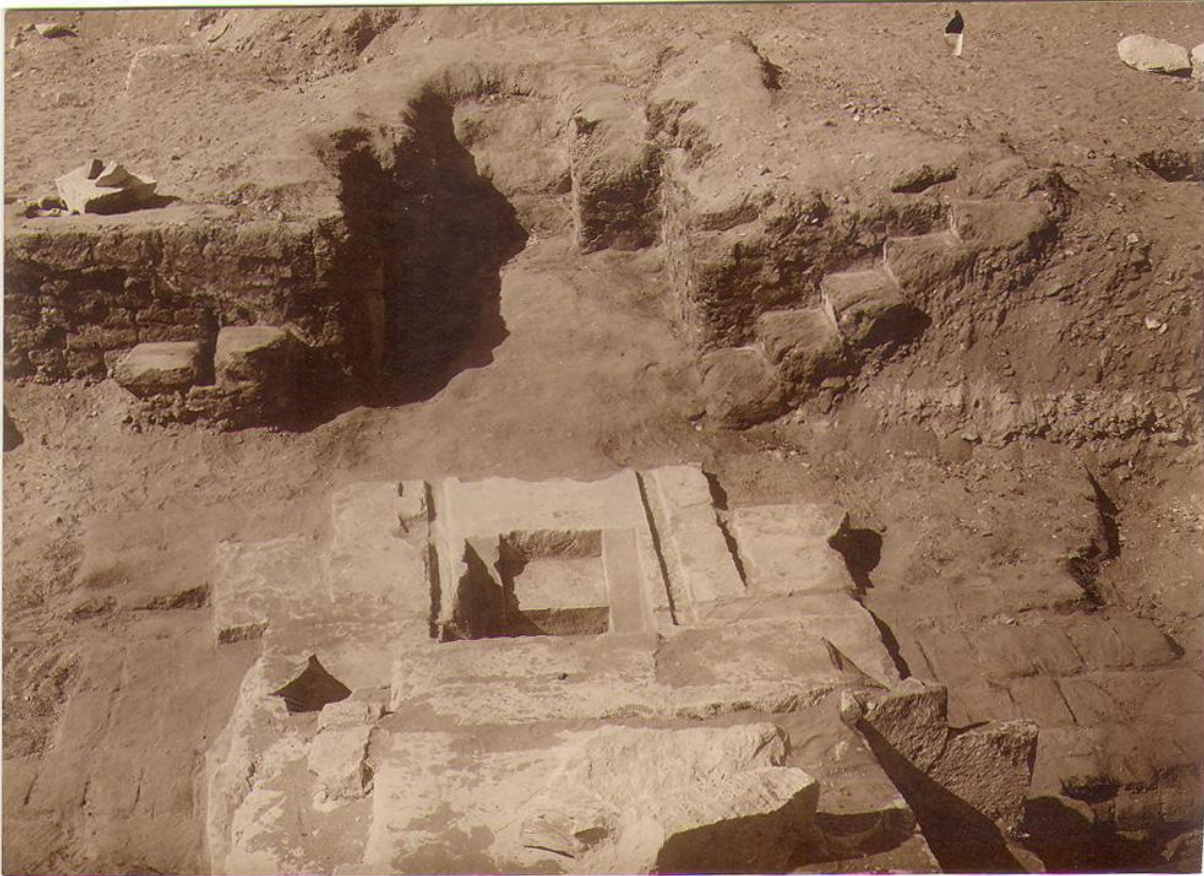
The above image of the entrance to Khendjer's pyramid shows it exiting in the floor of its foundation trench; the trench retaining wall can be seen, with stairs leading down to the trench either side of a deeper opening in front of the entrance, which has its own access steps at its rear. This opening may have been for the storage of a closure stone, which would have been slid forward with the help of the grooves visible in the limestone floor and seal the entrance. This stone would likely merge with the surrounding foundations stones, in a bid to thwart robbers.

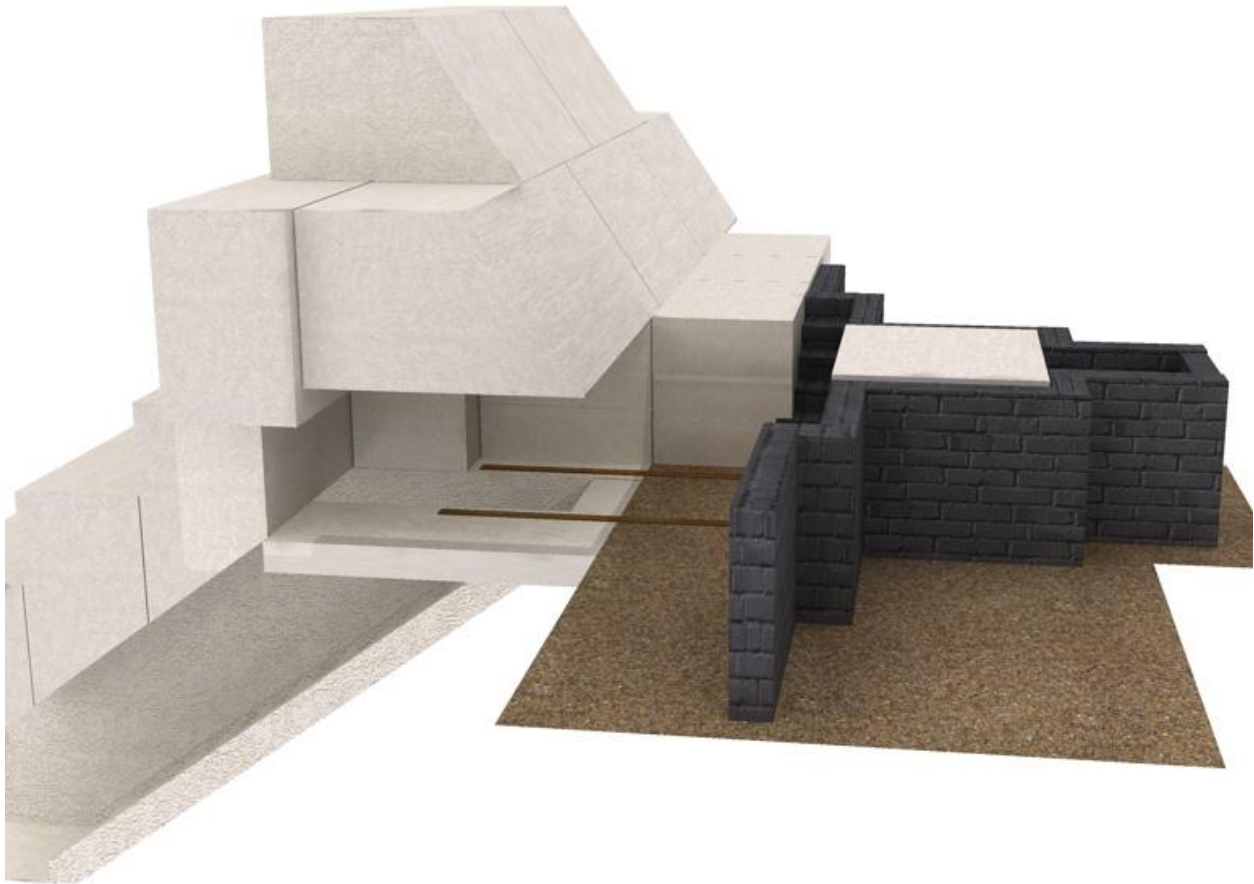
The old reports don't provide much information to work on, but the above reconstruction may have been one possibility in the closure of Khendjer's pyramid.

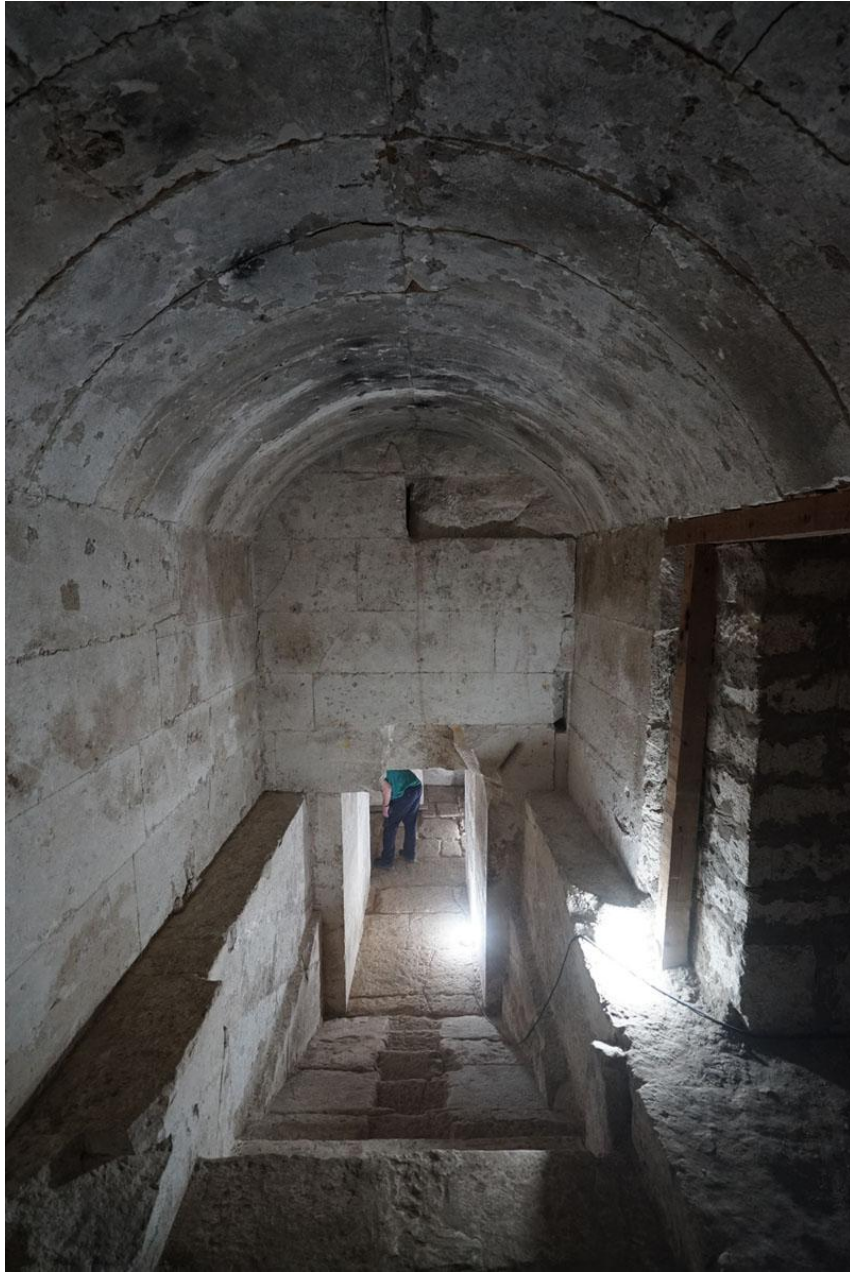
In the above image we can see the stairway leading down to O4; the uncertain entrance on the right has been repaired to support the ceiling slabs. The narrow ledges either side of the stairs are clearly visible.

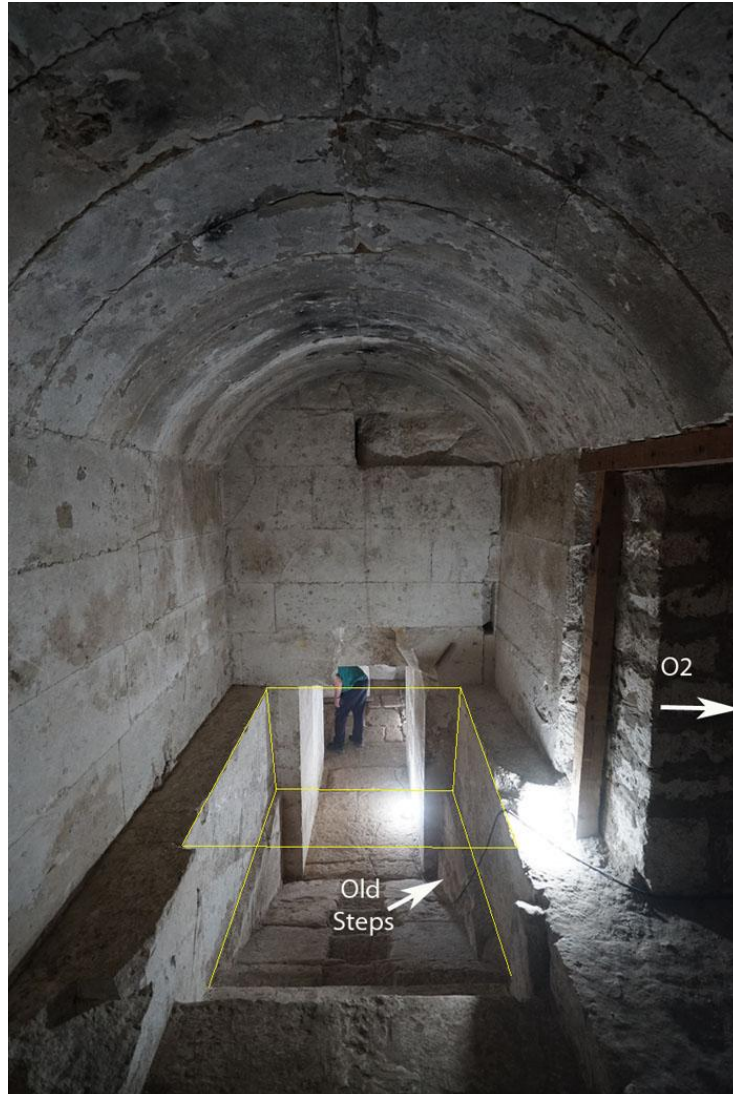
I have highlighted the area above the steps which is determined by the ledges and platform at the top of the steps; by scale rule from Arnold's plate 45 this area is 2m long 1.55m wide and 0.95m deep. How this area was concealed by masonry is unknown, but it could have been as little as two blocks each of 1 x 1.55 x 0.95m.

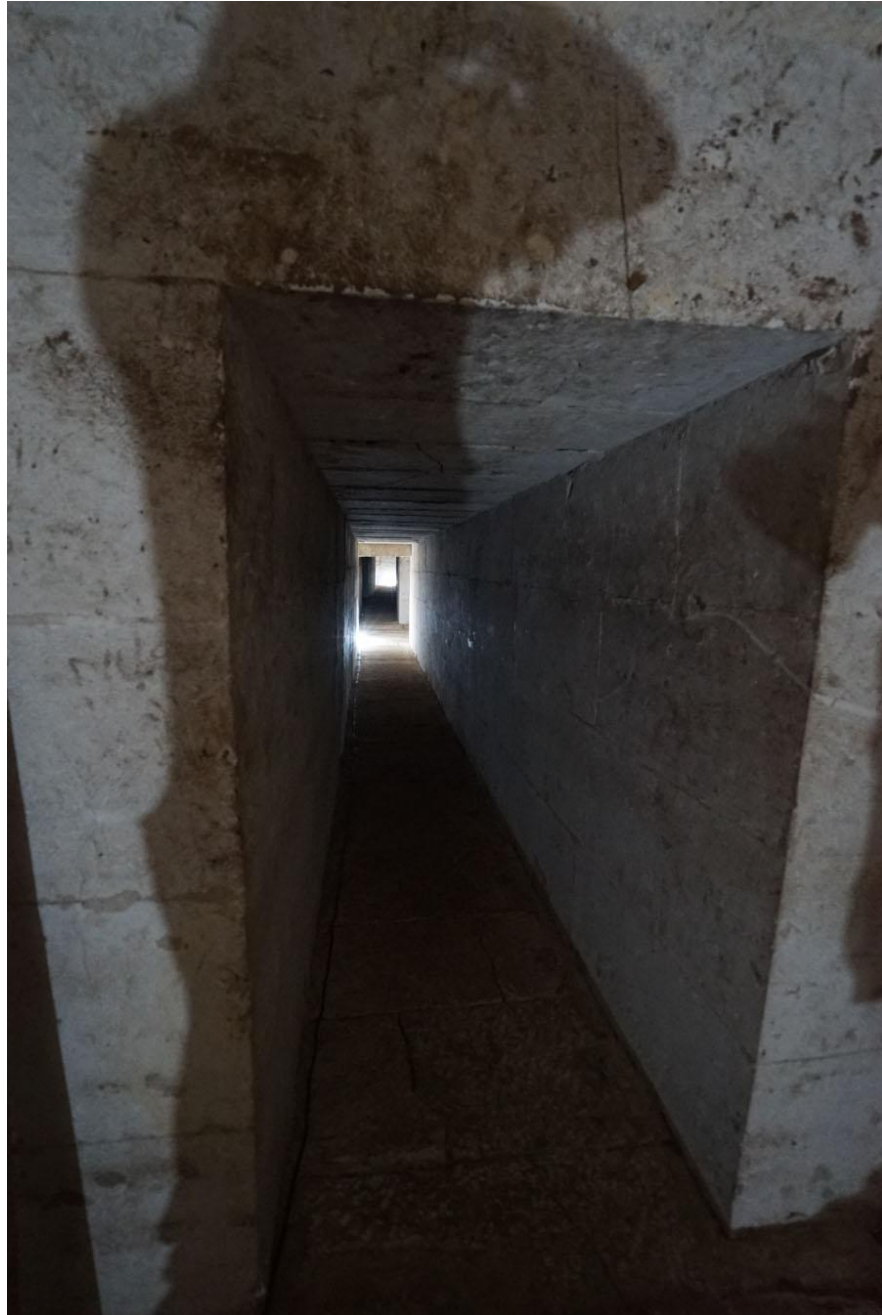
Passage O11

In the above image we are looking along O11 from O8; at the end of passage we can see the lintel of O12 which reduces the passage height here by some 26cm. The passage height varies from 2.03m at south end to 2.09 at north end: both passages O7 & O11 appear to exhibit a slight downward slope to O12; we have a

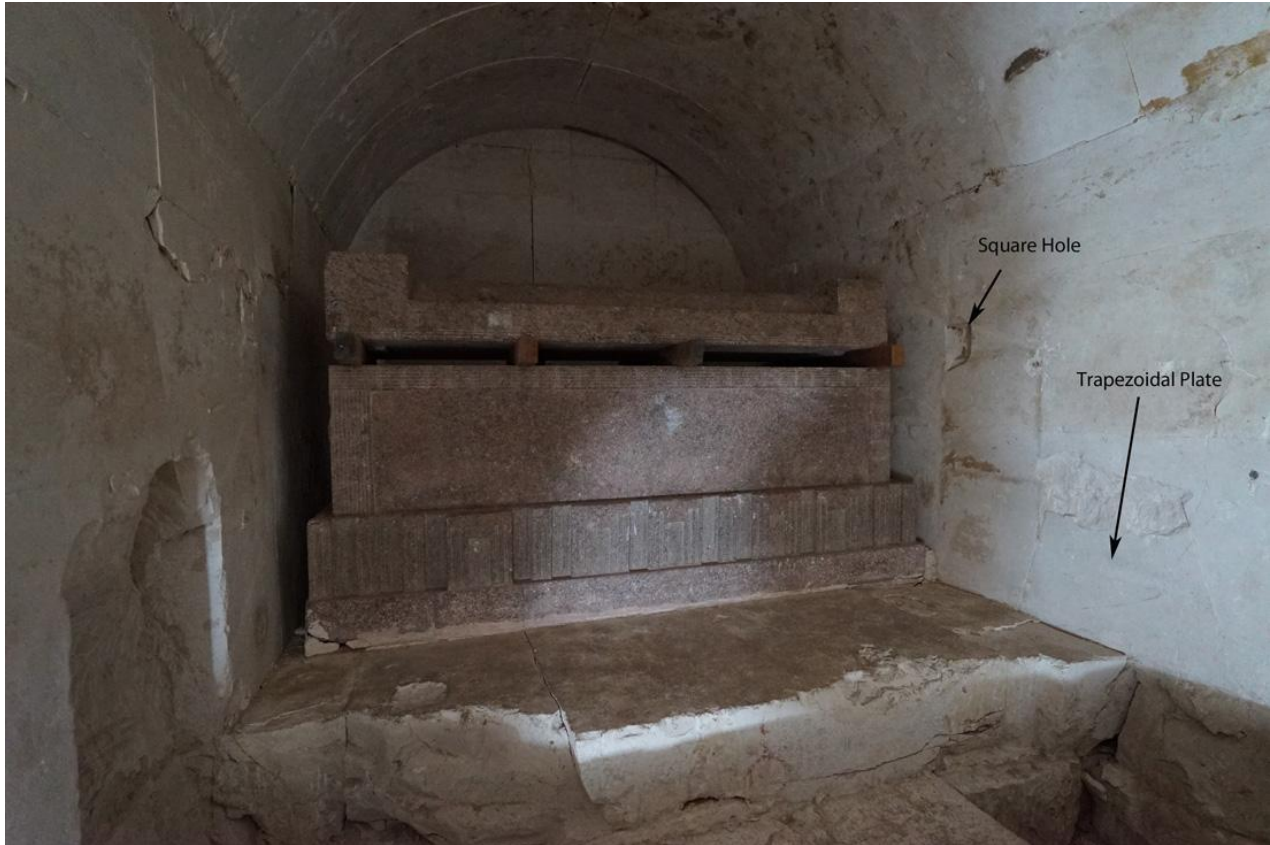
The above image shows some of the features in the Kings chamber; the trapezoidal plate in the north wall is fairly intact whilst the southern has been breached, at some unknown time. The square hole is also visible in the north wall; its southern counterpart can just be made out, with its blanking plate intact. At some point in its history a strip of paving has been removed by searchers; this allows us to see that the Kings chamber had two foundation courses, with the lower course being longitudinal.⁵⁶

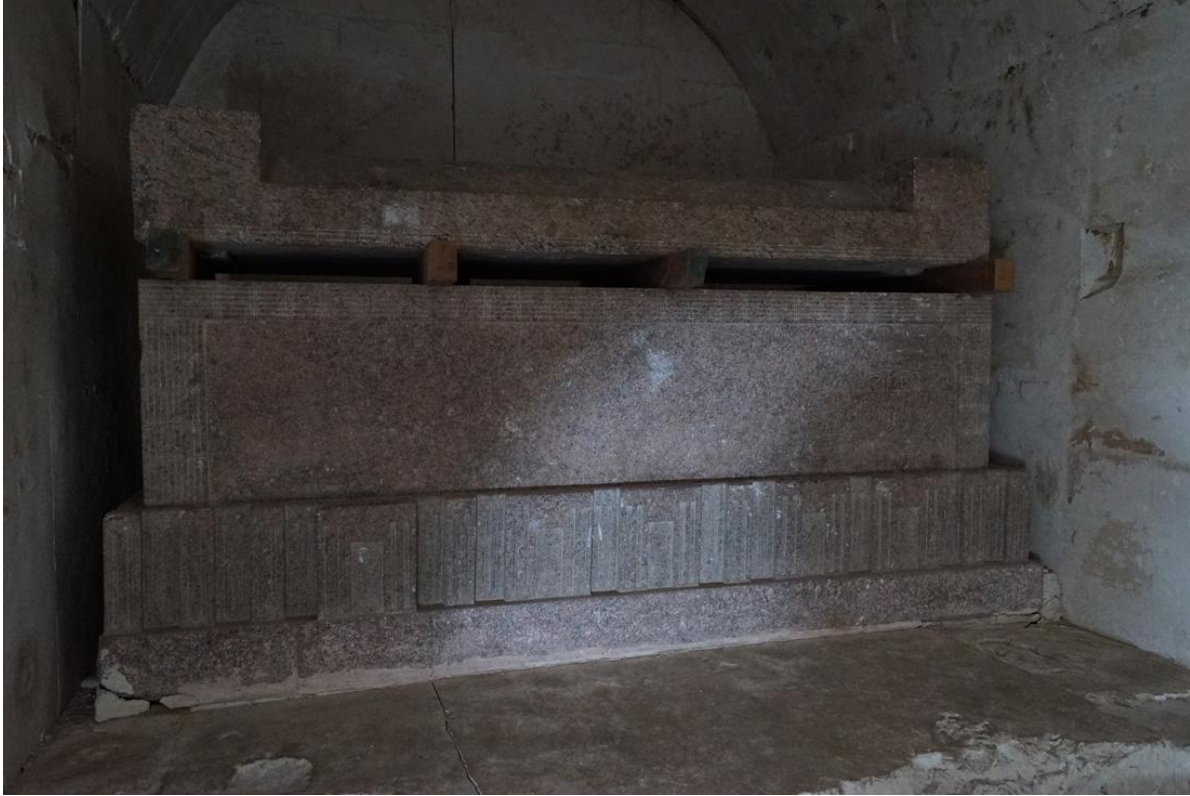
In the above image, one can just make out the eyes on the north end of the box; also we can more clearly make out the protruding entrance gate in the plinth. Arnold reports that as the walls and their foundations sunk, this left the ends of the sarcophagus protruding somewhat over these foundation stones; this left a gap that was filled with bits of stone and plaster, which was painted pink in an attempt to match the sarcophagus. Further, as gypsum traces were found on the chamber walls, it suggests that this chamber was blocked with stone blocks; so the plaster repair had to have been done before the blocking.⁵⁷

The sarcophagus, made from red granite has a wide base of some 1.15m, a length of 2.61m, and a height of 1.32m. The prominent base, like his predecessor's mimics Djoser's enclosure wall; though extra detail is given in the form of reed matting that frames the edges of the box and a pair of wadjet eyes that face east.

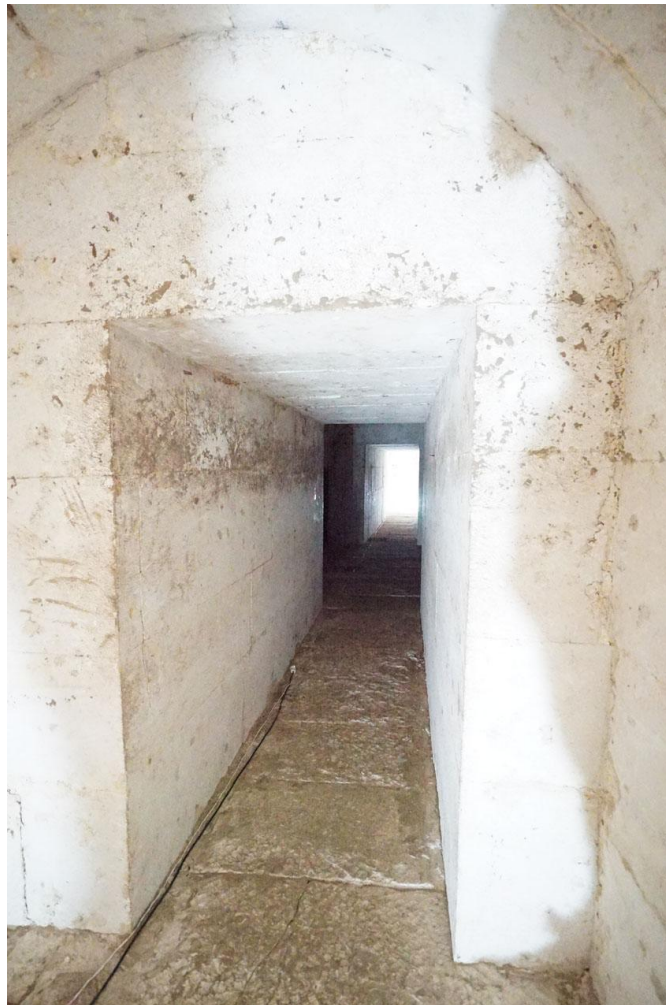
The image on the previous page shows the short passage O17 from inside O12; we can also see that the passage is not located centrally to O12 but shifted to the east: further, according to Arnold's Faltplan 1, it appears to deviate slightly to the north-east, as does passage O21.

Retracing our steps from the kings chamber we return to O12 and head north via a short passage O17; some 3.96m long, 1.09m wide and 2.09m high.

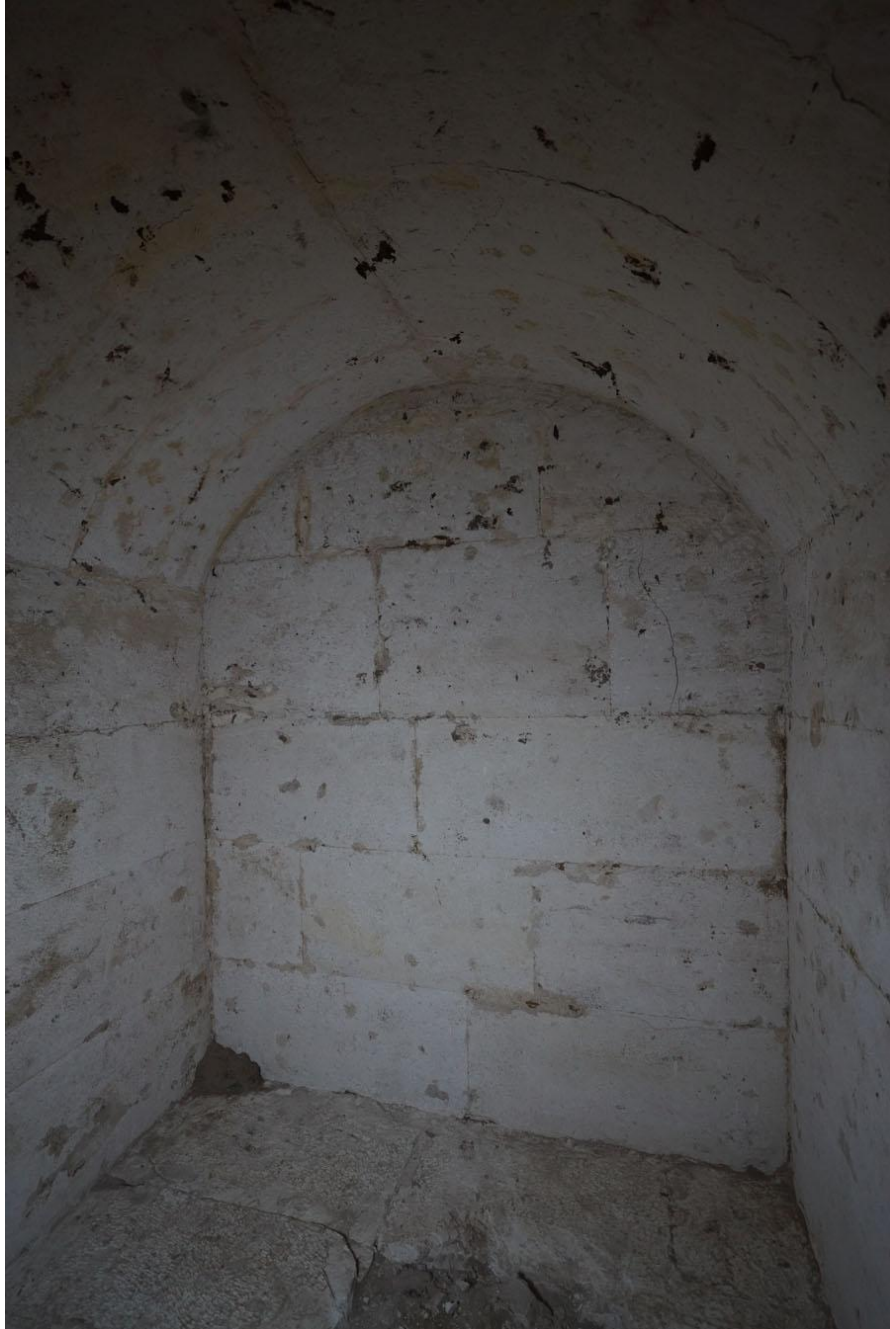
The above image shows one of the side chambers, and judging by the floor slabs, we appear to be looking at the north wall of O20.

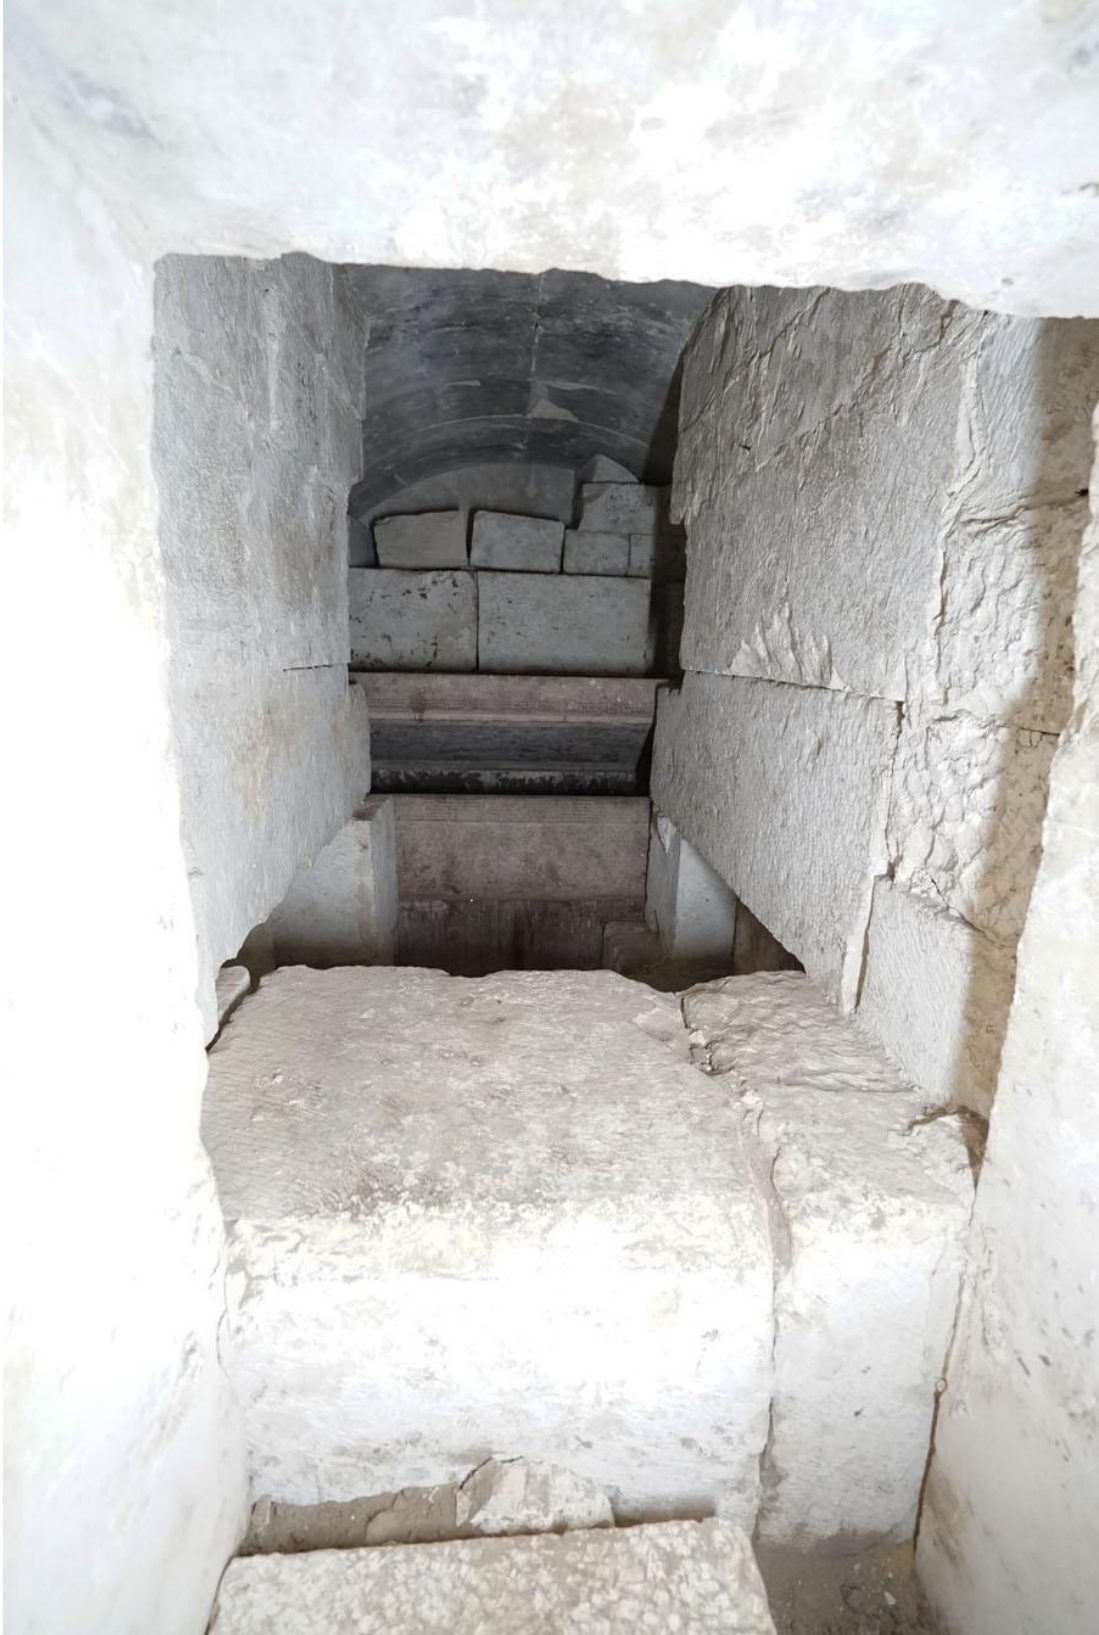
The image on the previous page is taken from inside W7, looking into Queen Aat's burial chamber; the sarcophagus lid is propped open, and the masonry fill to reinforce the chamber is still quite extensive. At the top of the west wall, we can see that they even shaped the fill blocks to match the contour of the ceiling. In front of the sarcophagus a transverse space has been left by the builders of the masonry fill, which was spanned by long beams on edge around 1.8m long; these beams rested on masonry blocks that fronted along the sarcophagus and the east wall (some of this masonry has been removed in front of the sarcophagus by Arnold, who sawed through two blocks, in order to view the niche decoration). This transverse space is given as 2.80m wide and 1,10m deep, so it takes up the width of the chamber.

The short passage W7 which leads to the burial chamber W8 is practically identical in size to that by the Kings chamber O15. Access to the Queens chamber is still largely restricted by a sizeable mass of stone filling, which prevents us from closely examining the makeup of the chambers masonry; the robbers appear to have extracted enough to allow them to go about their work. The fine granite sarcophagus, like the kings, is set a distance from the west wall, which allows the lid to be stored behind and pulled forward on closure: all three sarcophagi have a ramped projection on the undersides of their lids, so that on closure, the edge of this projection would abut against the inside edge of the box, and prevent it from being pulled off. The sarcophagus at its widest projections is 2.61m long, 1.05m wide? (The stone blocking makes it hard to examine all areas of the sarcophagus) and 1.30m high. This makes it the same length as the Kings sarcophagus and as the three burial chambers share the same width (which helps in roofing beam production) we run into the same problem as to how the sarcophagus was introduced. The stone filling prevents us from observing the walls to see if trapezoidal plates exist, or the square holes that might have assisted fitment of the lid. If construction shafts existed that allowed the sarcophagi to be pushed in without turning, then they are more likely to exist outside of the chambers west walls. It might be worth doing some GPR through these walls and see if they exist.

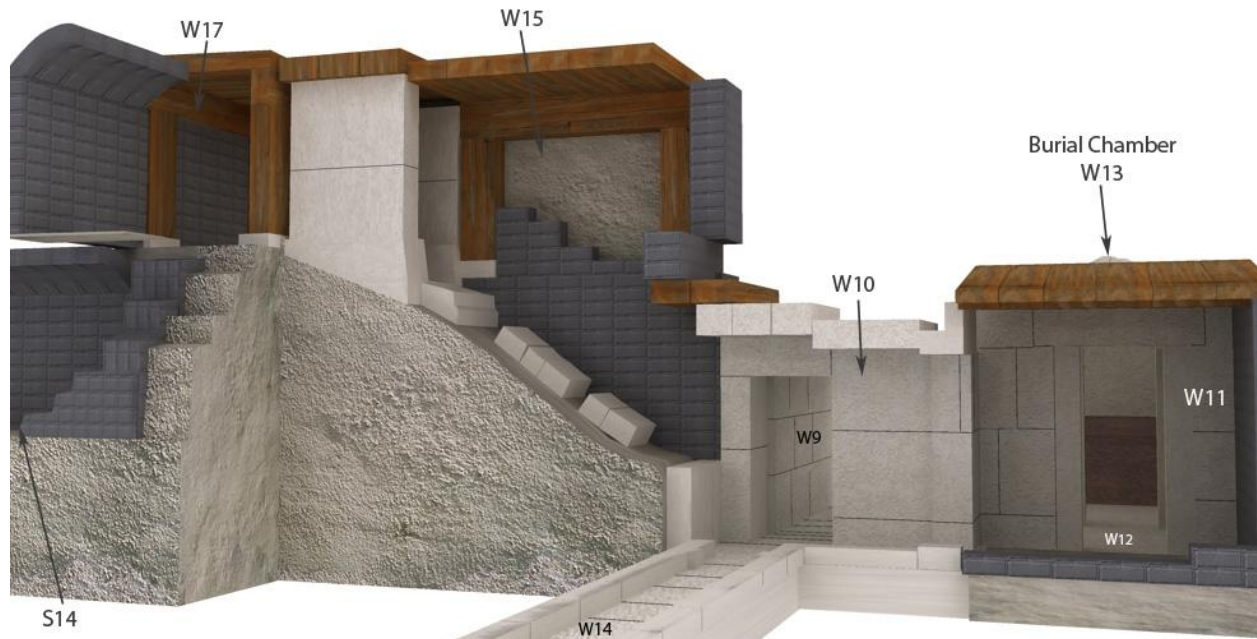
The above section gives a rough idea of the layout of the unidentified Queens apartments; the similarity to Aat's is clear, though dimensions vary. There are three routes of entry, two from the west; the upper passage W16 and the lower passage W9, whilst the long passage W14 enters from the east. The lower passages W9 & W14 converge on the short passage W10, and like in W5 this lower passage appears to cut through the unfinished stairway of W15. At the bottom of the unfinished stairs, two limestone blocks were found abutting against its vertical face, as if an attempt had been made to wall up the unfinished stairway: the stairway itself was found completely bricked up to the ceiling, and an attempt had been made to remove some of this filling from the bottom; either by De Morgan's men or robbers.⁷⁹ W10 had been badly affected with the stresses imposed on it and De Morgan had the passage shored up with timber, which prevented Arnold from closely observing its construction.

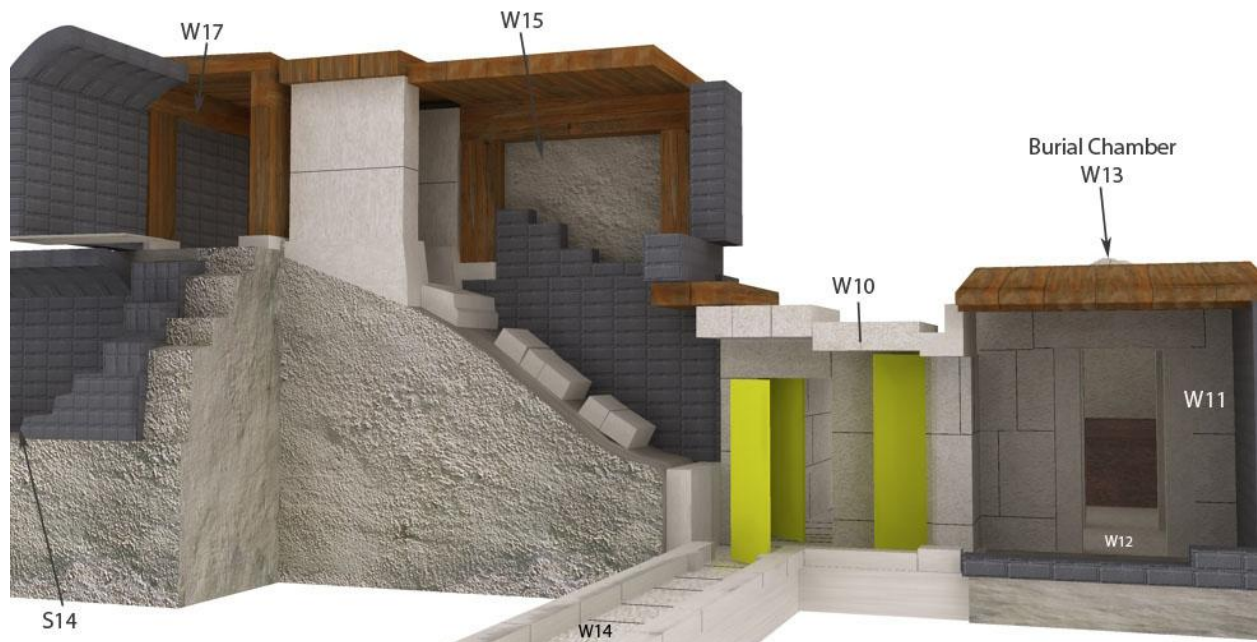
The three door positions are shown above, all doors open and are locked from inside W10 (two other door locations exist inside the pyramid, one at the west end of W9, which is locked from inside W9, and the other at the east end of W14, which is locked from inside O4. Of these 5 doors, only the most western door by W9/W5 had a pivot hole in the floor)

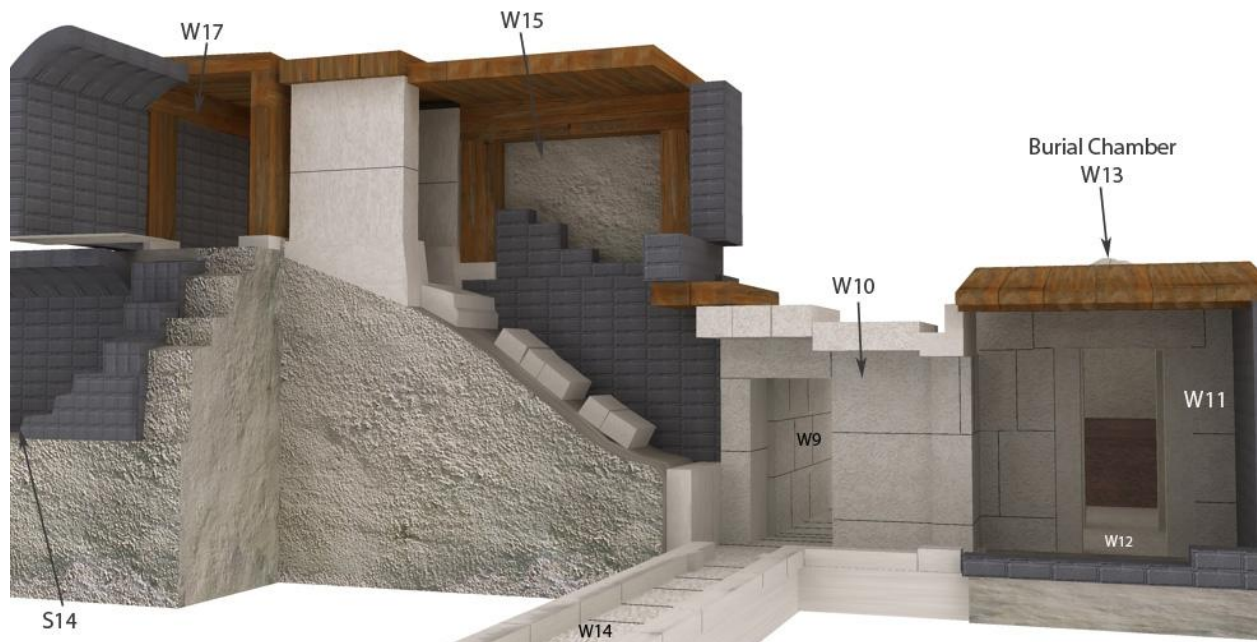
W15 was basically framed in wooden beams with the walls between filled with brick that was found whitewashed. In the image above we can see that the west wall was bricked up to a certain level, then limestone pads were placed on it, followed by a wooden beam; two of these each end of the chamber, supported a wooden crossbeam, which in turn supported the wooden ceiling beams: the space in between was further filled with brick, to help support the crossbeam. The north wall is strange in that the lower three courses protrude out at the bottom and rest on more wooden beams.
