The Black Pyramid of Amenemhet III at Dahshur

A Layman's guide

Keith Hamilton

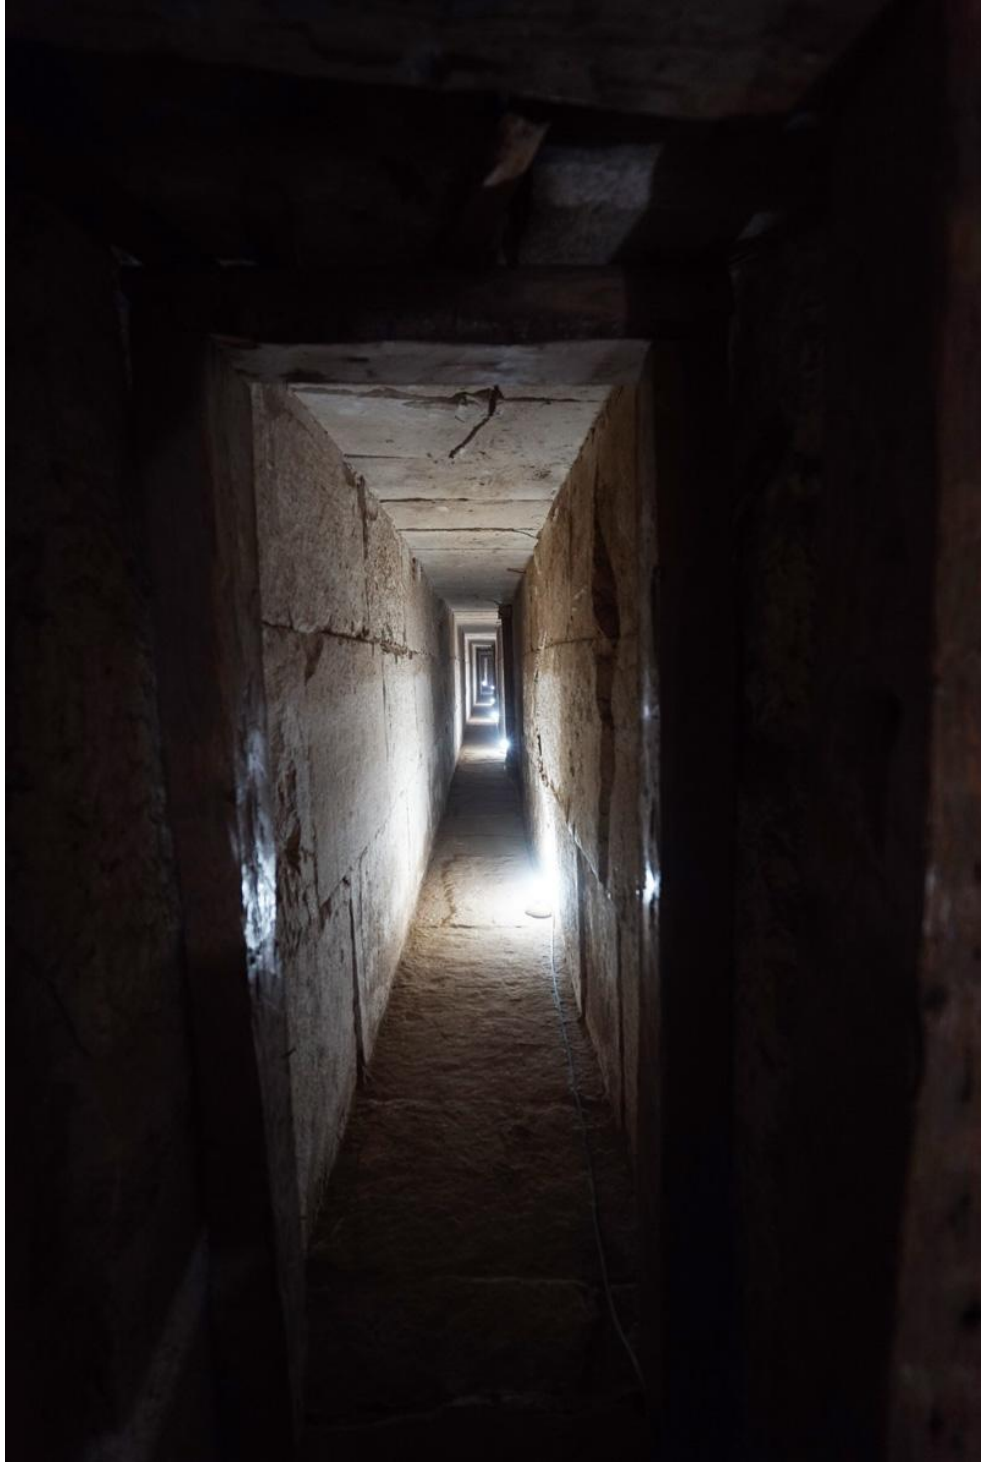
Long passage W14, length 27.15m, width 0.60m, height 1,71m

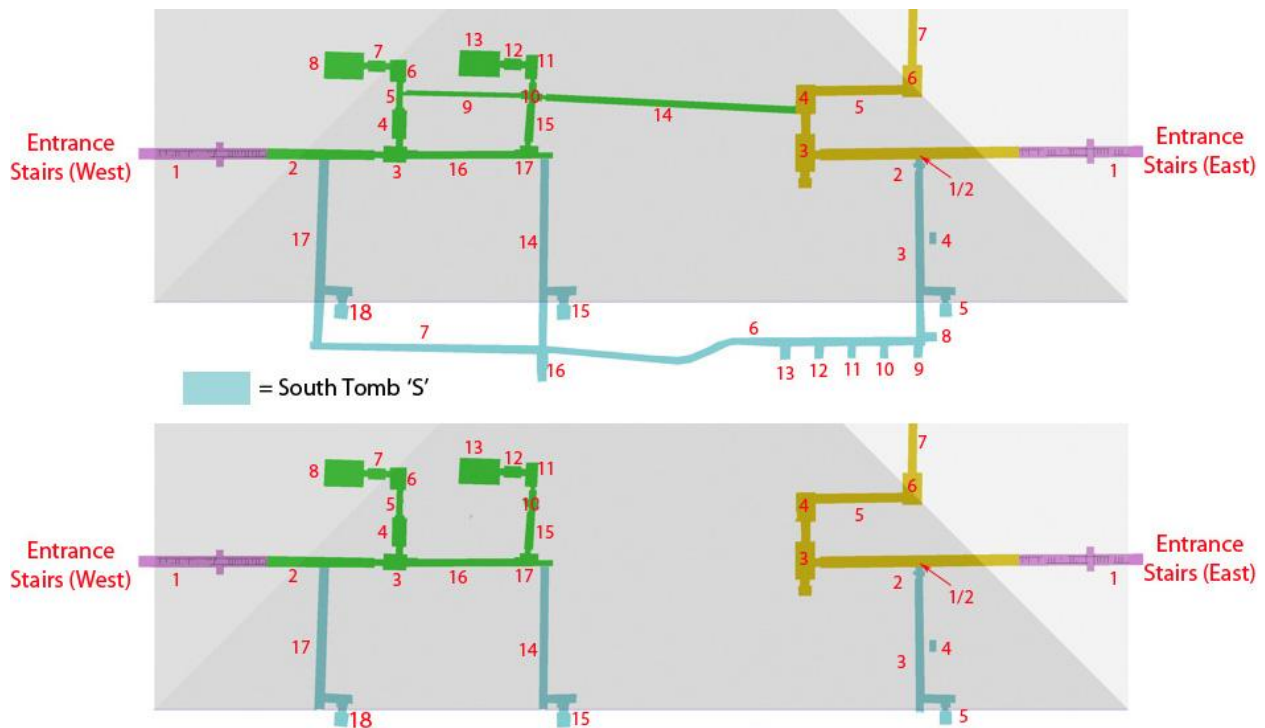
The layout of the south tomb appears strange, as well as being a security concern; could the lower plan above be the original intent of the builders, with the rest being later modifications? The construction of S1/2 is a concern as this effectively closes access to S5, and the large opening in the floor of O2, is an awkward obstacle to the introduction of materials to the inner tomb; moreover, it's rough unfinished
